Investigation Report for Exceedances of Action Level and Limit Level of Water Quality Monitoring in December 2022

Environmental Team for Hung Shui Kui/ Ha Tsuen New Development Area Stage 1 Works – Site Formation and Engineering Infrastructure								
Date	Station	Parameter (Unit)	Depth-averaged Measured Value	Action Level	Limit Level	Exceedance		Investigation Results
						AL	LL	
6/12	TKW1	DO (mg/L)	2.2	2.8	2.8		✓	When exceedances of action level (AL) and/ or limit level (LL) of <i>in situ</i> water quality monitoring results were observed, the water sampling team had conducted repeat <i>in situ</i> measurements to confirm findings in accordance with the corresponding Event and Action Plan. After confirmation of exceedances, sampling team had taken photos of the sampling point and the surrounding environmental to identify sources of impact. No upstream sediment plume was observed. There was no evidence to demonstrate that the water quality monitoring exceedances were caused by the construction works from Road D1 construction site. Site investigations were carried out by the ET on 9, 16, 23 and 28 December 2022. During the meantime, the Contractor was applying effluent discharge l

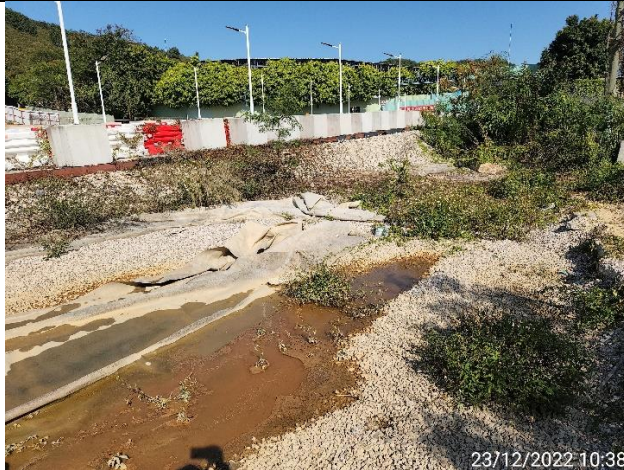
23 December 2022

All wastewater / surface runoff was collected and diverted to sump pit. Direct effluent discharge was not allowed to be discharged from the site. No discharge of wastewater was observed during site investigation.

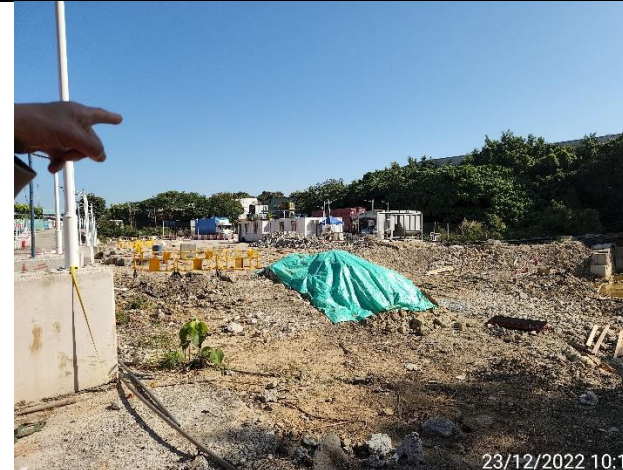
Stockpile of dusty materials was covered properly to avoid generation of muddy runoff.

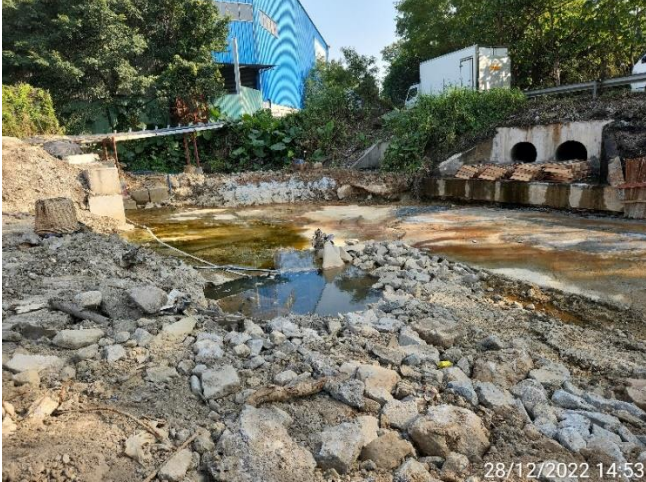
<p style="text-align: right; font-size: small;">28/12/2022 14:53</p>

<p style="text-align: right; font-size: small;">28/12/2022 15:00</p>
<p>All wastewater / surface runoff was collected and diverted to sump pit. Direct effluent discharge was not allowed to be discharged from the site. No discharge of wastewater was observed during site inspection.</p>	<p>Stockpile of dusty materials was covered properly to avoid generation of muddy runoff.</p>
