Investigation Report for Exceedance of Limit Level of Water Quality Monitoring on 1 March 2023

Environmental Team for Hung Shui Kui/ Ha Tsuen New Development Area Stage 1 Works – Site Formation and Engineering Infrastructure								
Date	Station	Parameter (Unit)	Depth-averaged Measured Value	Action Level	Limit Level	Exceedance		Project Related (Y/N)
						AL	LL	
01/03	SW	Suspended Solids (SS) (mg/L)	14.0	8.8	10.5		✓	N

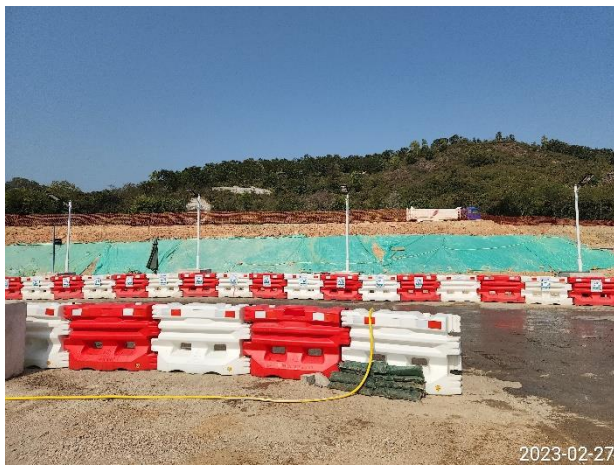
(P1)

Stockpile of dusty materials was covered properly to avoid generation of muddy runoff

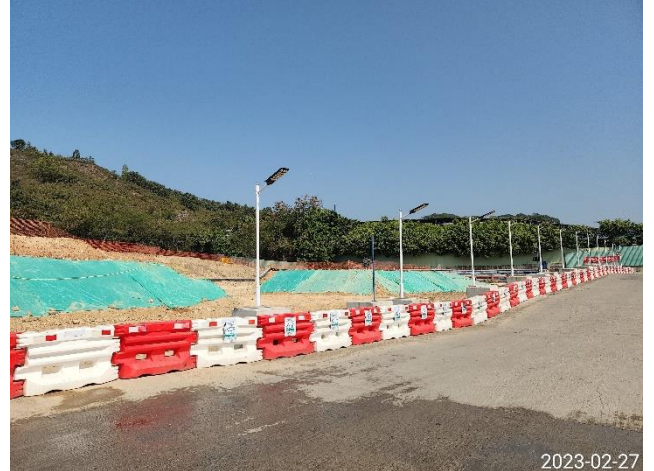
(P2)

No muddy surface runoff and direct effluent discharge was observed during site inspection.

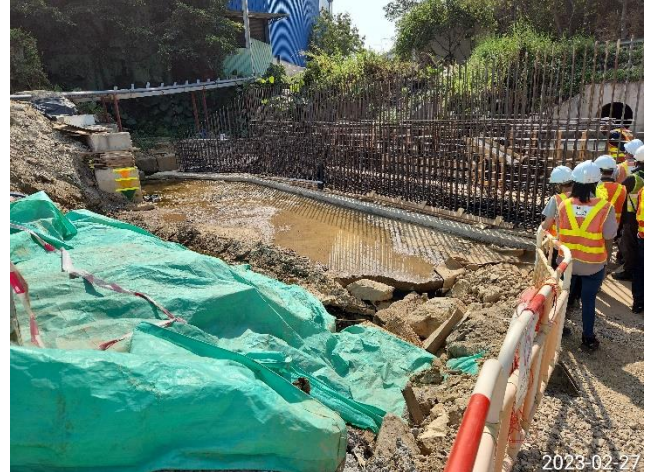
(P4)

Groundwater was collected and diverted to WetSep for temporary storage and deposition before the water was used for fugitive dust suppression on site. No direct effluent discharge was allowed.

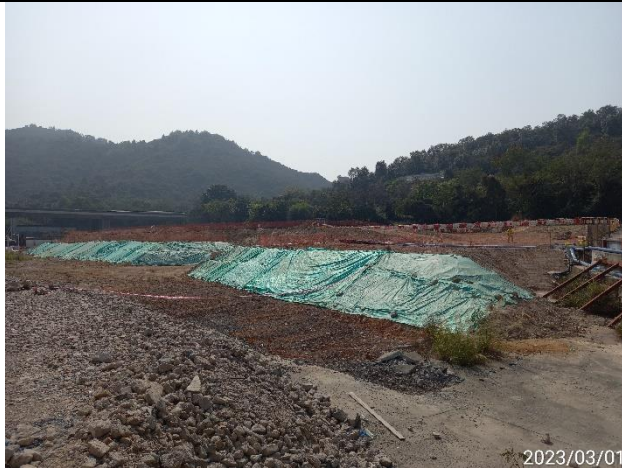
(R1)

Stockpile of dusty materials was covered properly to avoid generation of muddy runoff.

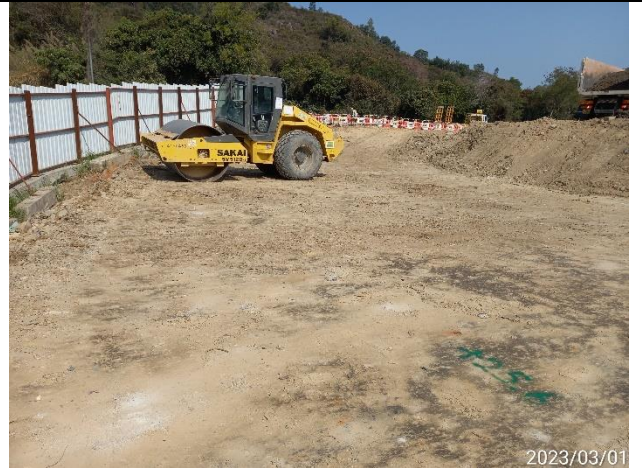
(R2)

Rolling pass was provided to prevent dust emission and generation of muddy runoff.

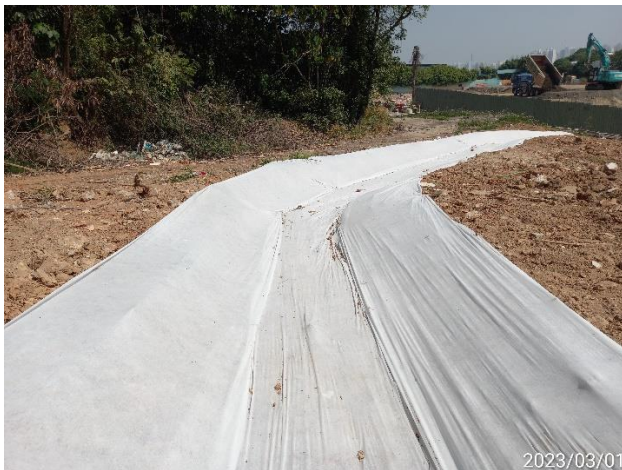
(R3)

Earth bund was provided to avoid muddy surface runoff. No muddy surface runoff and direct discharge of ground water was observed.

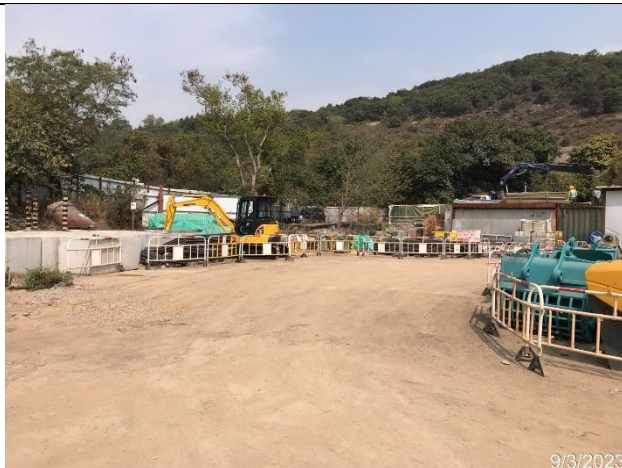
(R4)

No effluent discharge from the site was observed.

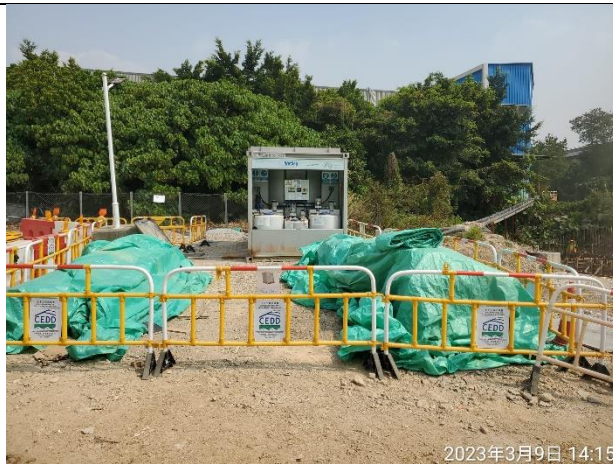
(P1)

Groundwater was collected and diverted to WetSep for temporary storage and deposition before the water was used for fugitive dust suppression on site. No direct effluent discharge was allowed.

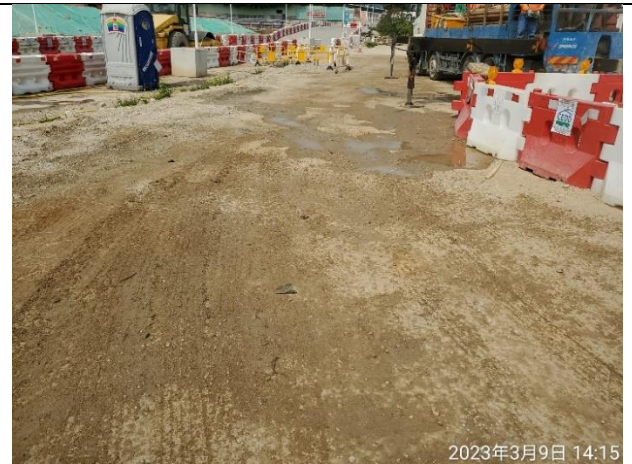
(P2)

No muddy surface runoff, pollution discharge and direct effluent discharge was observed during the site inspection.

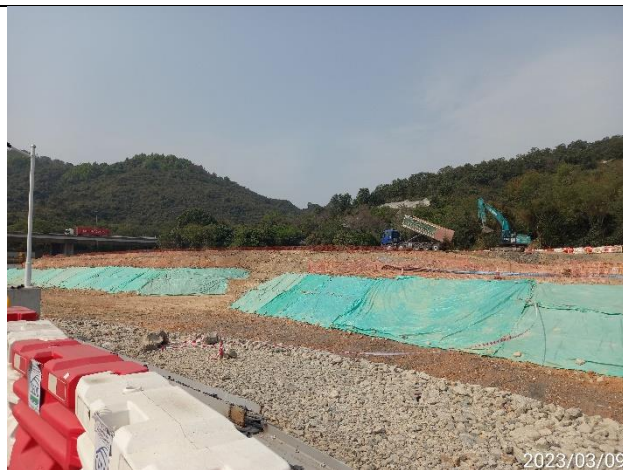
(R1)

Stockpile of dusty materials was covered properly to avoid generation of muddy runoff.

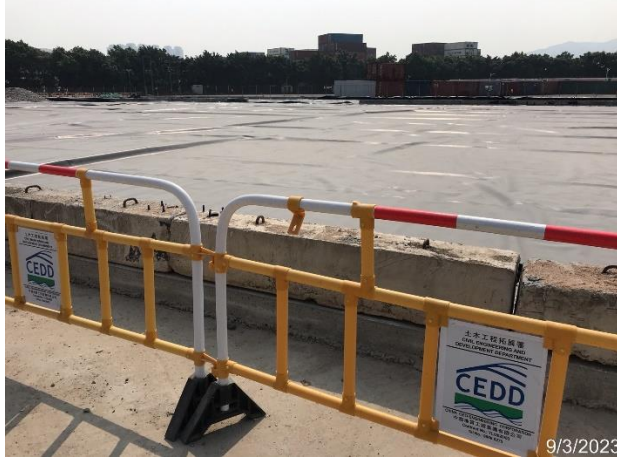
(R2)

No surface runoff or effluent was leaked from the contaminated soil treatment area during the site inspection.

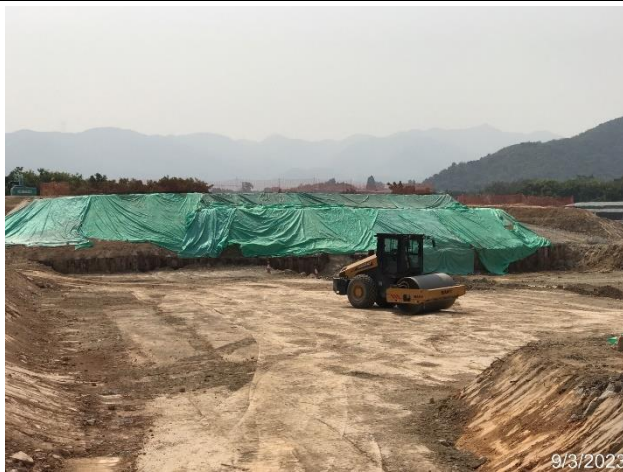
(R3)

No effluent discharge from the site was observed.

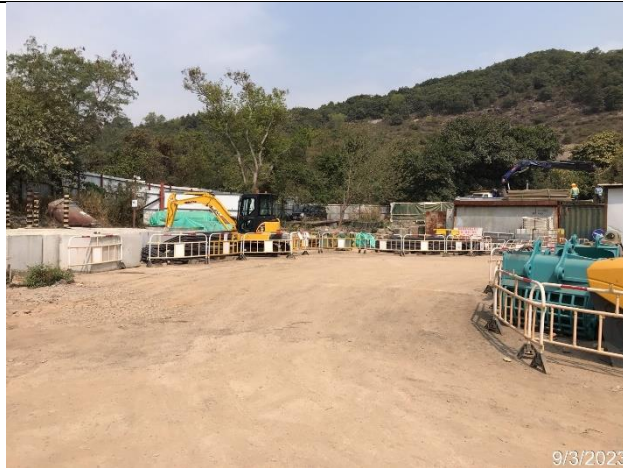
(R4)

No effluent discharge from the site was observed.

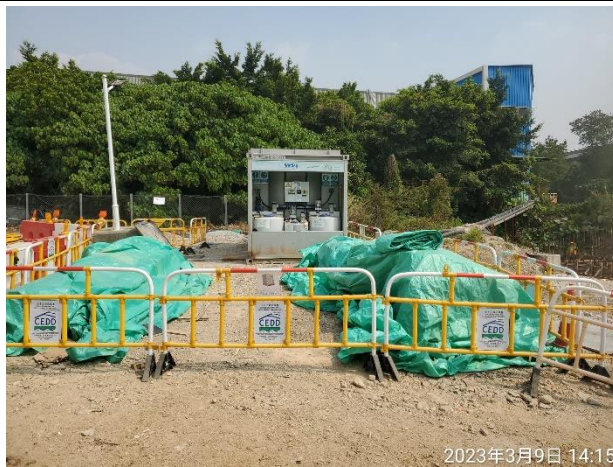
(P1)

Groundwater was collected and diverted to WetSep for temporary storage and deposition before the water was used for fugitive dust suppression on site. No direct effluent discharge was allowed.

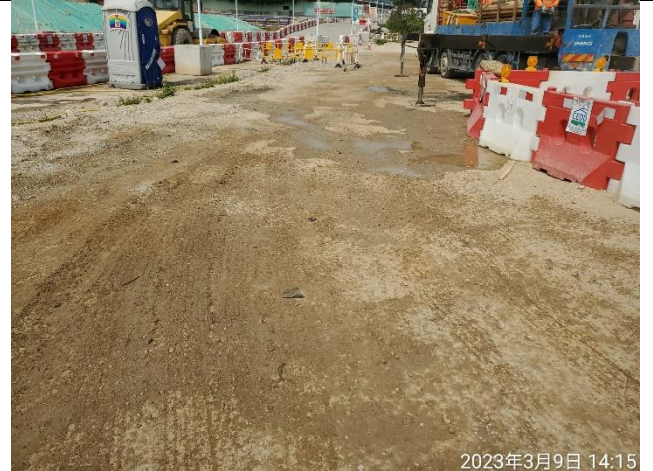
(P2)

No muddy surface runoff, pollution discharge and direct effluent discharge was observed during the site inspection.

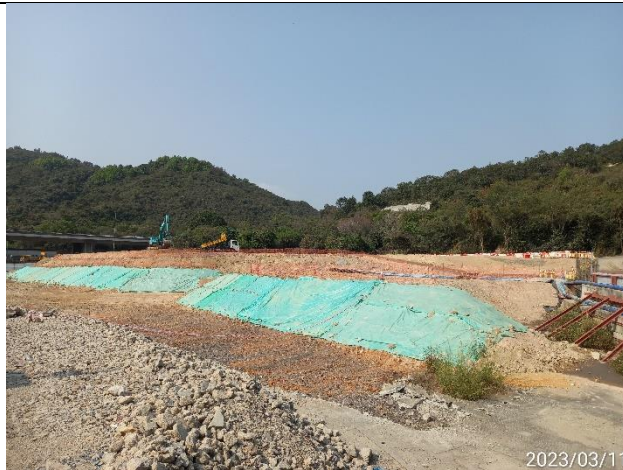
(R1)

Stockpile of dusty materials was covered properly to avoid generation of muddy runoff.

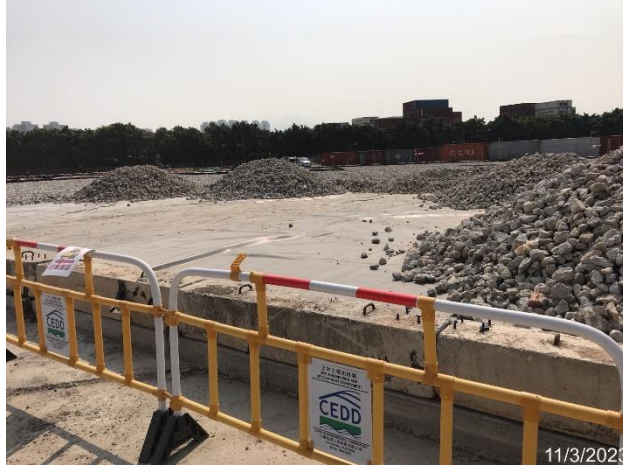
(R2)

No surface runoff or effluent was leaked from the contaminated soil treatment area during the site inspection.

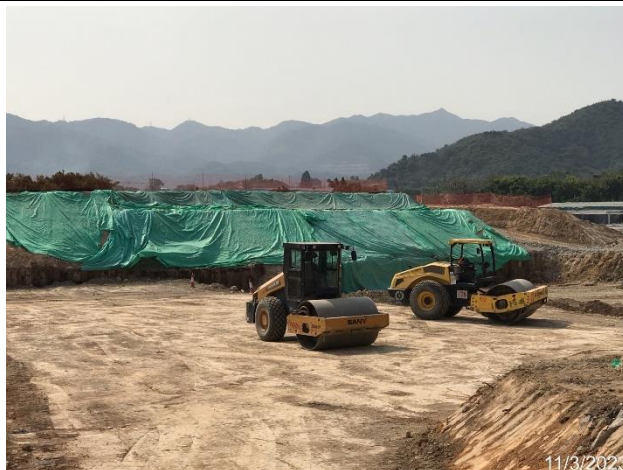
(R3)

No effluent discharge from the site was observed.

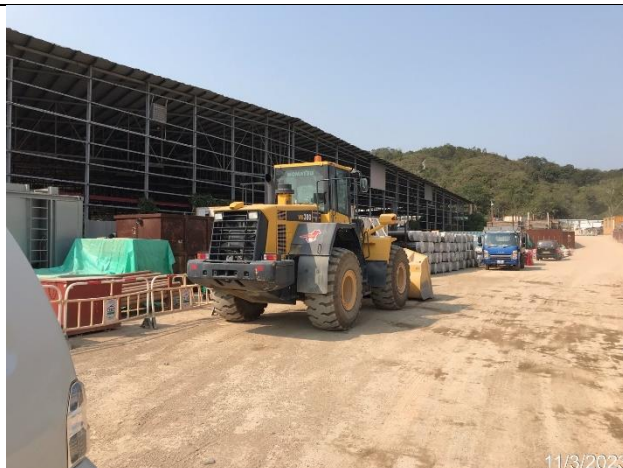
(R4)

No effluent discharge from the site was observed.

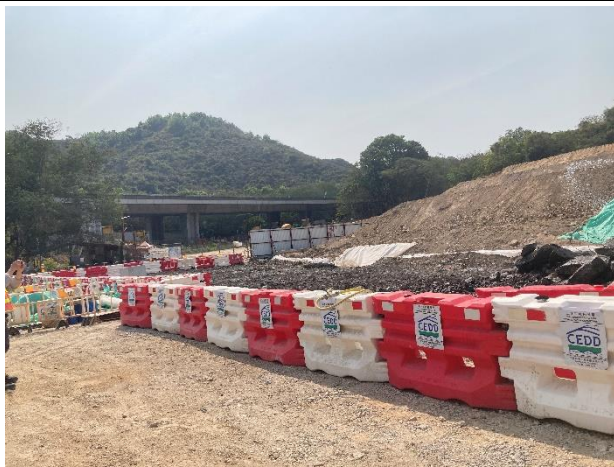
(P1)

Breaking up temporary access road of community isolation facility were carried out at Road D1. The works location was far away from any watercourse. No muddy surface runoff was observed during site inspection.

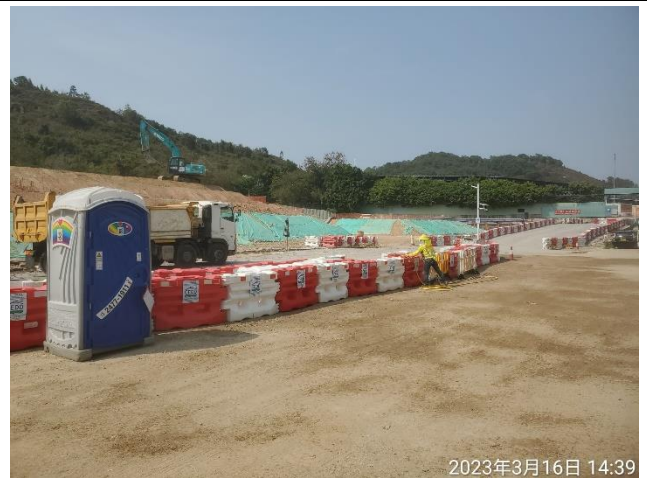
(P2)

No muddy surface runoff, pollution discharge and direct effluent discharge was observed during the site inspection.

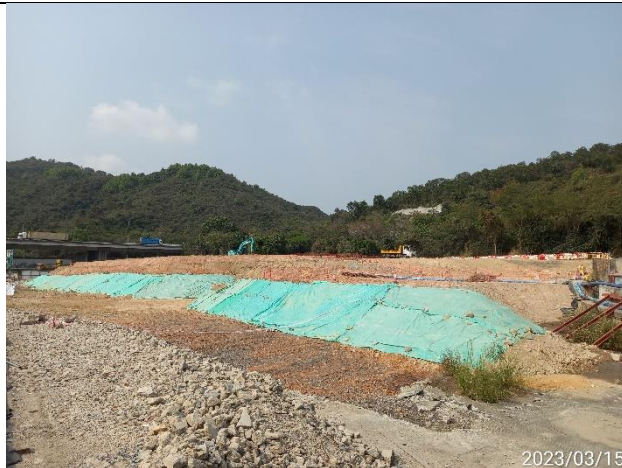
(R1)

Stockpile of dusty materials was covered properly to avoid generation of muddy runoff.

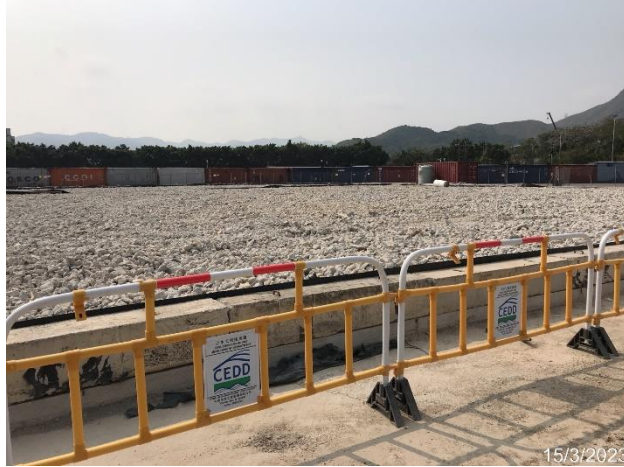
(R2)

No surface runoff or effluent was leaked from the contaminated soil treatment area during the site inspection.

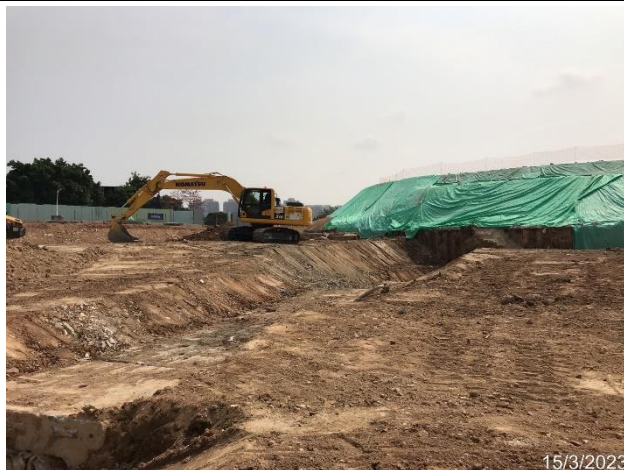
(R3)

No effluent discharge from the site was observed.

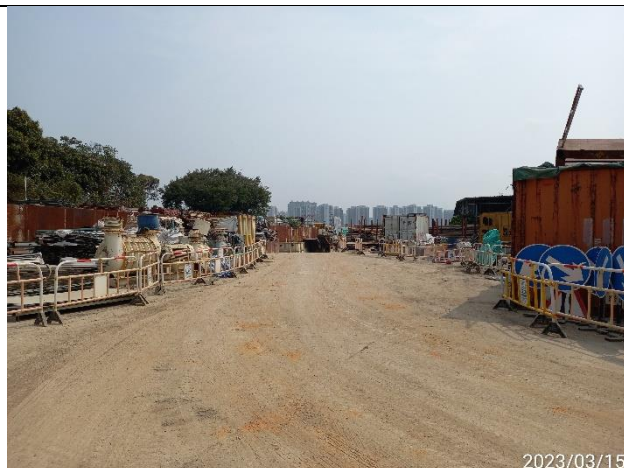
(R4)

No effluent discharge from the site was observed.

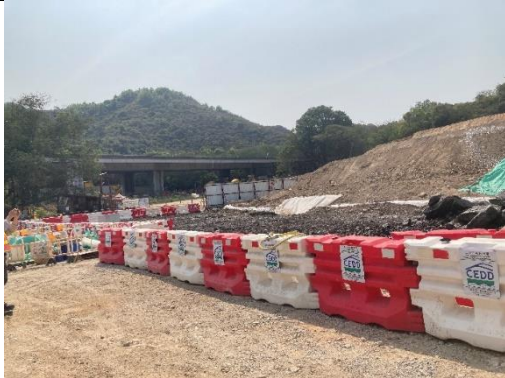
(P1)

Breaking up temporary access road of community isolation facility were carried out at Road D1. The works location was far away from any watercourse. No muddy surface runoff was observed during the site inspection.

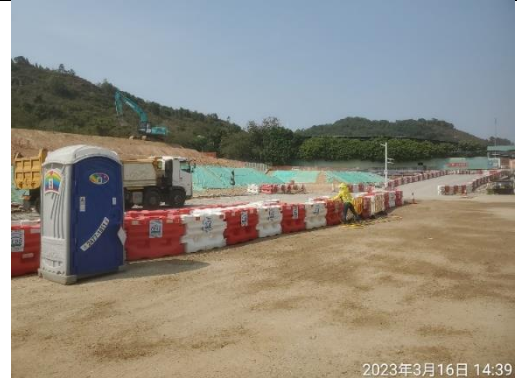
(P2)

No muddy surface runoff, pollution discharge and direct effluent discharge was observed during site inspection.

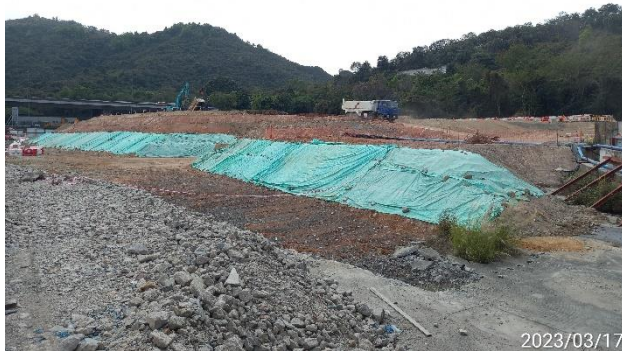
(R1)

Stockpile of dusty materials was covered properly to avoid generation of muddy runoff.

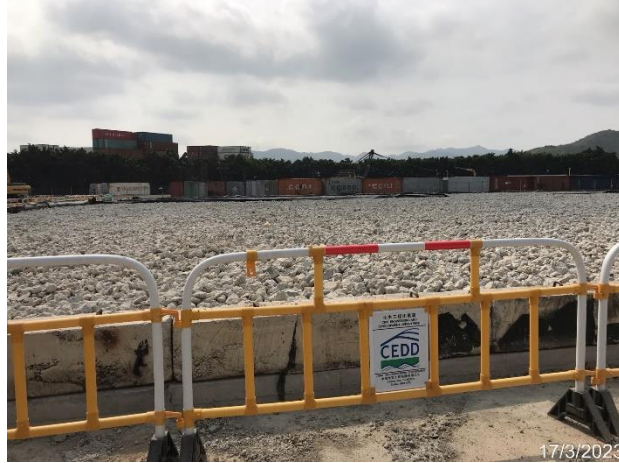
(R2)

No surface runoff or effluent was leaked from the contaminated soil treatment area during the site inspection.

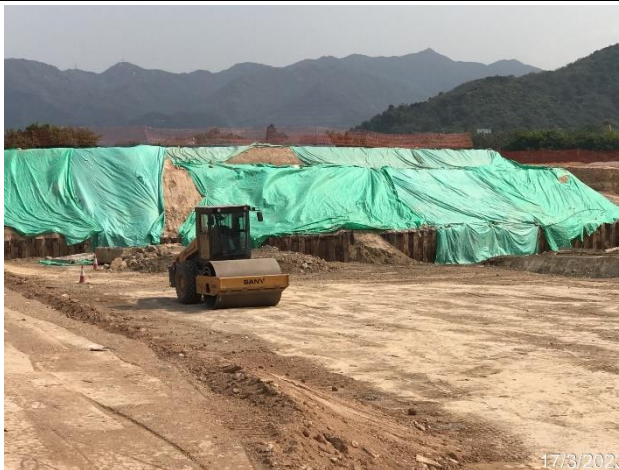
(R3)

No effluent discharge from the site was observed.

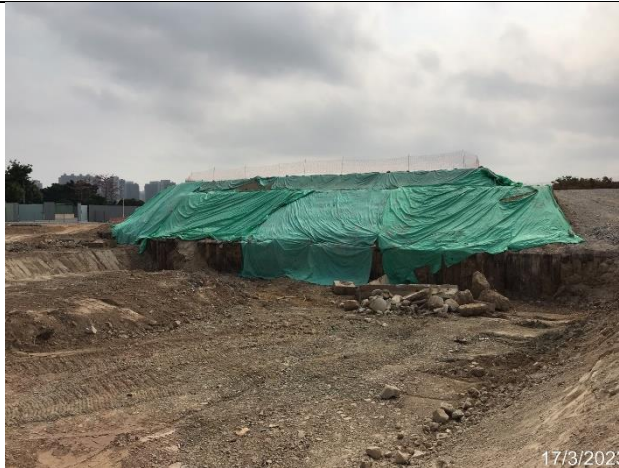
(R4)

No effluent discharge from the site was observed.

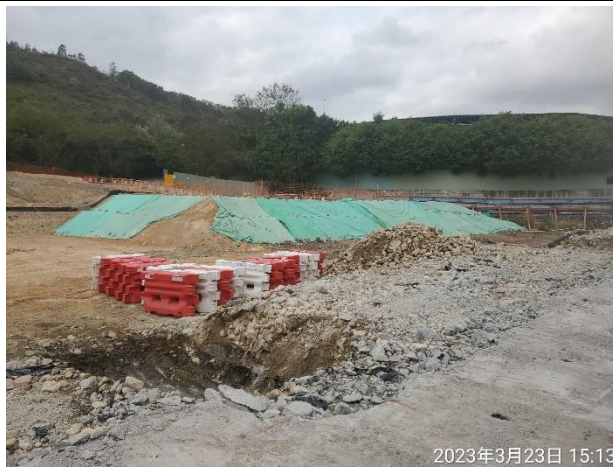
(P1)

A stockpile of dusty materials was covered properly to avoid generation of muddy runoff. No muddy surface runoff and direct effluent discharge was observed during the site inspection.

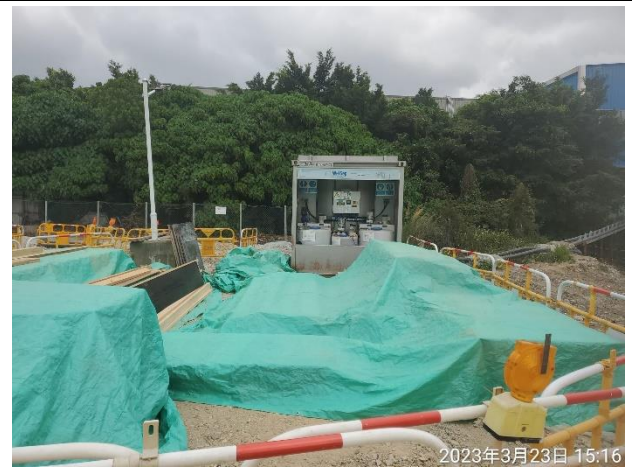
(P2)

Groundwater and surface runoff was collected and diverted to WetSep for temporary storage and deposition before the water was used for fugitive dust suppression on site. No direct effluent discharge was allowed.

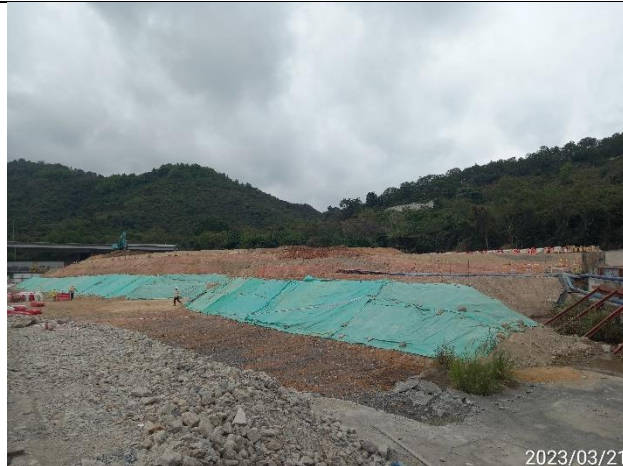
(R1)

Stockpile of dusty materials was covered properly to avoid generation of muddy runoff.

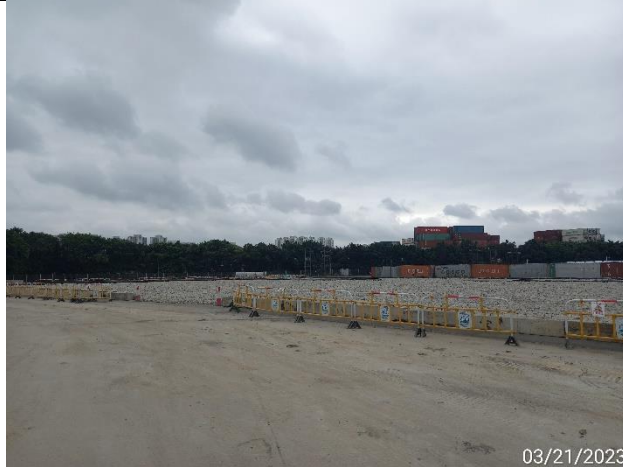
(R2)

No surface runoff or effluent was leaked from the contaminated soil treatment area during the site inspection.

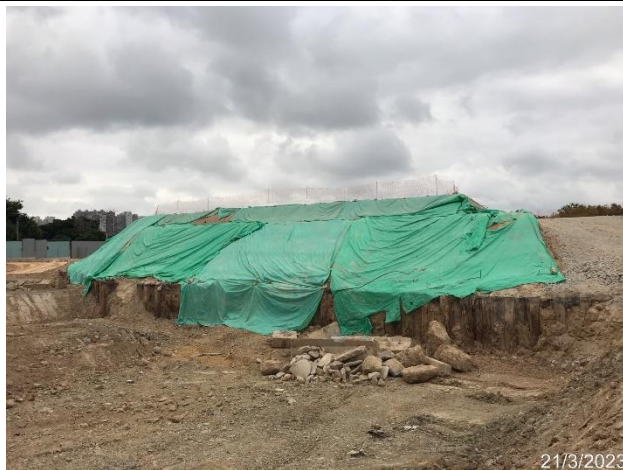
(R3)

No effluent discharge from the site was observed.

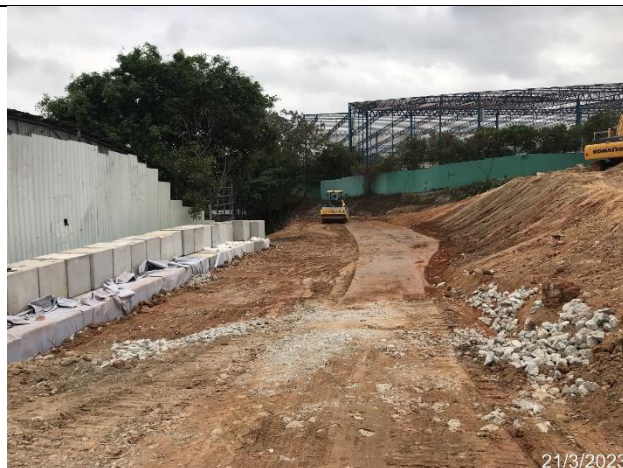
(R4)

No effluent discharge from the site was observed.

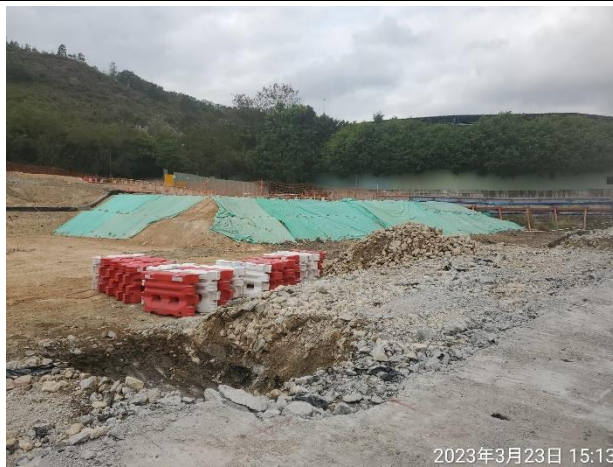
(P1)

A stockpile of dusty materials was covered properly to avoid generation of muddy runoff. No muddy surface runoff was observed during the excavation of inspection pit and the process of soil sampling. No direct effluent discharge was observed during the site inspection.

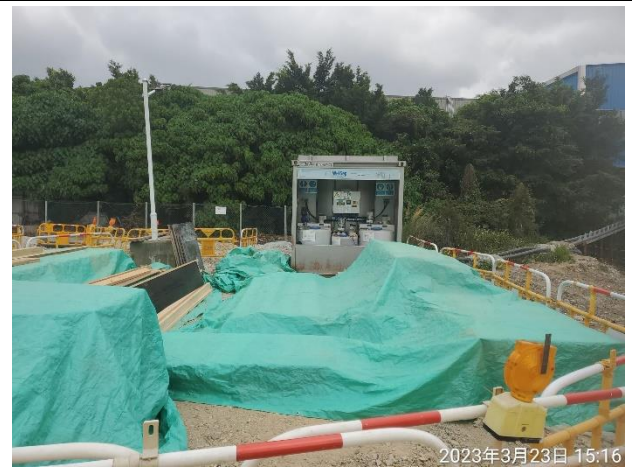
(P2)

Groundwater was collected and diverted to WetSep for temporary storage and deposition before the water was used for fugitive dust suppression on site. No direct effluent discharge was allowed.

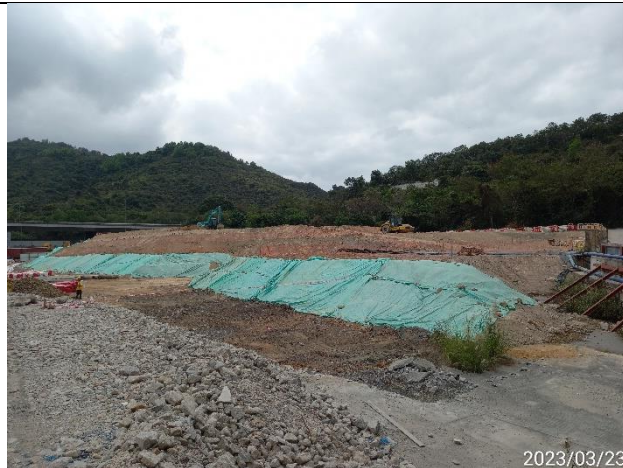
(R1)

Stockpile of dusty materials was covered properly to avoid generation of muddy runoff.

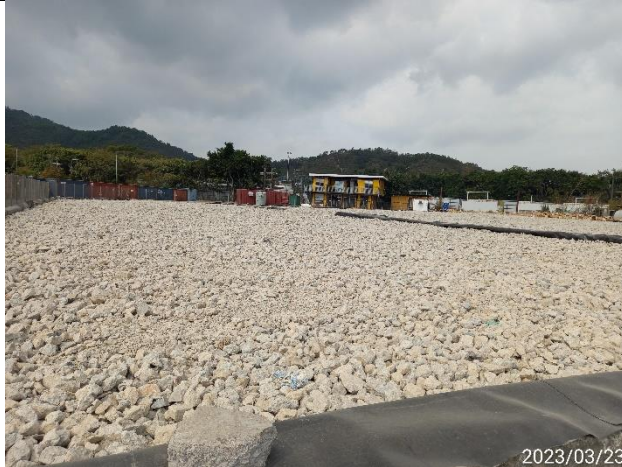
(R2)

No surface runoff or effluent was leaked from the contaminated soil treatment area during the site inspection.

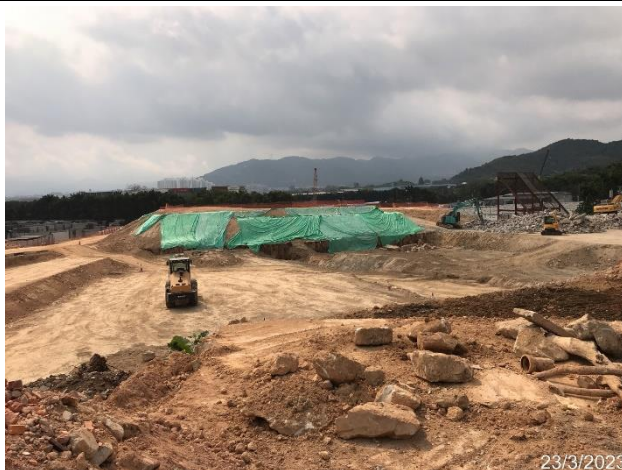
(R3)

No effluent discharge from the site was observed.

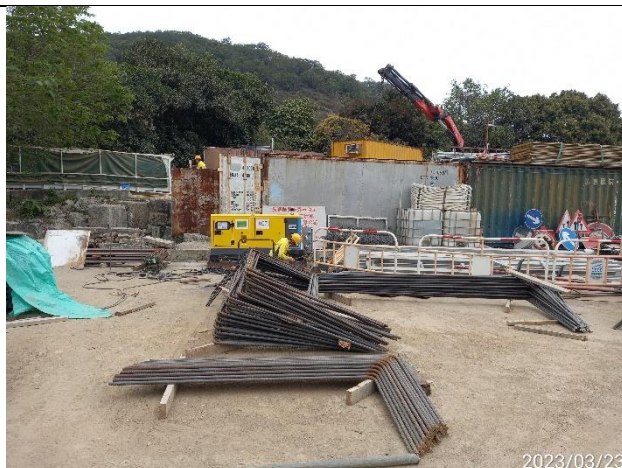
(R4)

No effluent discharge from the site was observed.

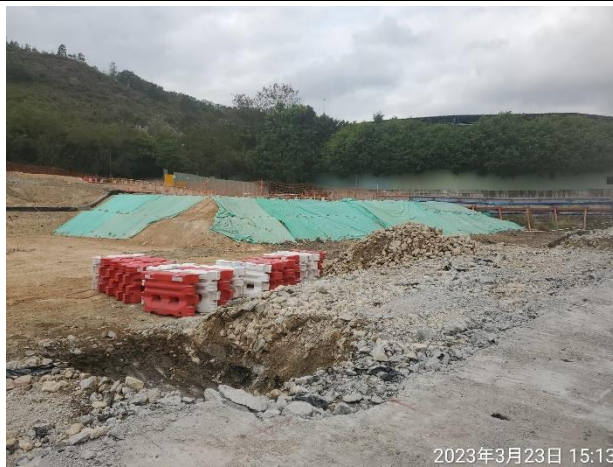
(P1)

A stockpile of dusty materials was covered properly to avoid generation of muddy runoff. No muddy surface runoff was observed during the excavation of inspection pit and the process of soil sampling. No direct effluent discharge was observed during the site inspection.

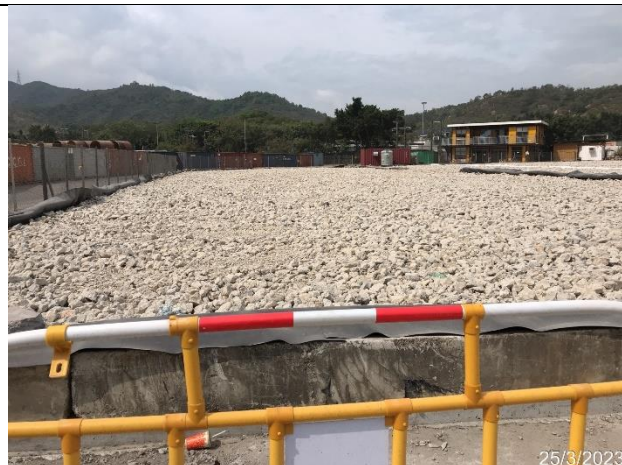
(R2)

No surface runoff or effluent was leaked from the contaminated soil treatment area during the site inspection.

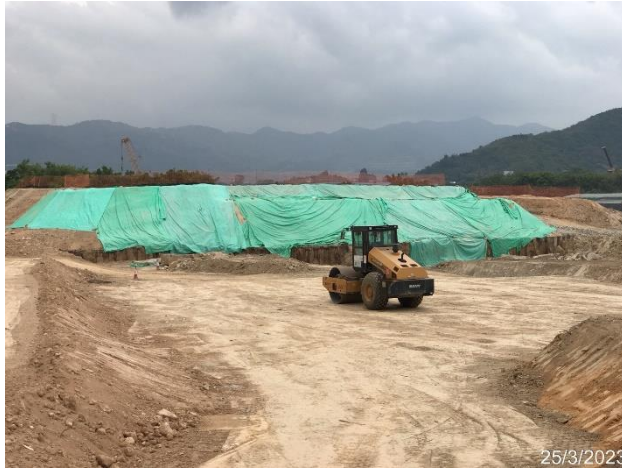
(R3)

No effluent discharge from the site was observed.

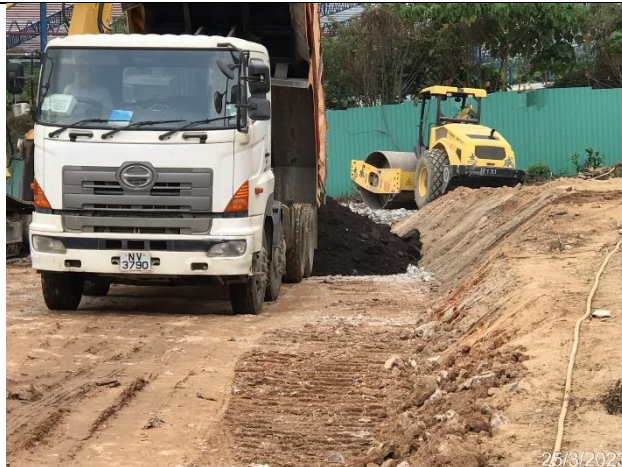
(R4)

No effluent discharge from the site was observed.
