Investigation Report for Exceedances of Limit Levels of Water Quality Monitoring on 19 April 2023

Environmental Team for Hung Shui Kui/ Ha Tsuen New Development Area Stage 1 Works – Site Formation and Engineering Infrastructure								
Date	Station	Parameter (Unit)	Depth-averaged Measured Value	Action Level	Limit Level	Exceedance		Project Related (Y/N)
						AL	LL	
19/04	TKW1	Turbidity (NTU)	212.0	27.9	29.2		✓	N
	TKW		282.0	24.2	24.6		✓	N
	HT		60.9	32.3	32.6		✓	N
	TKW1	Suspended Solids (SS) (mg/L)	37.5	16.0	18.4		✓	N
	TKW		66.5	19.8	21.6		✓	N
	SW		11.5	9.7	9.9		✓	N

Investigation Report for Exceedance of Limit Level of Water Quality Monitoring on 21 April 2023

Investigation Report for Exceedances of Limit Level of Water Quality Monitoring on 27 April 2023

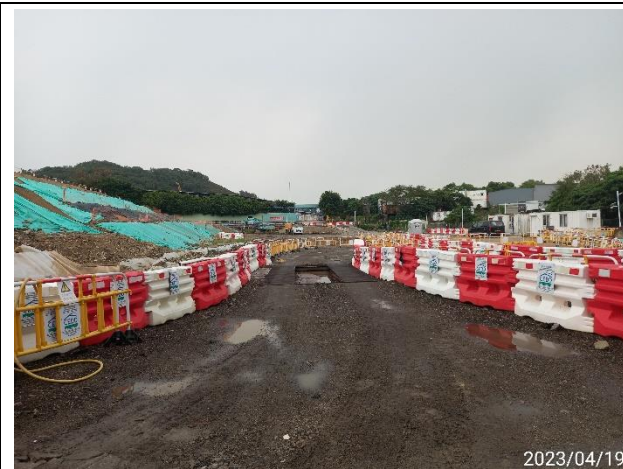
Works areas on both sides of the access road
(R1)

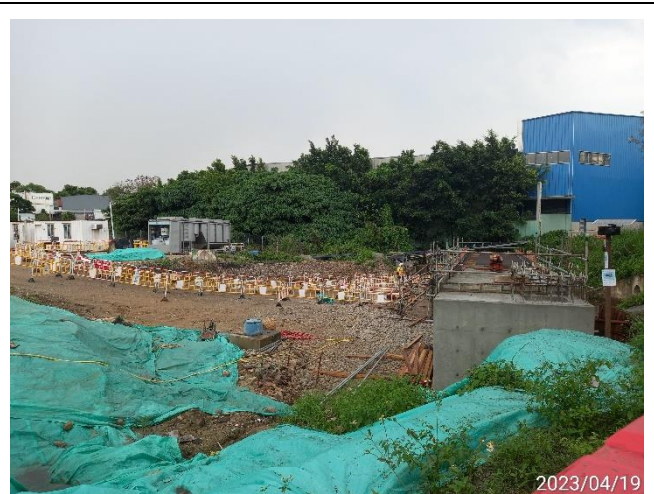
Works area near the box culvert (R2)

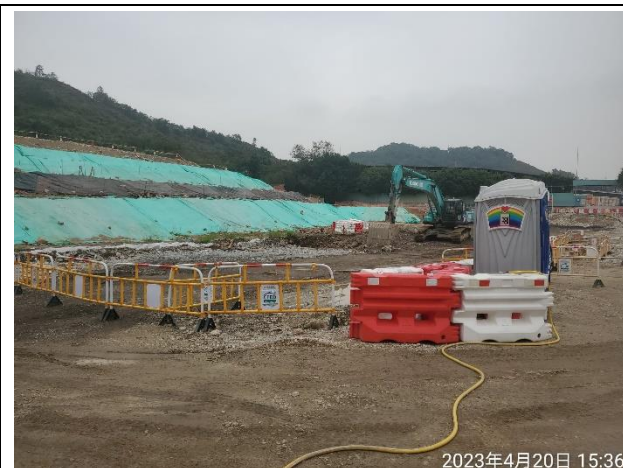
(P1)

Slopes and stockpiles of dusty materials were covered properly to avoid generation of muddy runoff. No muddy surface runoff and no direct effluent discharge were observed during the site inspection. No direct effluent discharge was observed during the site inspection.

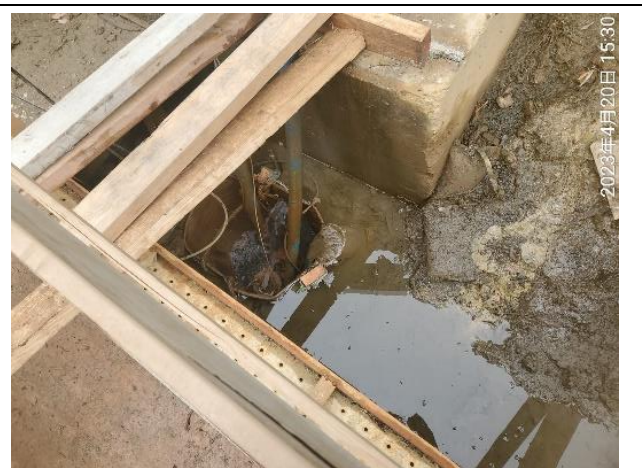
(P2)

Site runoff and upstream river water were collected and pumped to WetSep on site for temporary storage and treatment. No muddy surface runoff and direct effluent discharge was observed during the site inspection.

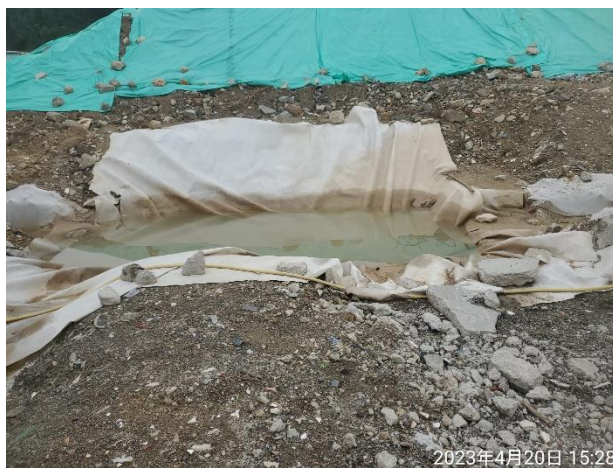
(P3)

Surface runoff was directed to the sump pit for temporary storage. No muddy surface runoff and direct discharge of ground water was observed.

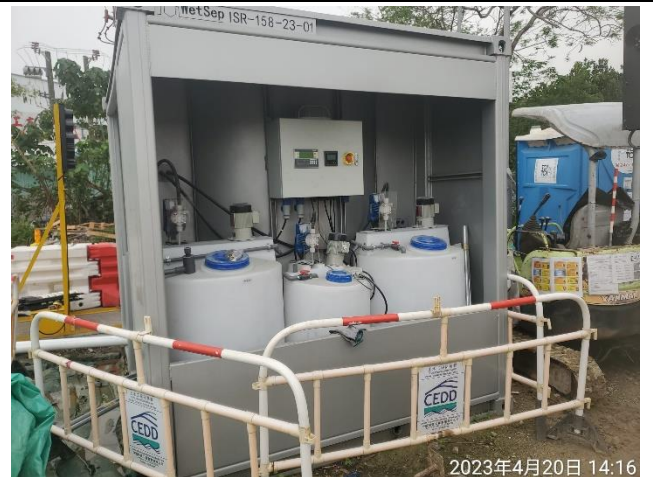
(P4)

Surface runoff and site effluent was collected and diverted to sump pit and WetSep for temporary storage and treatment before the water was reused for fugitive dust suppression on site. No direct effluent discharge was allowed.

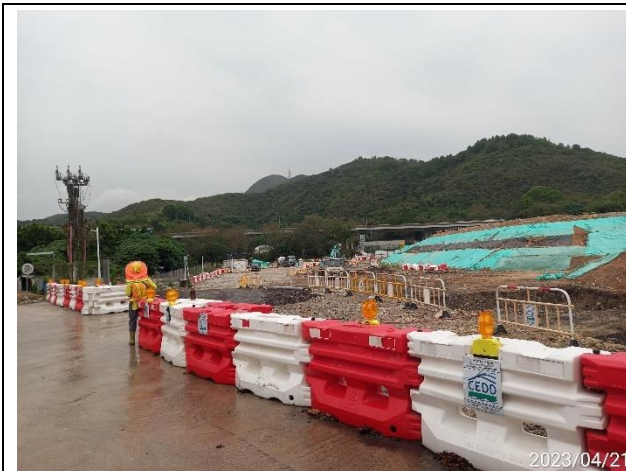
Works area next to the access road/ Site 3-8
(R1)

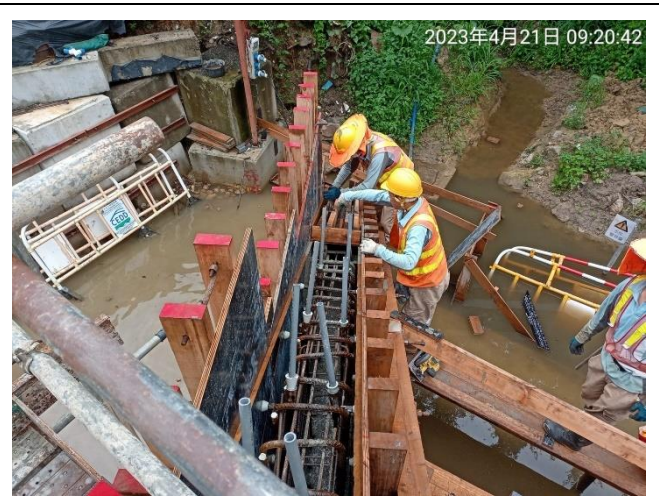
Works at the box culvert (R2)

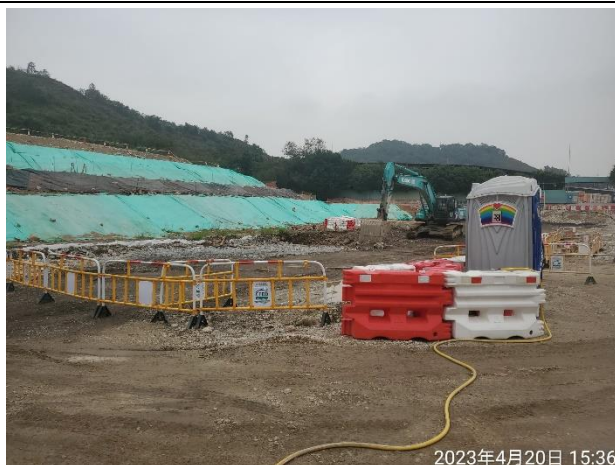
(P1)

Slopes and stockpiles of dusty materials were covered properly to avoid generation of muddy runoff. No muddy surface runoff was observed during the excavation of the site inspection. No direct effluent discharge was observed during the site inspection.

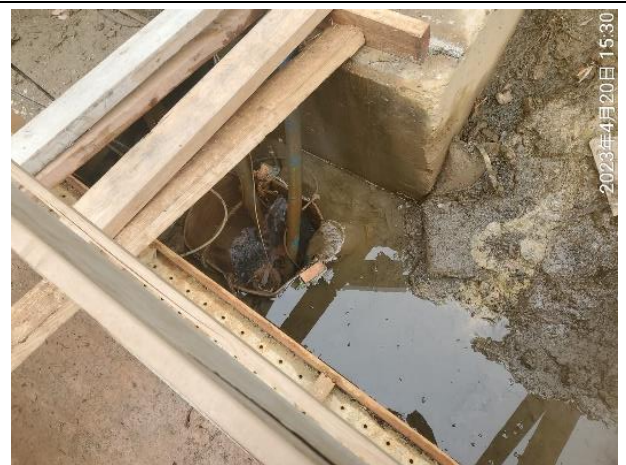
(P2)

Site runoff and upstream river water was collected and pumped to WetSep on site for temporary storage and treatment. No muddy surface runoff and direct effluent discharge was observed during the site inspection.

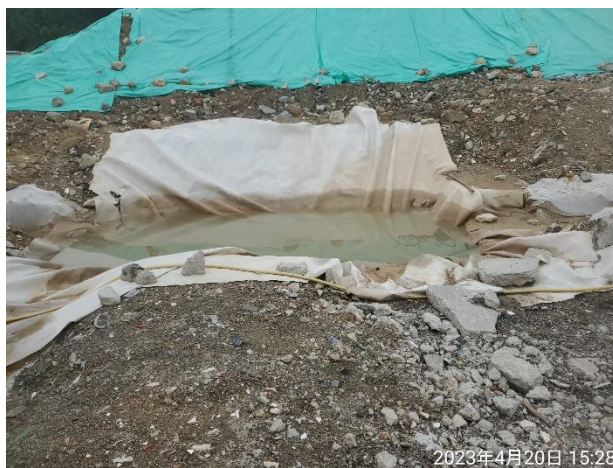
(P3)

Surface runoff was directed to the sump pit for temporary storage. No muddy surface runoff and direct discharge of ground water was observed.

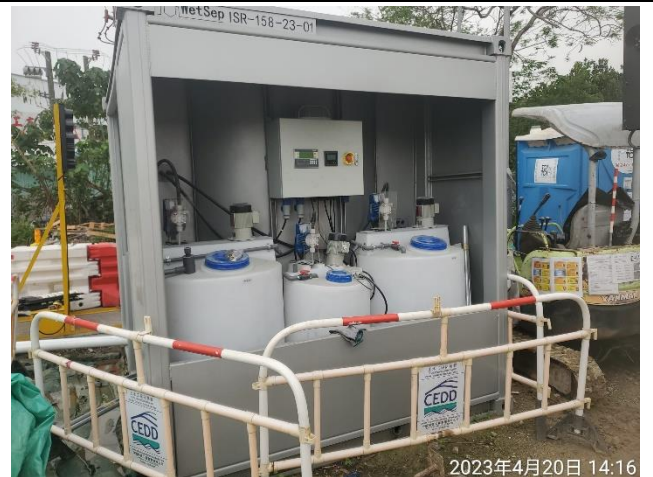
(P4)

Surface runoff and site effluent were collected and diverted to sump pit and WetSep for temporary storage and treatment before the water was used for fugitive dust suppression on site. No direct effluent discharge was allowed.

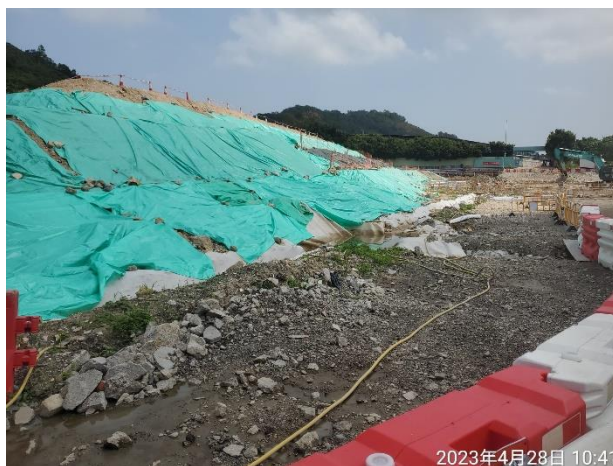
(P5)

Stockpile of dusty materials was covered properly to avoid generation of muddy runoff. No muddy surface runoff was observed during the inspection.

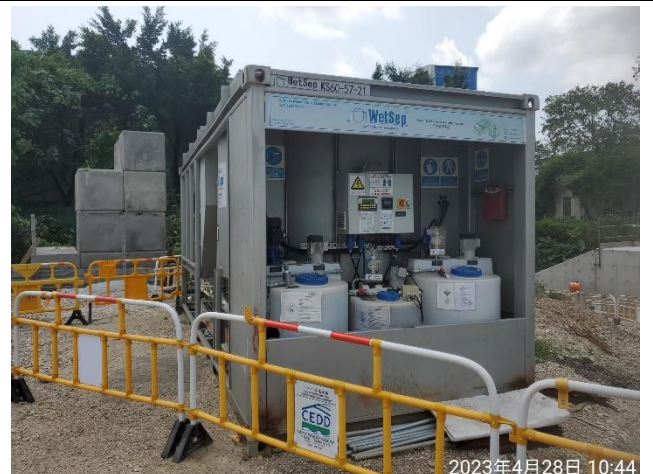
(P6)

Surface runoff and site effluent were collected and diverted to sump pit and WetSep for temporary storage and treatment before the water was reused for fugitive dust suppression on site.

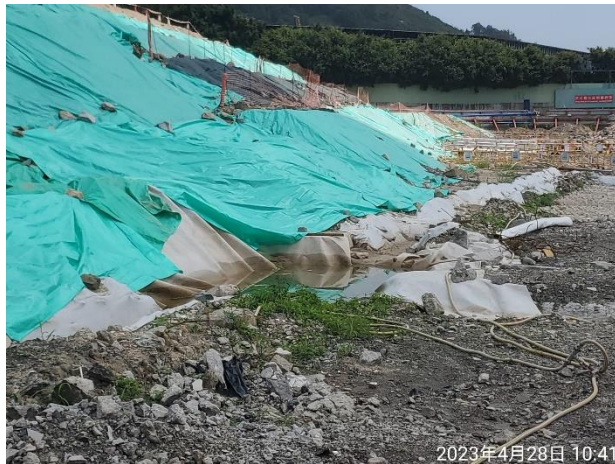
(P7)

Surface runoff was directed to sump pit for temporary storage. No muddy surface runoff and no direct discharge of ground water were observed.

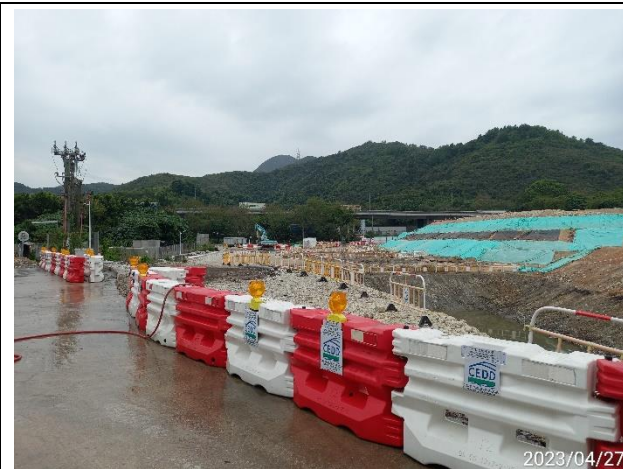
Works area next to the access road/ Site 3-8
(R1)

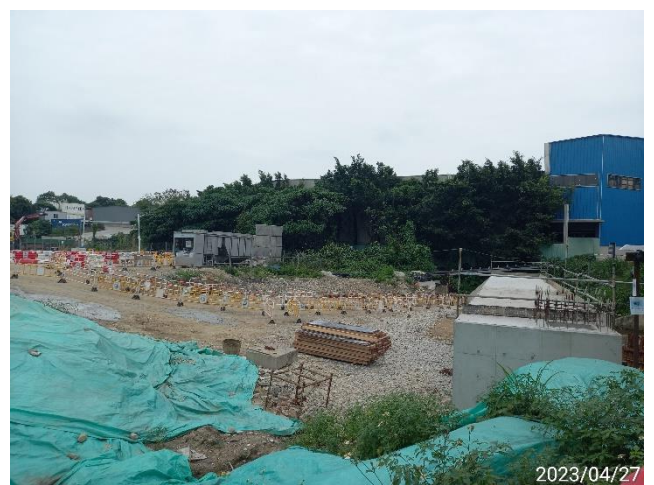
Works area near the box culvert (R2)

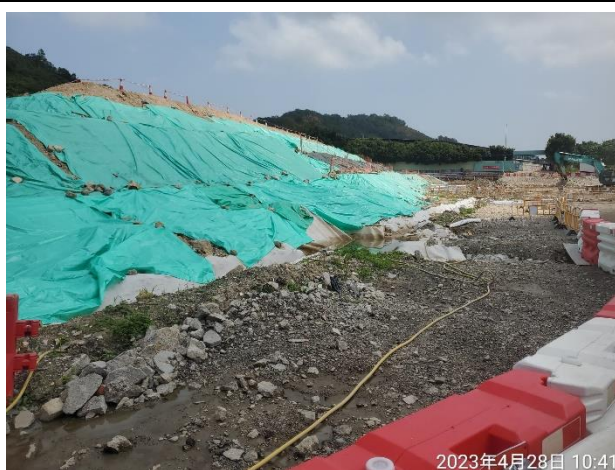
(P1)

Stockpile of dusty materials was covered properly to avoid generation of muddy runoff. No muddy surface runoff was observed during the inspection.

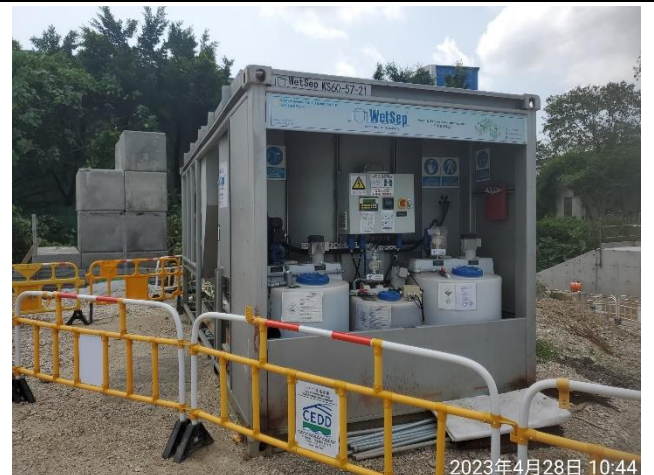
(P2)

Surface runoff and site effluent were collected and diverted to the WetSep for temporary storage and treatment before the water was reused for fugitive dust suppression on site.

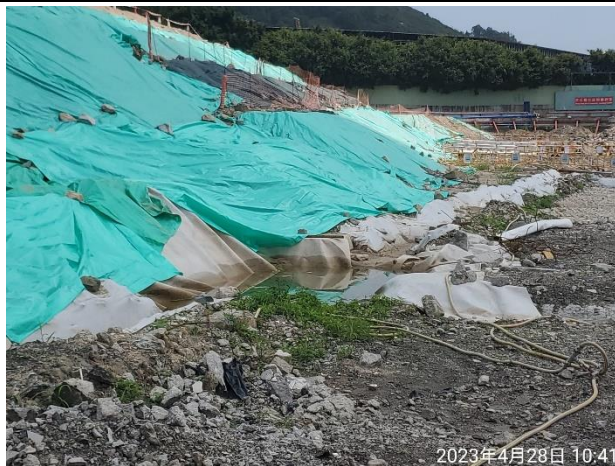
(P3)

Surface runoff was directed to sump pit for temporary storage. No muddy surface runoff and no direct discharge of ground water were observed.
