## Investigation Report for Exceedances of Limit Level of Water Quality Monitoring on 4 May 2023

Environmental Team for Hung Shui Kui/ Ha Tsuen New Development Area Stage 1 Works – Site Formation and Engineering Infrastructure								
Date	Station	Parameter (Unit)	Depth-averaged Measured Value	Action Level	Limit Level	Exceedance		Project Related (Y/N)
						AL	LL	
04/05	TKW1	Suspended Solids (SS) (mg/L)	66.0	16.0	18.4		✓	N
	TKW		54.0	19.8	21.6		✓	N

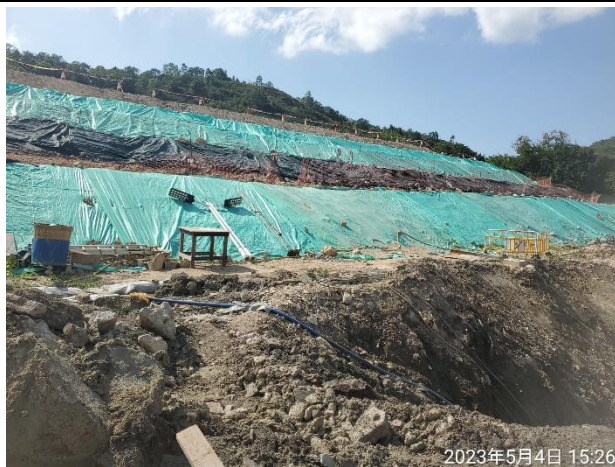
(P1)

Stockpile of dusty materials was covered properly to avoid generation of muddy runoff. No muddy surface runoff was observed during the site inspection.

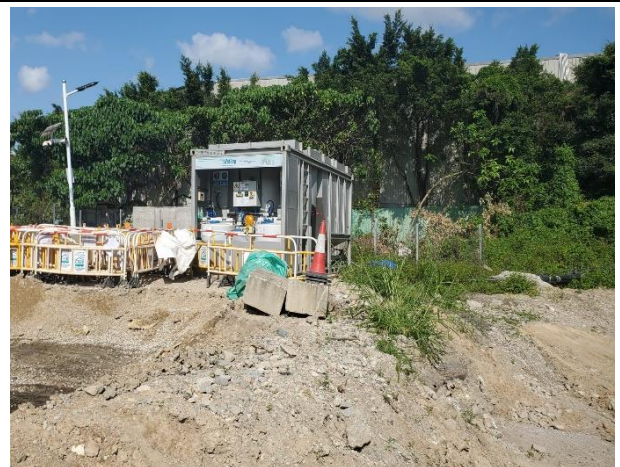
(P2)

Surface runoff and site effluent was collected and diverted to the WetSep for temporary storage and treatment before the water was used for fugitive dust suppression on site.

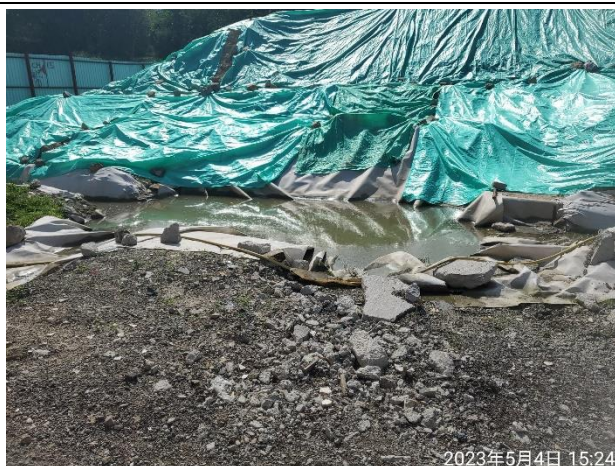
(P3)

Surface runoff was directed to sump pit for temporary storage. No muddy surface runoff and no direct discharge of ground water was observed.

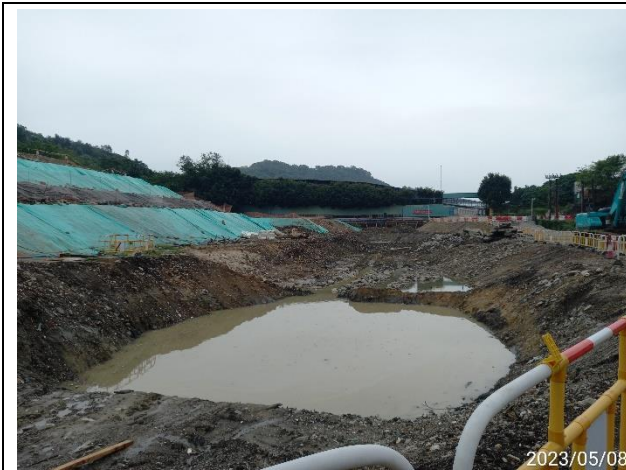
Temporary detention pond at the works area near the access road (R1)

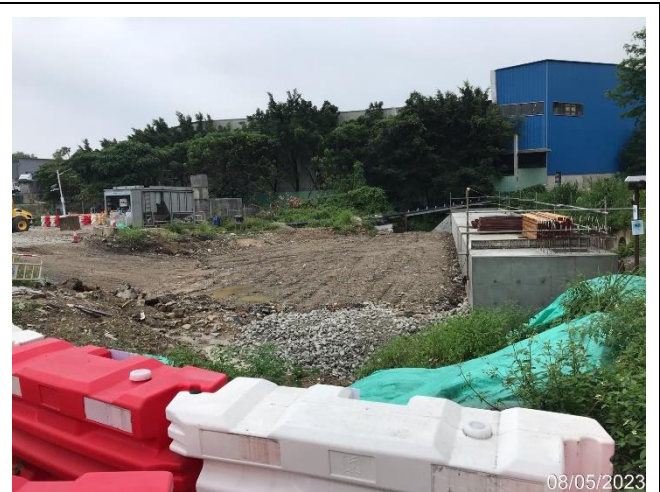
Works area near the box culvert (R2)

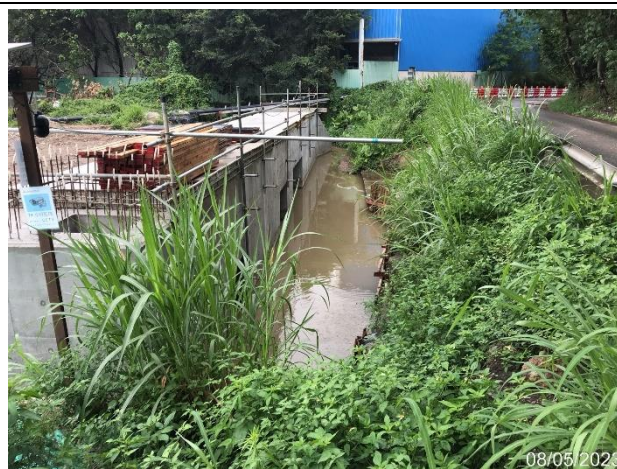
Water (mixed upstream river water and site runoff) detained temporarily behind the box culvert prior to treatment (R3)

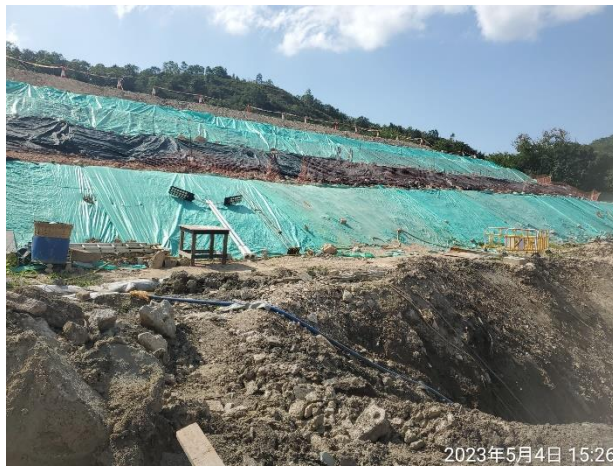
(P1)

Stockpile of dusty materials was covered properly to avoid generation of muddy runoff. No muddy surface runoff and no direct effluent discharge was observed during the site inspection.

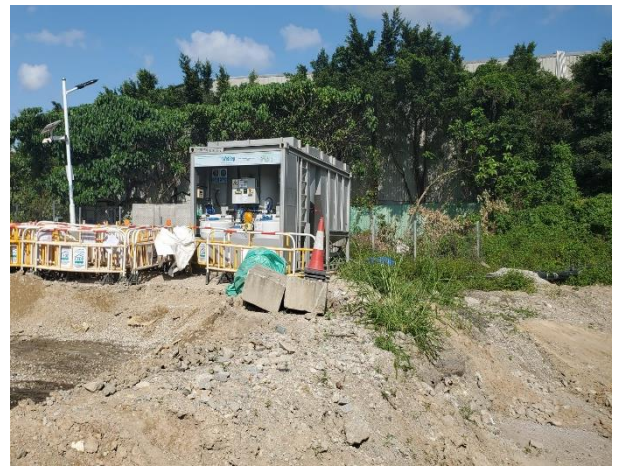
(P2)

Surface runoff and site effluent was collected and diverted to sump and WetSep for temporary storage and treatment before the water was used for fugitive dust suppression on site.

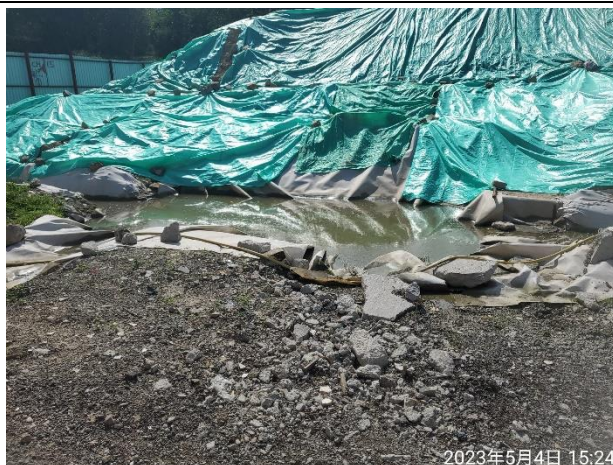
(P3)

Surface runoff was directed to sump pit for temporary storage. No muddy surface runoff and direct discharge of ground water was observed.

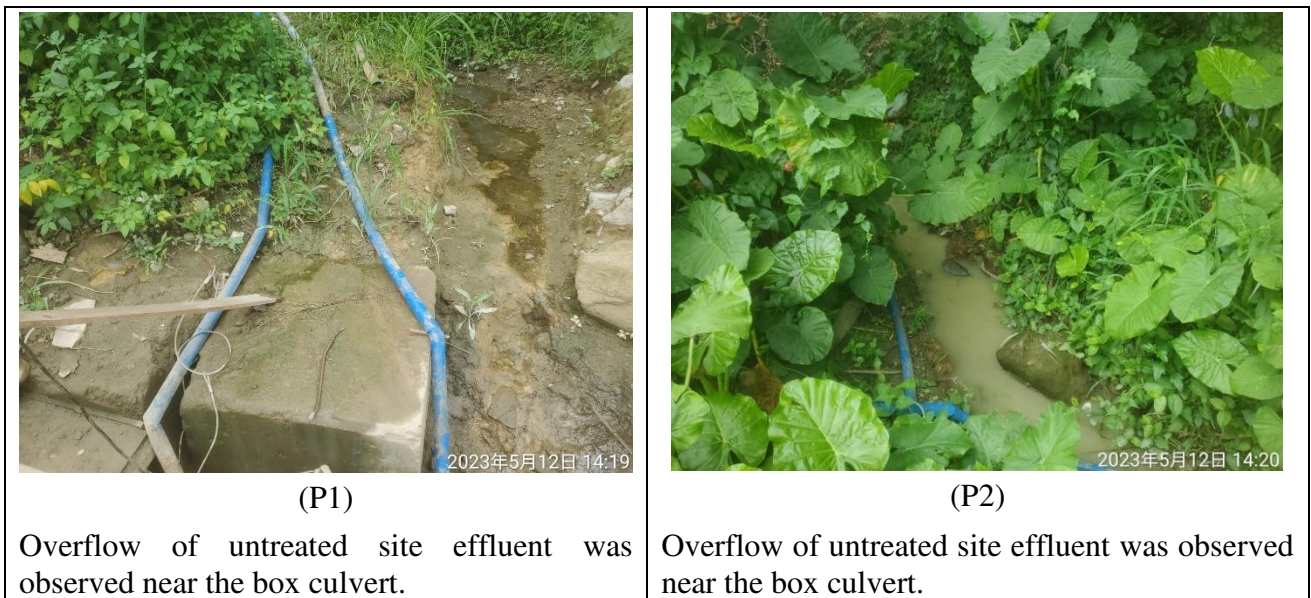
### Photo Records of Site Investigation held by the ET on 12 May 2023

Action taken / to be taken:	<ol style="list-style-type: none"> <li>1. Repeated in-situ measurement was carried out to confirm the turbidity level measured at SW.</li> <li>2. The source of impact may be related to the untreated site effluent overflow from the site when the WetSep was malfunctioned.</li> <li>3. A notification of exceedance has been issued to the IEC, the Contractor, and the EPD.</li> <li>4. Duplicate water samples were collected at the monitoring station and in-situ measurement was repeated. The monitoring data were checked and confirmed. All plant, equipment and the Contractor's working methods were checked during the site inspection. Malfunction of the WetSep was reported. No other non-compliance was observed.</li> </ol>

5. As requested by the RE and the ET, the Contractor stopped the overflow immediately and fixed the WetSep. No further overflow was observed after the WetSep resumed normal operation on the same day.

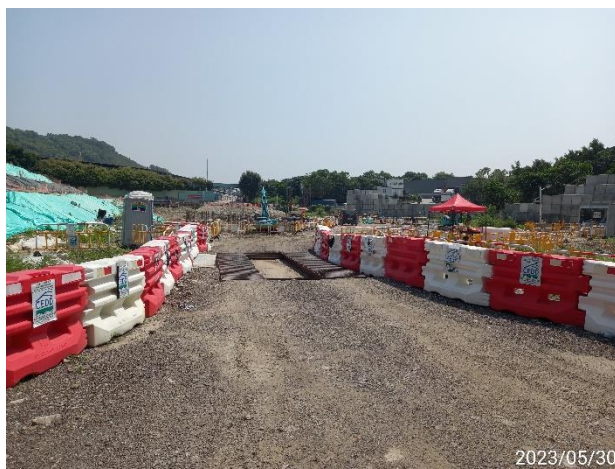
Works areas on both sides of the access road  
(R1)

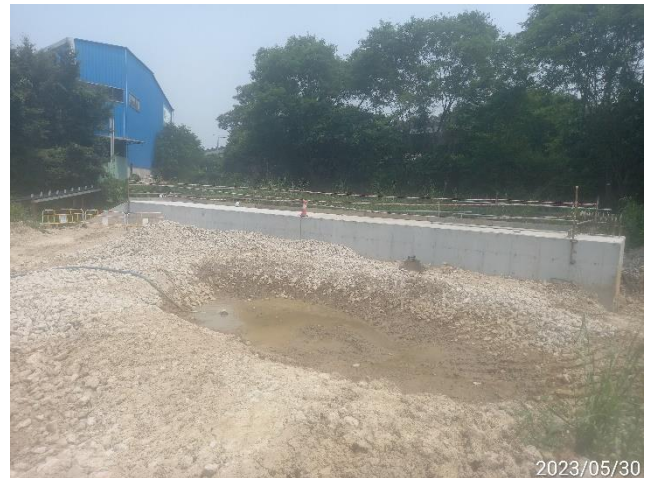
Sump formed next to the finished box culvert  
(R2)

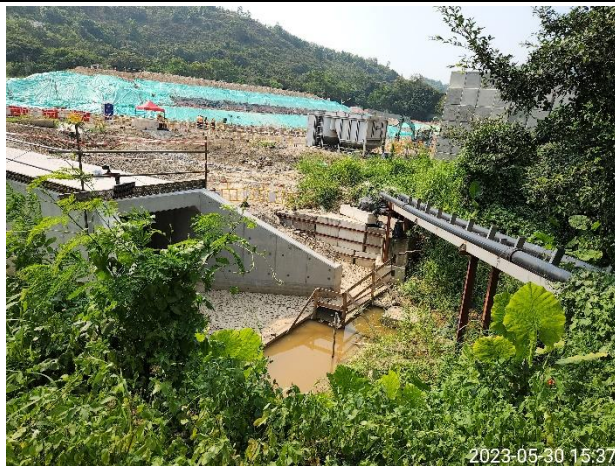
(P1)  
 Water (upstream river water and site runoff) detained near the box culvert.

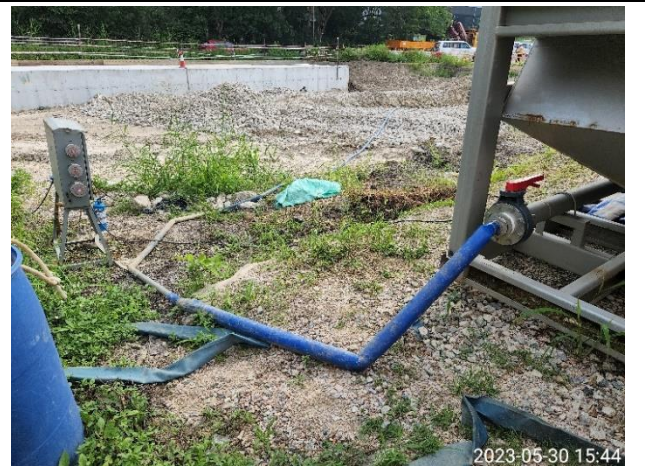
(P2)  
 Water detained within the sump was directed to the WetSep by a drainage pipe.

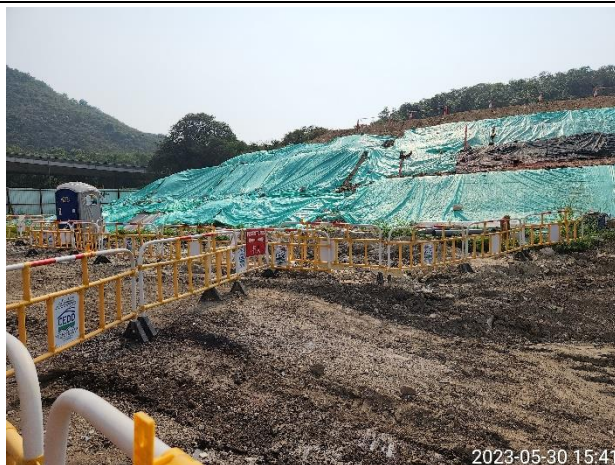
(P3)  
 Slope was covered by tarpaulin sheets to minimize muddy runoff under rainfall.
