Investigation Report for Exceedances of Limit Level of Water Quality Monitoring on 18 July 2023

Environmental Team for Hung Shui Kiu/ Ha Tsuen New Development Area Stage 1 Works – Site Formation and Engineering Infrastructure								
Date	Station	Parameter (Unit)	Depth-averaged Measured Value	Action Level	Limit Level	Exceedance		Project Related (Y/N)
						AL	LL	
18/07	TKW1	Turbidity (NTU)	121.5	27.9	29.2		✓	N
	TKW		122.5	24.2	24.6		✓	N
	TKW1	Suspended Solids (SS) (mg/L)	44.0	16.0	18.4		✓	N
	TKW		44.5	19.8	21.6		✓	N

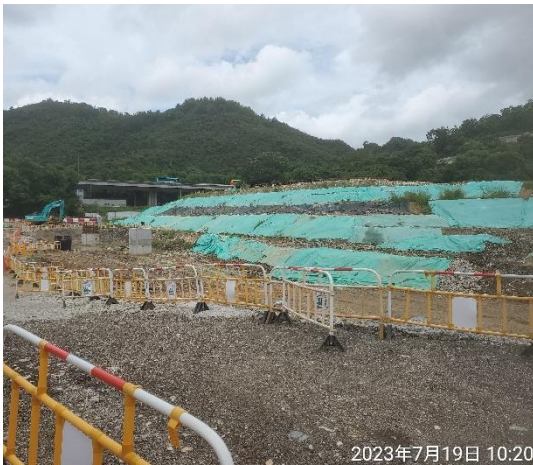
(P1)

Stockpile of dusty materials was covered properly to avoid generation of muddy runoff. No muddy surface runoff was observed during the site inspection.

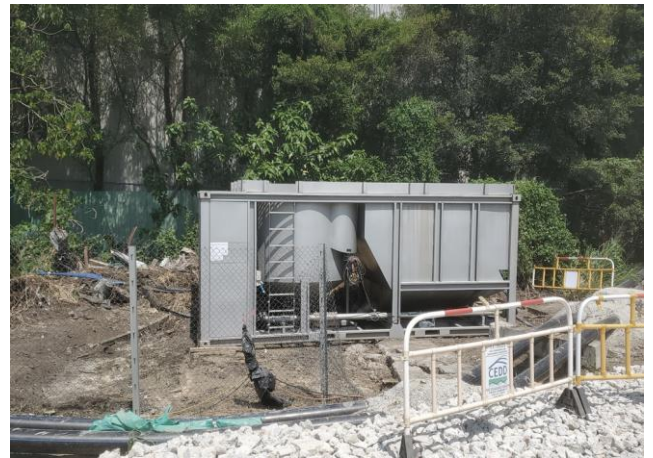
(P2)

Surface runoff and site effluent were collected and diverted to the WetSep for temporary storage and treatment before the water was used for fugitive dust suppression on site or discharged at designated location under the requirement of effluent discharge licence.

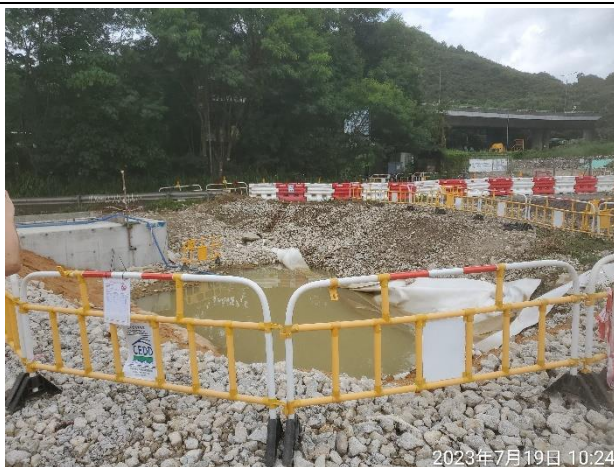
(P3)

Surface runoff was directed to the sump/detention pond for temporary storage. No muddy surface runoff and no direct discharge of construction effluent was observed.

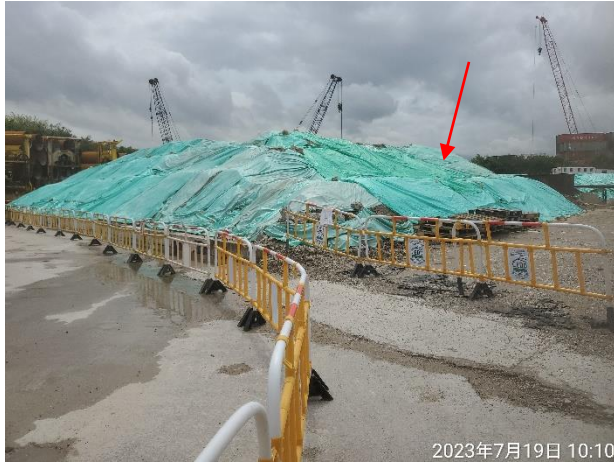
(P4)

Contaminated materials were stocked on site pending for decontamination.

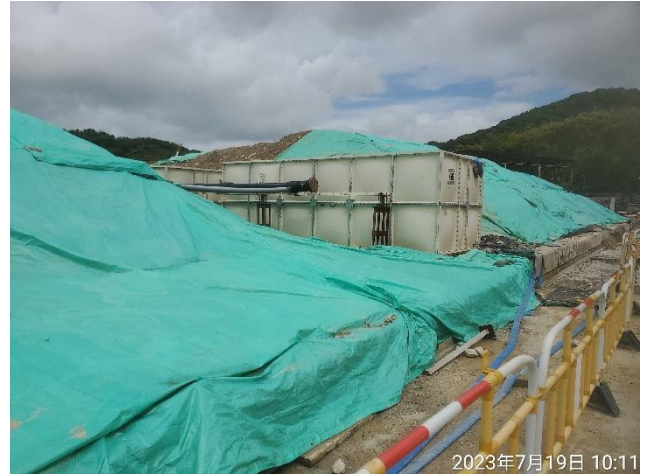
(P5)

Stockpiles within the contaminated soil treatment area were covered by impervious canvases. Leachate collection tanks were also in place.

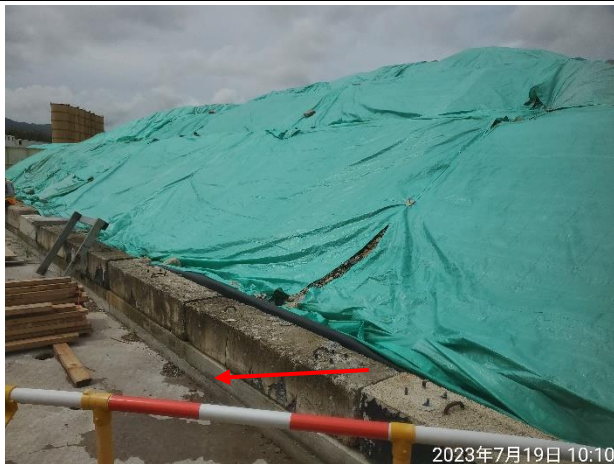
(P6)

Perimeter channels installed outside the contaminated soil treatment area.

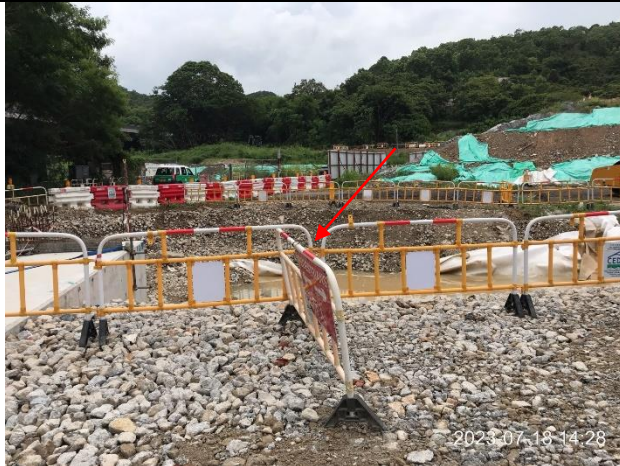
(R1)

Sump formed next to the finished box culvert.

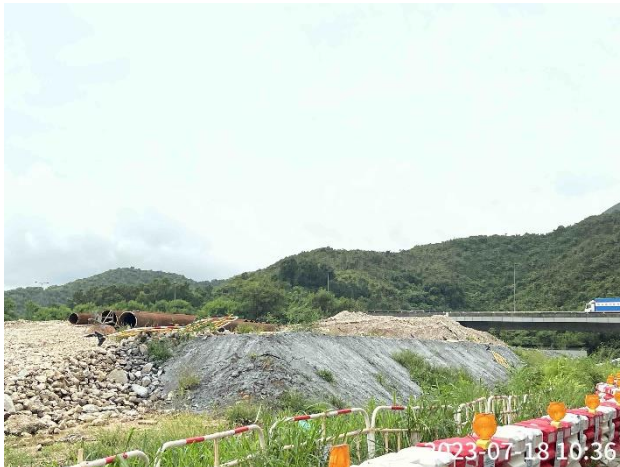
(R2)

No activity was carried out at Site 3-8 (Portion B6). No effluent discharge was observed.

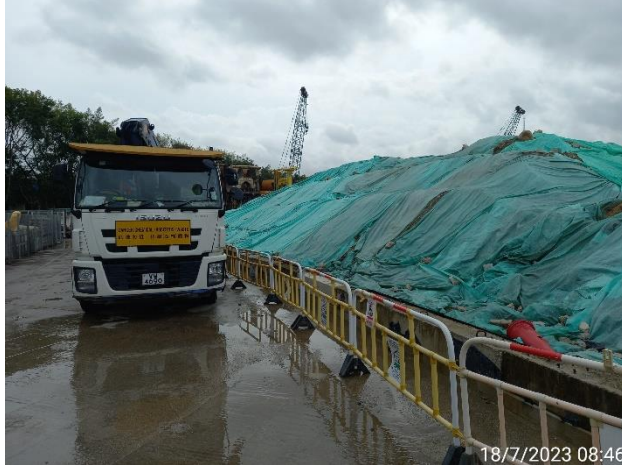
(R3)

Sloping surfaces of stockpiles within the contaminated soil treatment area were covered by impervious canvas. No surface runoff or effluent was leaked from the contaminated soil treatment area during the site inspection.

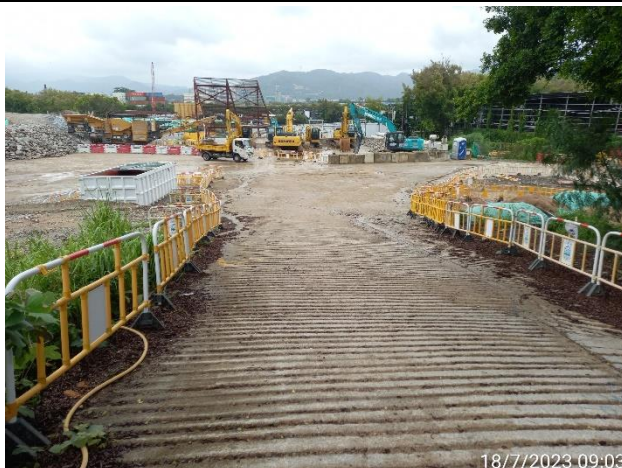
(R4)

No effluent discharge from the site was observed.

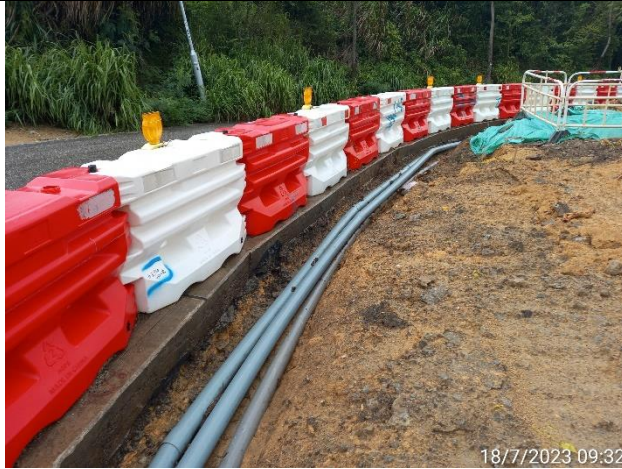
(R5)

No effluent discharge from the site was observed.

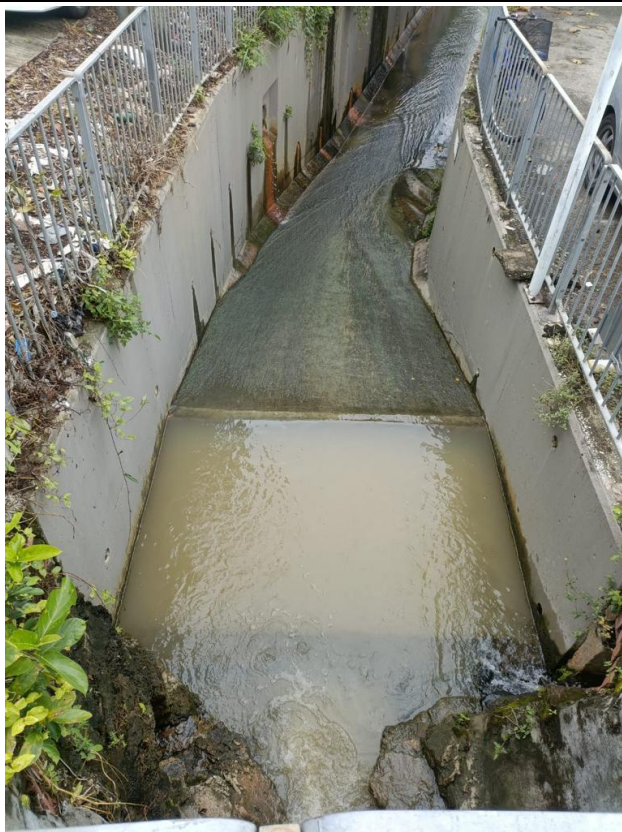
(W1)

Water Quality Monitoring Station: TKW

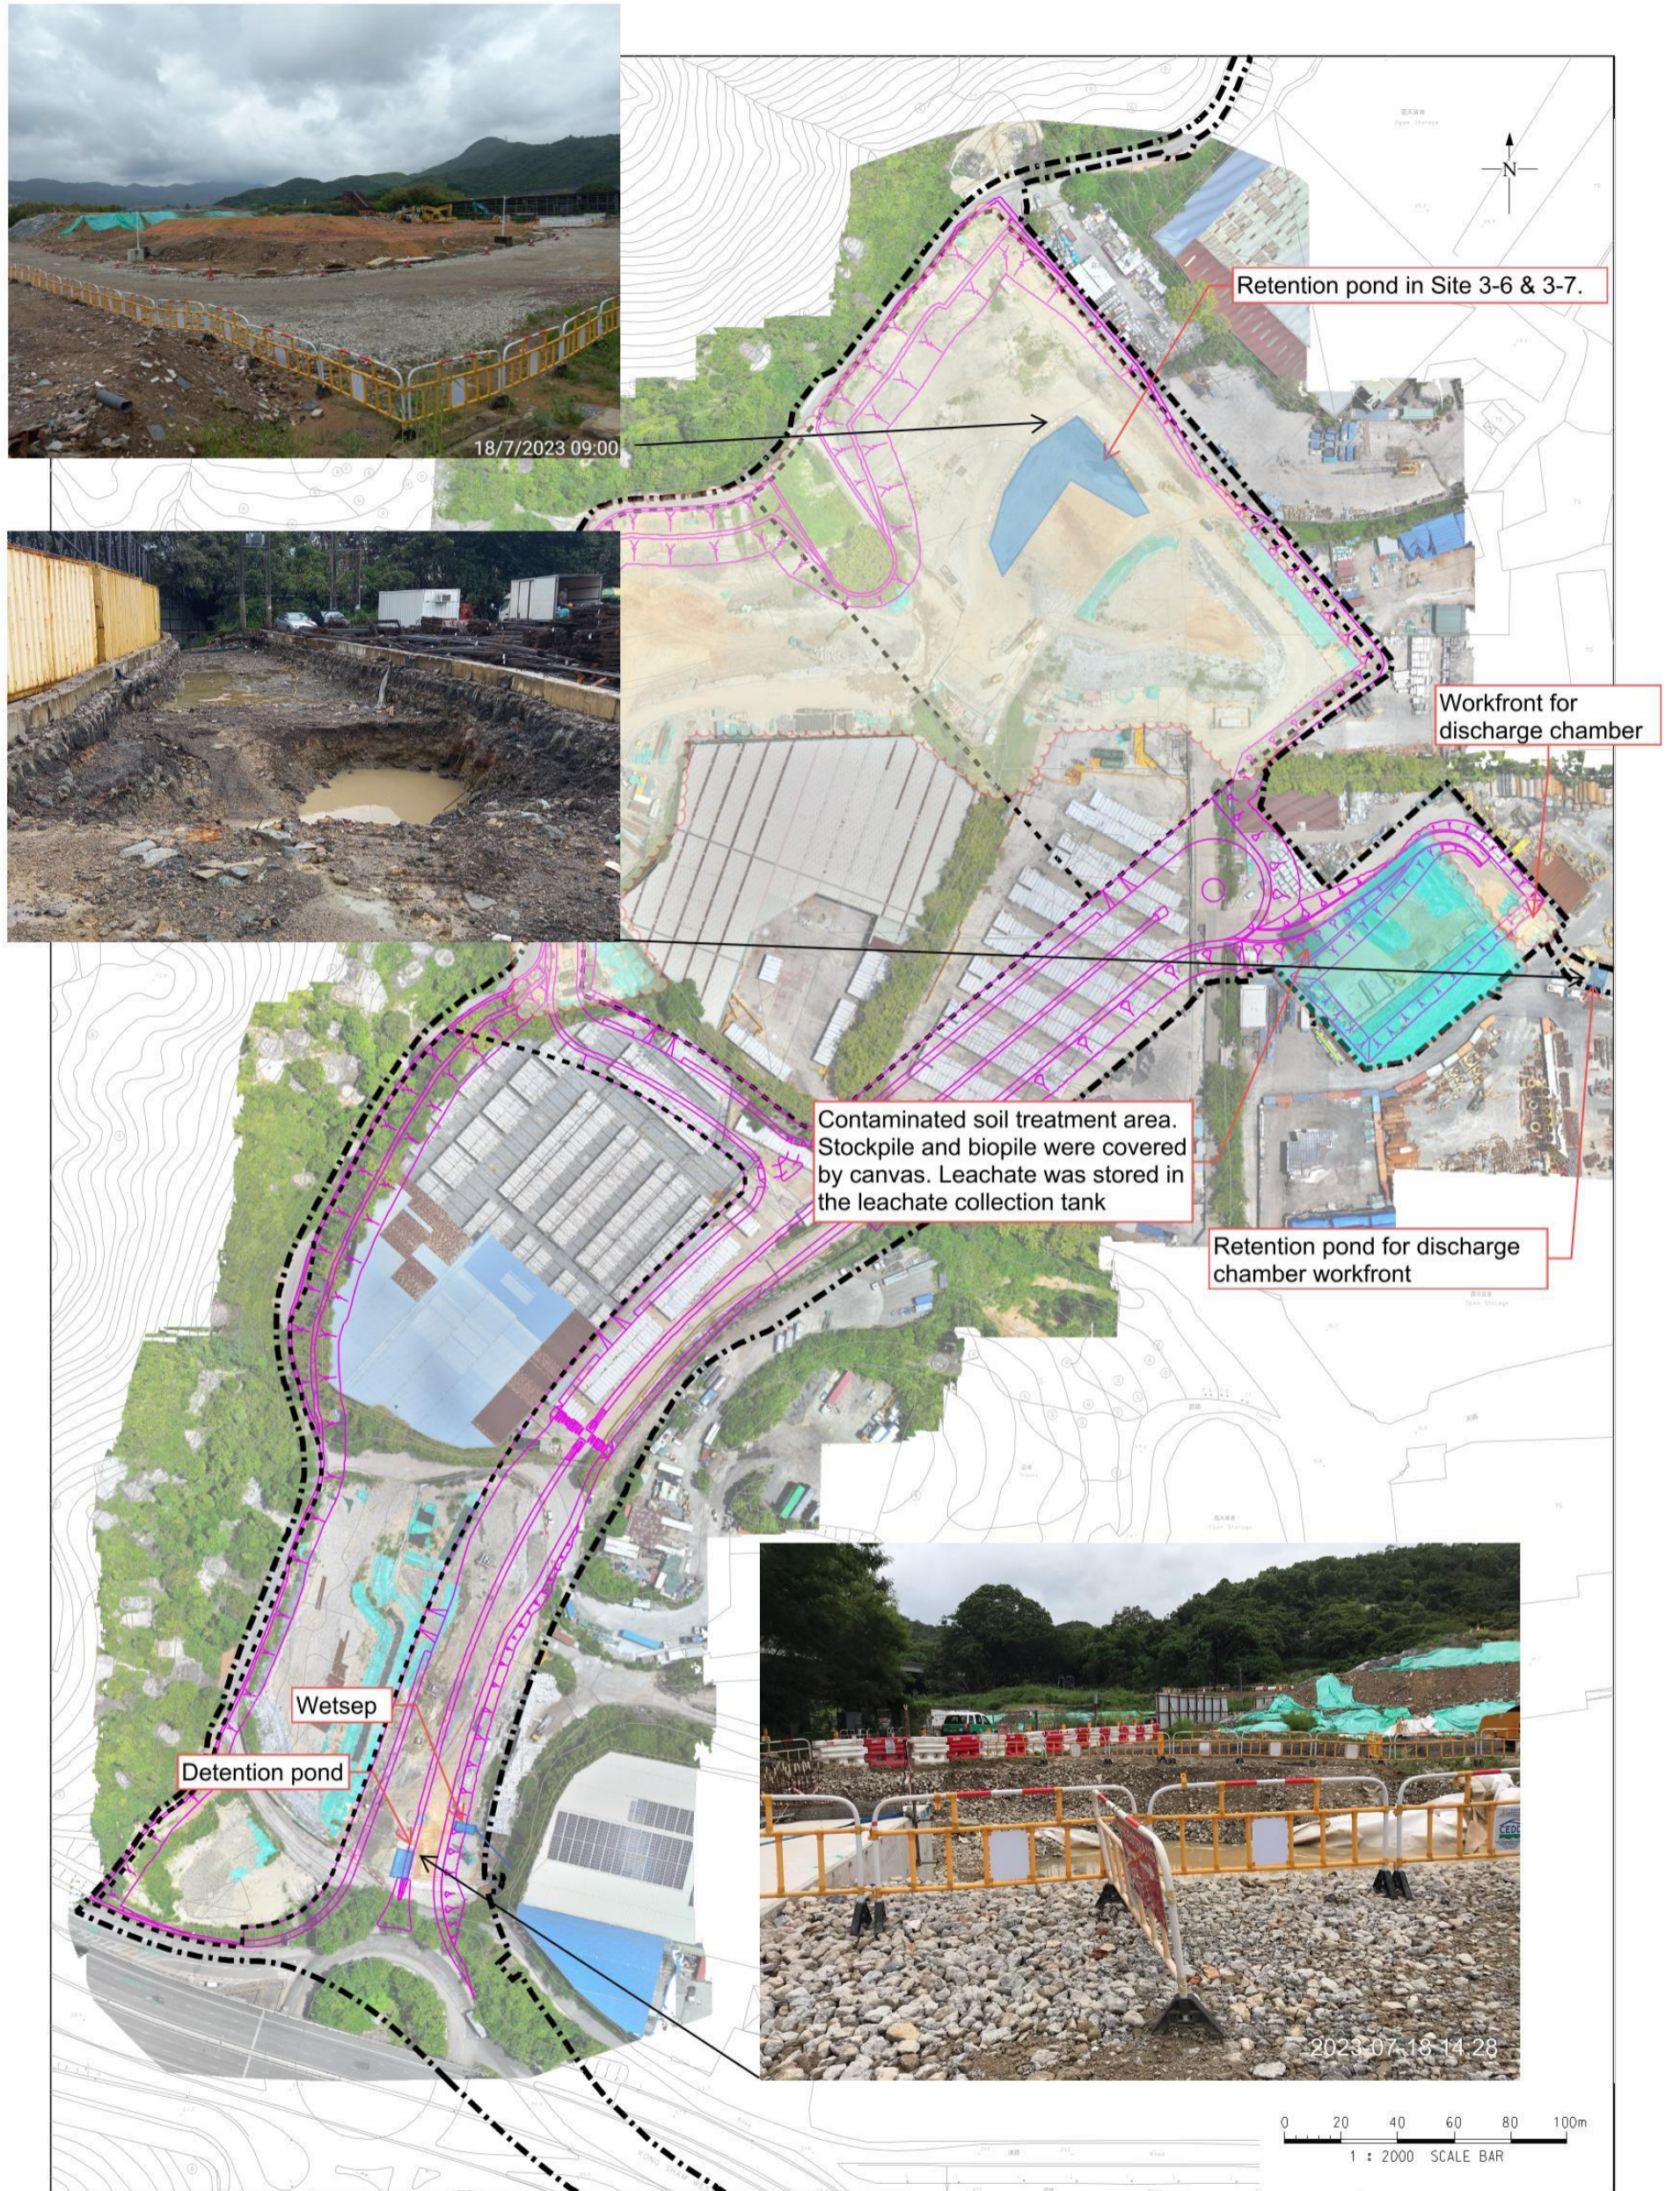
M MOTT MACDONALD	CONTRACT NO. YL/2020/03	Water quality pollution control measures implemented at Site 3-6 and Site 3-7	SCALE	1:2000 @ A3	DATE	13-JUL-23
	HUNG SHUI KIU/HA TSUEN NEW DEVELOPMENT AREA STAGE 1 WORKS		CHECK		Figure 3 380288/SK0050	
		JOB NO.	SK0050	SKETCH NO.		
						30

- g. Impervious canvases are deployed to cover the stockpiles at the contaminated soil treatment area to minimise contaminated surface runoff (Figure 3).

- i. A retention pond is set up at Site 3-6 (Portion B1) to store effluent and surface runoff from Site 3-6 and Site 3-7 (Figure 3).
 - j. Another retention pond is also set up near the contaminated soil treatment area for the discharge chamber workfront to collect effluent and surface runoff (Figure 3).
