**Investigation Report for Exceedances of Limit Levels of Water Quality Monitoring on 29 August 2023**

<b>Environmental Team for Hung Shui Kiu/ Ha Tsuen New Development Area Stage 1 Works – Site Formation and Engineering Infrastructure</b>								
Date	Station	Parameter (Unit)	Depth-averaged Measured Value	Action Level	Limit Level	Exceedance		Project Related (Y/N)
						AL	LL	
29/08	TKW1	Turbidity (NTU)	42.4	27.9	29.2		✓	N
	TKW		48.1	24.2	24.6		✓	N

**Photo Records of Site Inspection held by the ET on 31 August 2023**

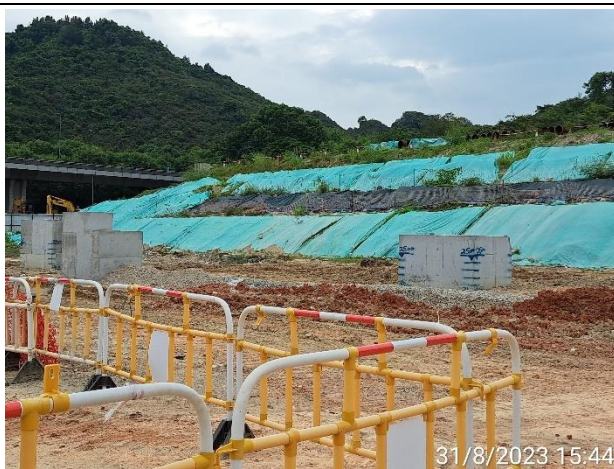
(P1)

Stockpile of dusty materials was covered properly to avoid generation of muddy runoff. No muddy surface runoff was observed during the site inspection.

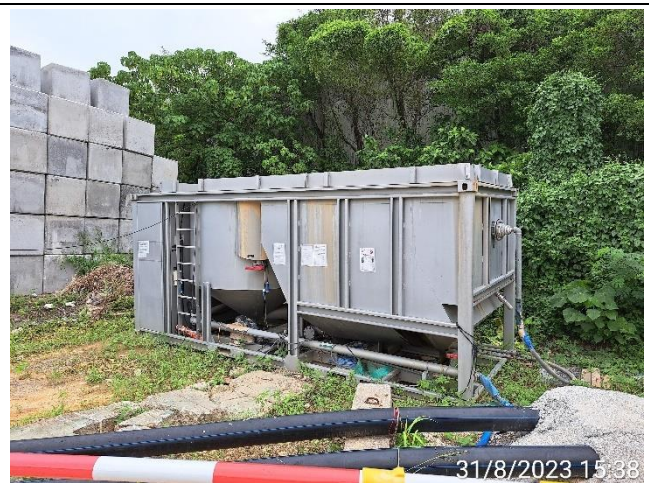
(P2)

Surface runoff and site effluent were collected and diverted to the WetSep for temporary storage and treatment before the water was used for fugitive dust suppression on site or discharged at designated location under the requirement of effluent discharge licence.

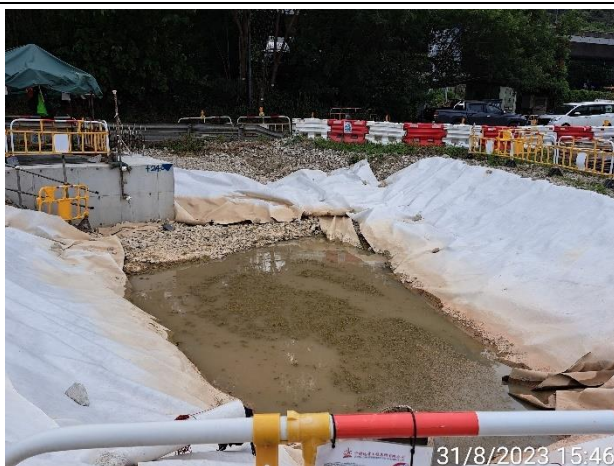
(P3)

Surface runoff was directed to the sump/ detention pond for temporary storage. No muddy surface runoff and no direct discharge of construction

effluent was observed.

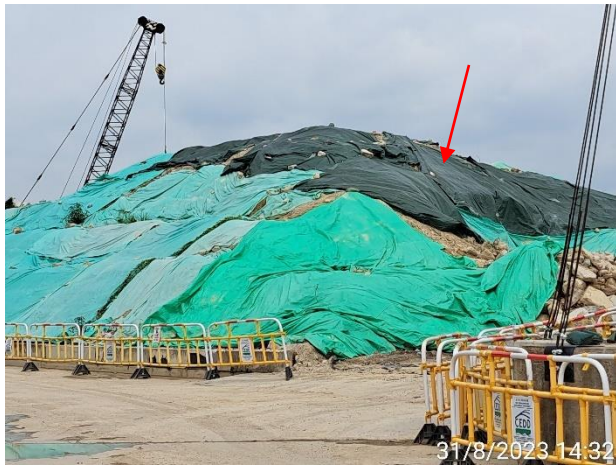
(P4)

Contaminated materials were stocked on site pending for decontamination.

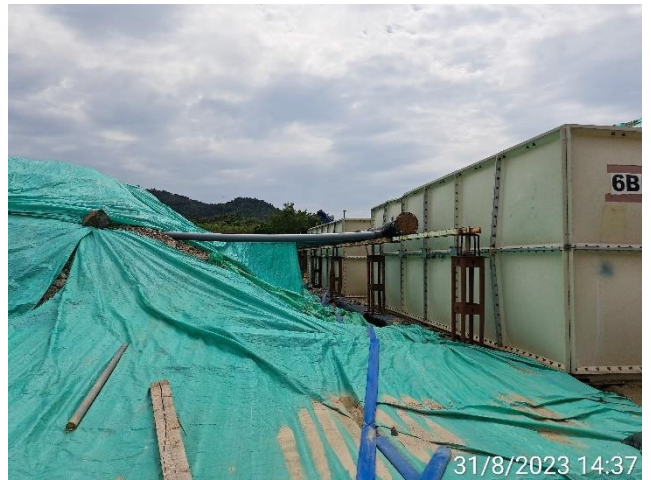
(P5)

Stockpiles within the contaminated soil treatment area were covered by impervious canvases. Leachate collection tanks were also in place.

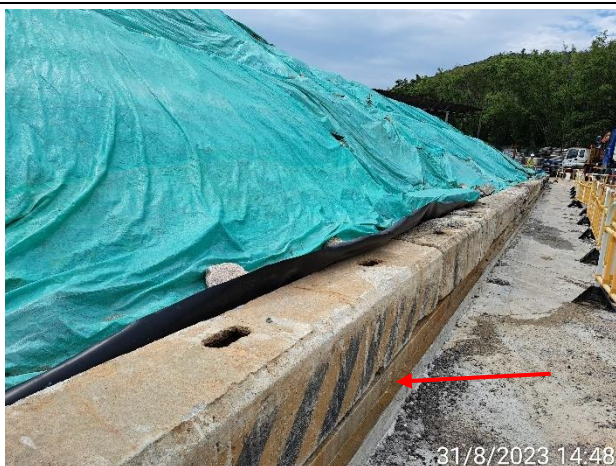
(P6)

Perimeter channels were installed outside the contaminated soil treatment area.

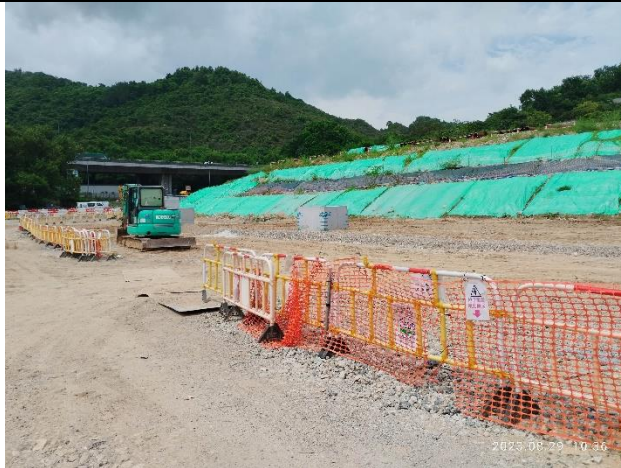
(R1)

Stockpile of dusty materials was covered properly to avoid generation of muddy runoff.

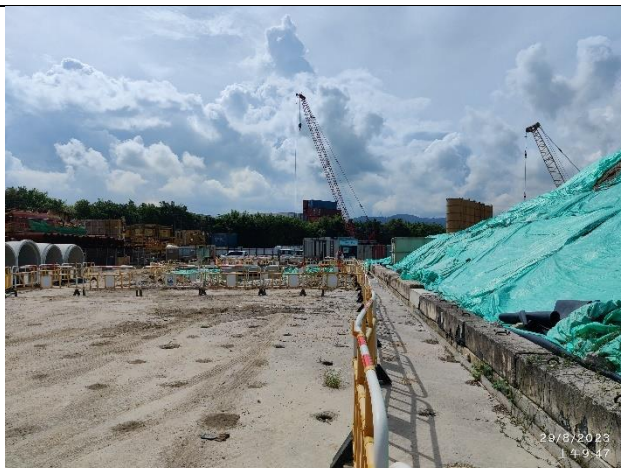
(R2)

Sloping surfaces of stockpiles within the contaminated soil treatment area were covered by impervious canvas. No surface runoff or effluent was leaked from the contaminated soil treatment area during the site inspection.

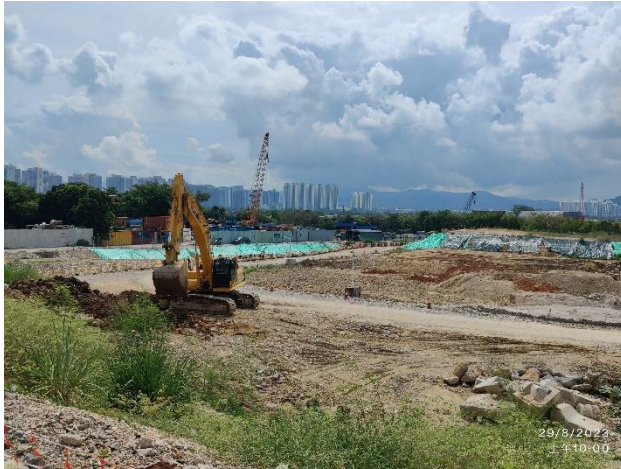
(R3)

No effluent discharge from the site was observed.

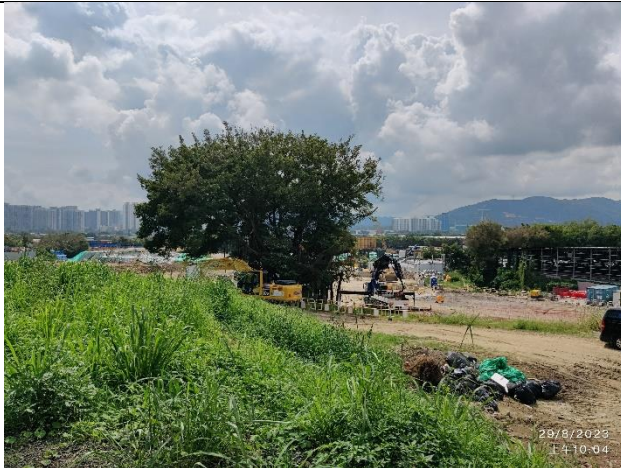
(R4)

No effluent discharge from the site was observed.

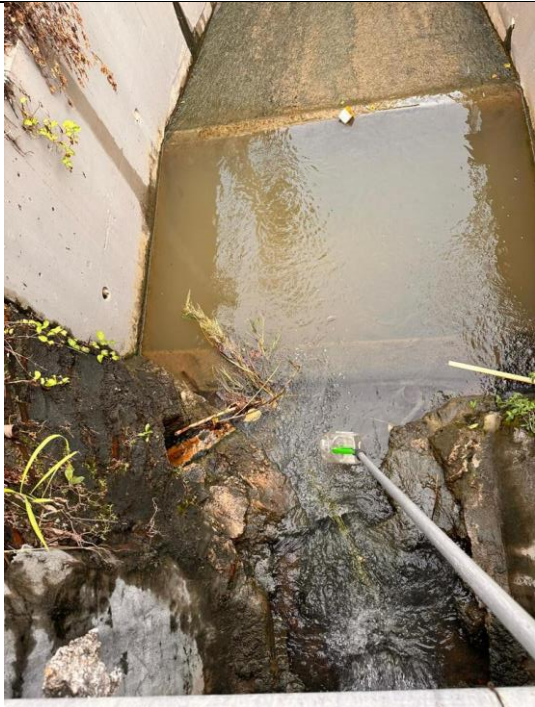
(W1)

Water Quality Monitoring Station: TKW

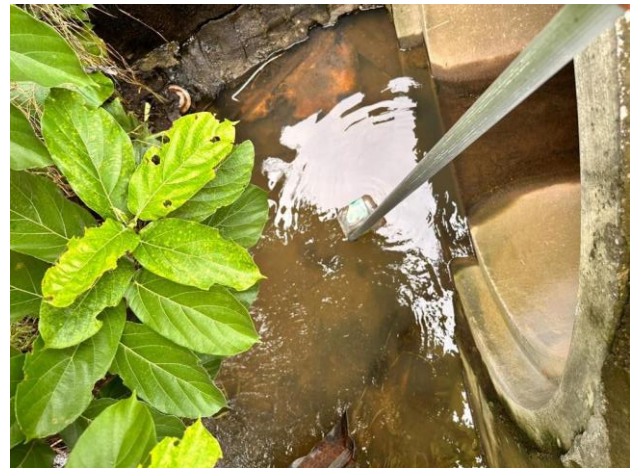
(W2)

Water Quality Monitoring Station: TKW1

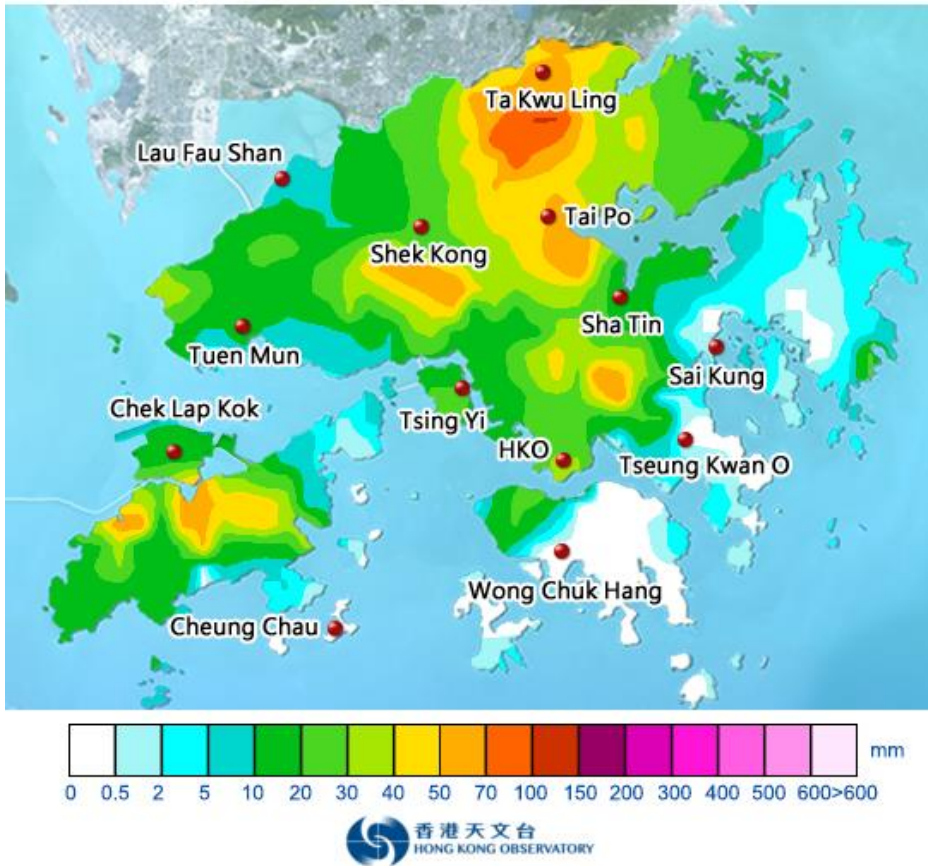
### Figure 1 Rainfall Records from the Hong Kong Observatory

Total rainfall on 29-Aug-2023 (based on raingauges and radar data)
