**Investigation Report for Exceedances of Limit Levels of Water Quality Monitoring on 13 January 2024**

<b>Environmental Team for Hung Shui Kiu/ Ha Tsuen New Development Area Stage 1 Works – Site Formation and Engineering Infrastructure</b>								
Date	Station	Parameter (Unit)	Depth-averaged Measured Value	Action Level	Limit Level	Exceedance		Project Related (Y/N)
						AL	LL	
13/01	TKW	Suspended Solids (SS) (mg/L)	13.0	7.0	7.1		✓	N
	SW		36.5	8.8	10.5		✓	N

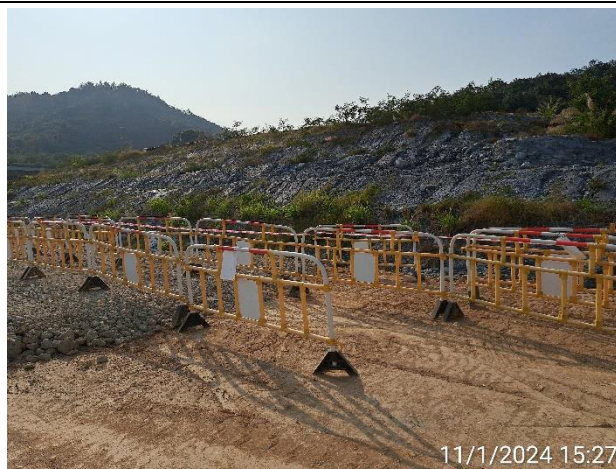
(P1)

Stockpile of dusty materials was covered properly to avoid generation of muddy runoff. No muddy surface runoff was observed during the site inspection.

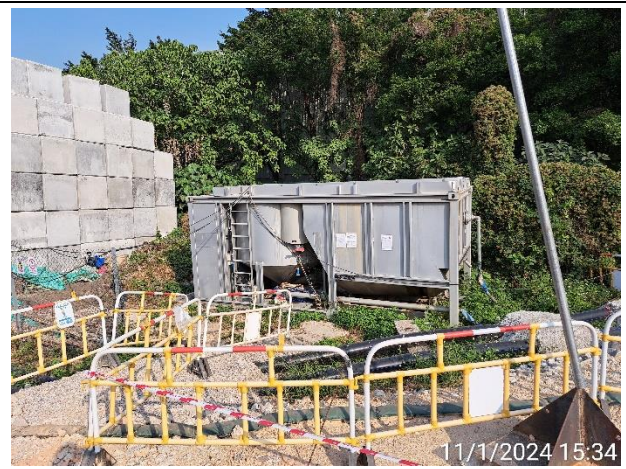
(P2)

Surface runoff and site effluent were collected and diverted to the WetSep for temporary storage and treatment before the water was used for fugitive dust suppression on site or discharged at designated location under the requirement of effluent discharge licence.

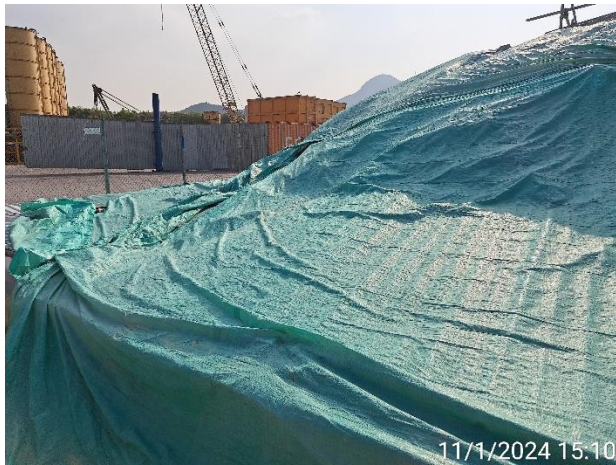
(P3)

Contaminated materials were stocked on site.

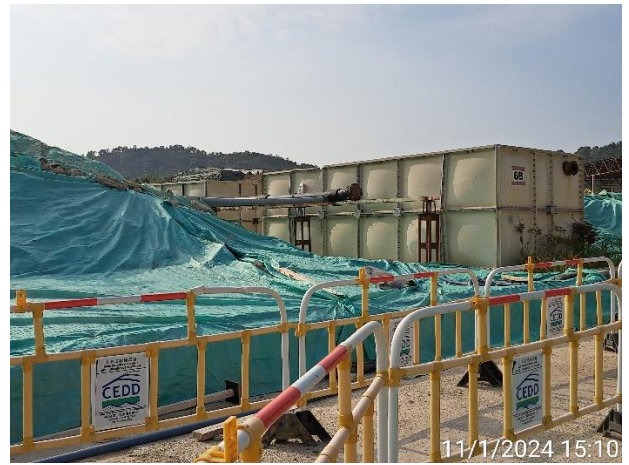
(P4)

Stockpiles within the contaminated soil treatment area were covered by impervious canvases. Leachate collection tanks were also in place.

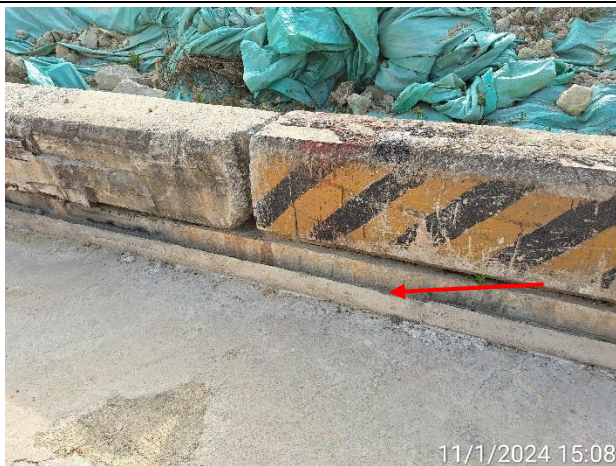
(P5)

Perimeter channels were installed outside the contaminated soil treatment area.

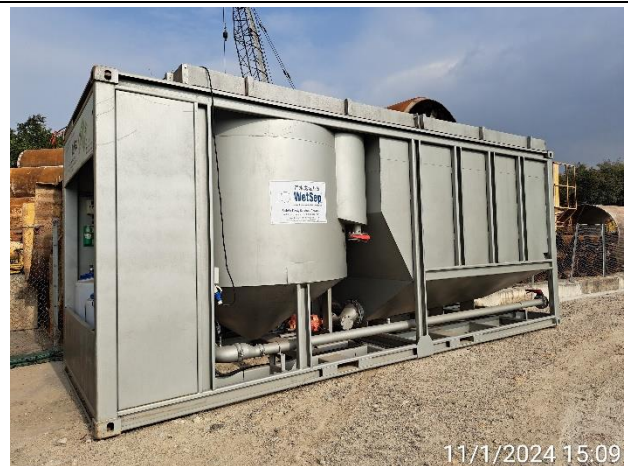
(P6)

A WetSep was provided on site to treat and store construction effluent from Site 3-6, Site 3-7, and Contaminated Soil Treatment Area. No off-site effluent discharge was recorded in January 2024.

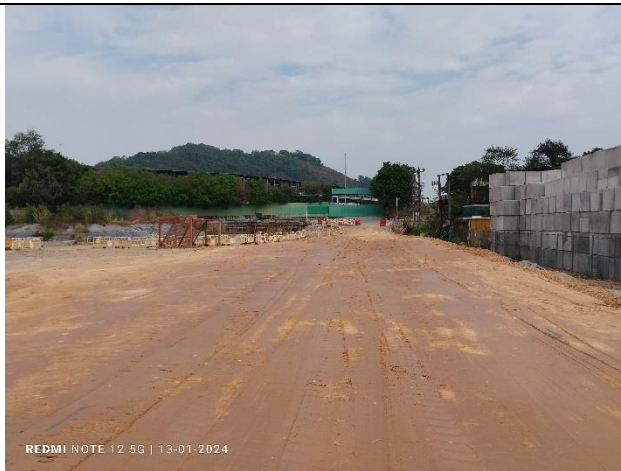
(R1)

The road roller was provided to avoid generation of muddy runoff.

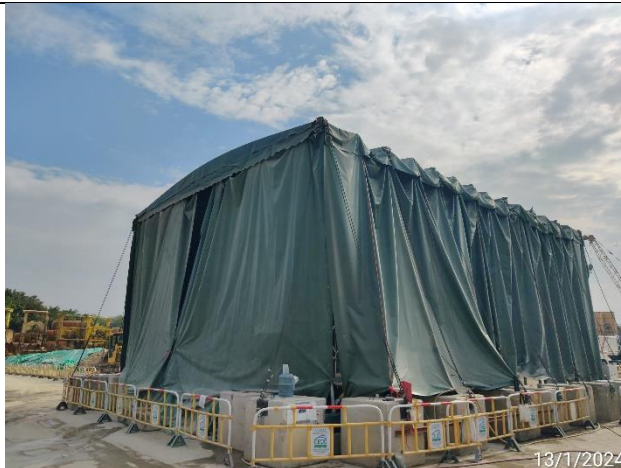
(R2)

The contaminated soil treatment area were covered by impervious canvas. No surface runoff or effluent was leaked from the contaminated soil treatment area during the site inspection.

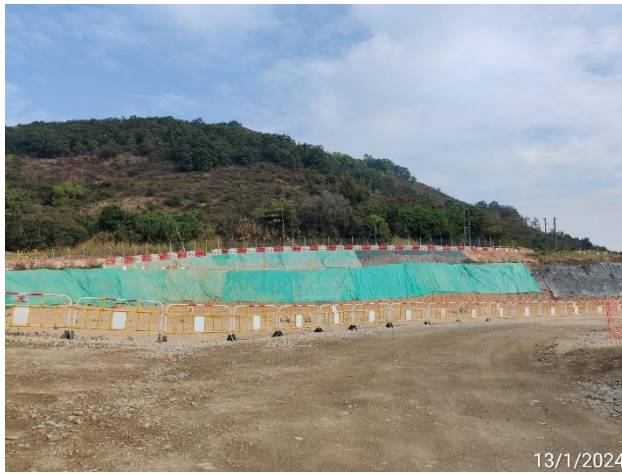
(R3)

No effluent discharge from the site was observed.

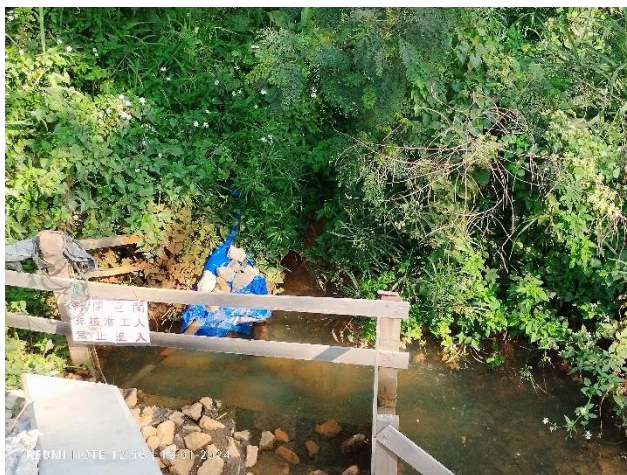
(R4)

No off-site effluent discharge was recorded in January 2024.

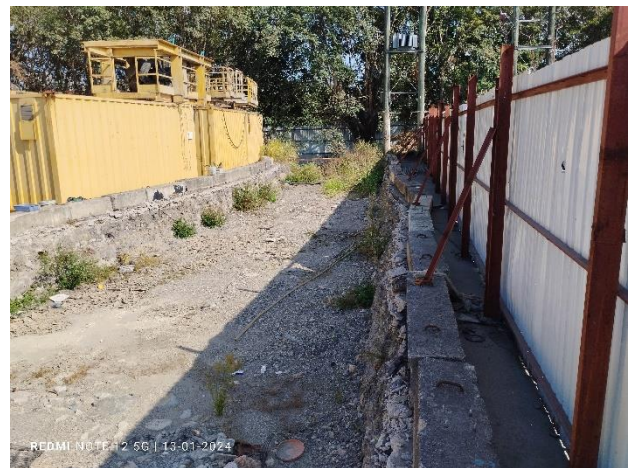
(R5)

No off-site effluent discharge was recorded in January 2024.

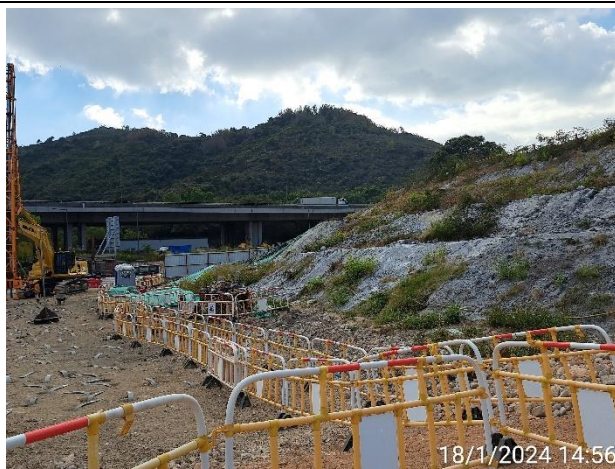
(P1)

Stockpile of dusty materials was covered properly to avoid generation of muddy runoff. No muddy surface runoff was observed during the site inspection.

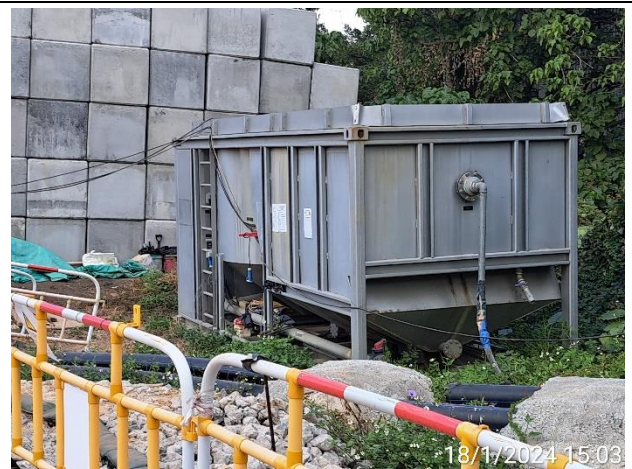
(P2)

Surface runoff and site effluent were collected and diverted to the WetSep for temporary storage and treatment before the water was used for fugitive dust suppression on site or discharged at designated location under the requirement of effluent discharge licence.

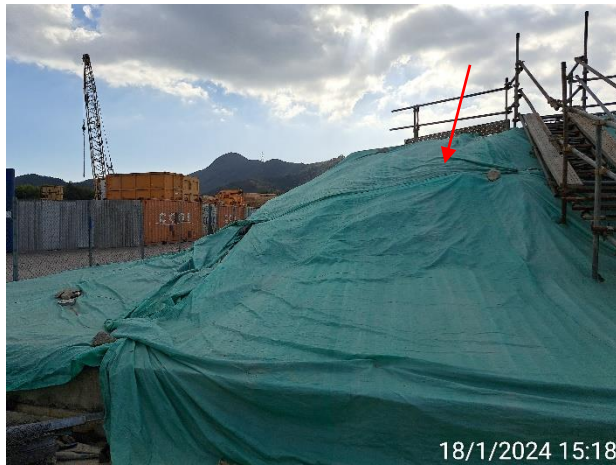
(P3)

Contaminated materials were stocked on site.

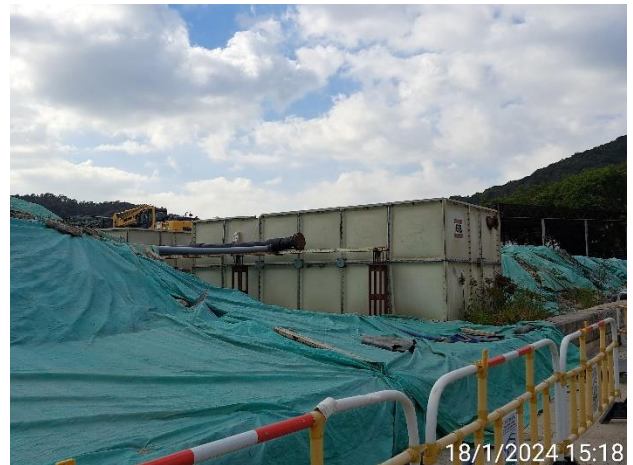
(P4)

Stockpiles within the contaminated soil treatment area were covered by impervious canvases. Leachate collection tanks were also in place.

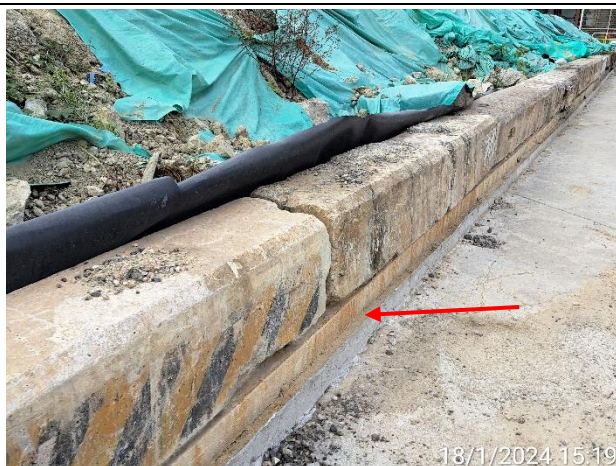
(P5)

Perimeter channels were installed outside the contaminated soil treatment area.

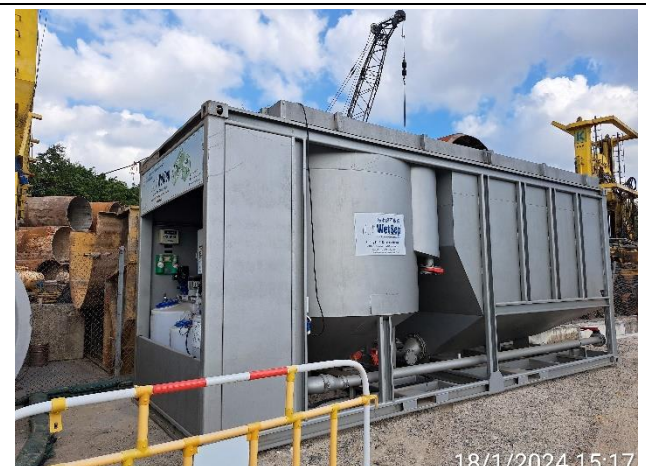
(P6)

A WetSep was provided on site to treat and store construction effluent from Site 3-6, Site 3-7, and Contaminated Soil Treatment Area. No off-site effluent discharge was recorded in January 2024.

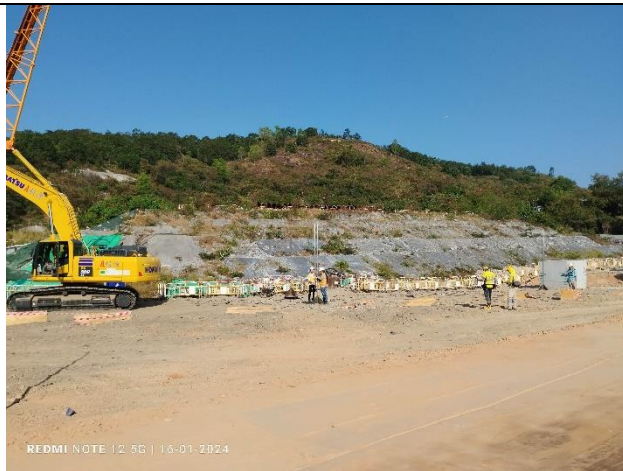
(R1)

No effluent discharge from the site was observed.

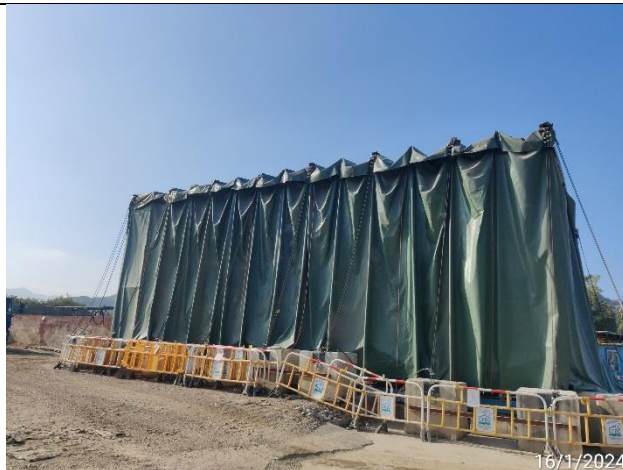
(R2)

The contaminated soil treatment area were covered by impervious canvas. No surface runoff or effluent was leaked from the contaminated soil treatment area during the site inspection.

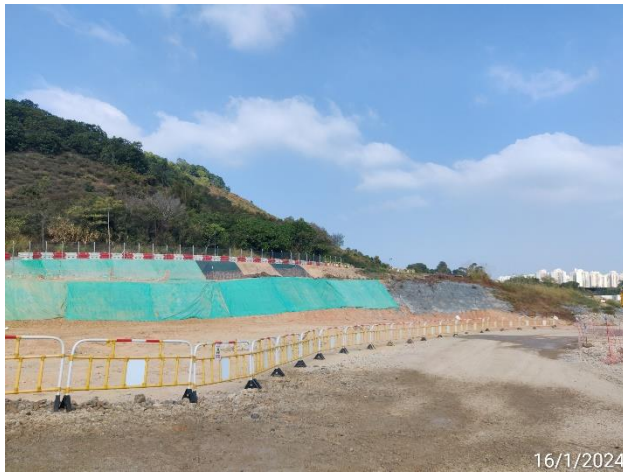
(R3)

No effluent discharge from the site was observed.

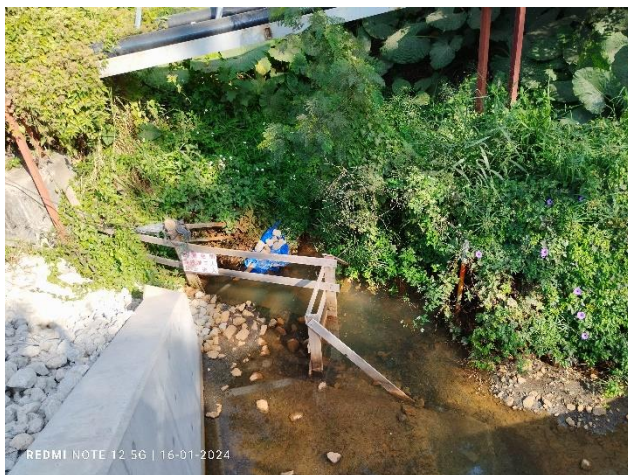
(R4)

No off-site effluent discharge was recorded in January 2024.

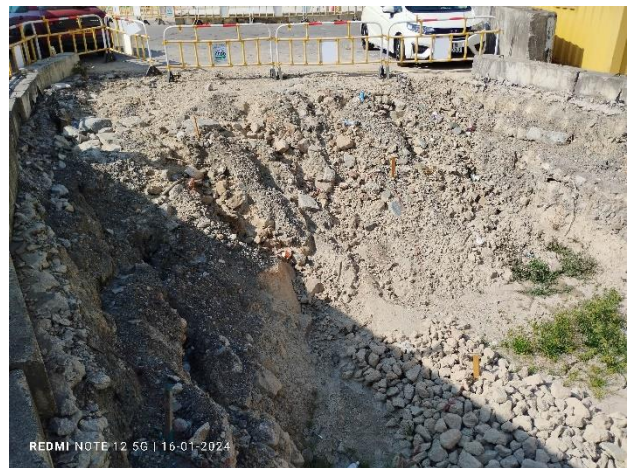
(R5)

No off-site effluent discharge was recorded in January 2024.

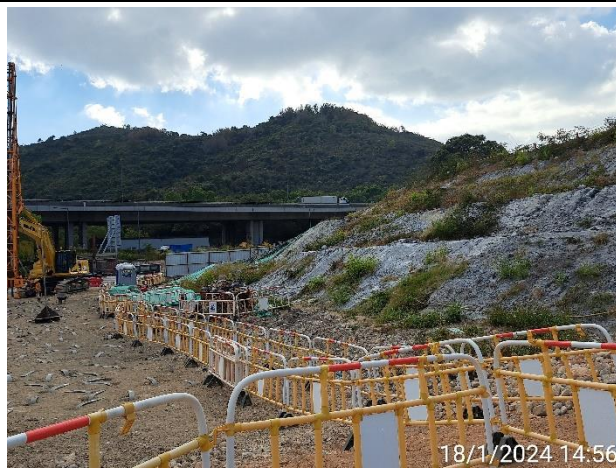
(P1)

Stockpile of dusty materials was covered properly to avoid generation of muddy runoff. No muddy surface runoff was observed during the site inspection.

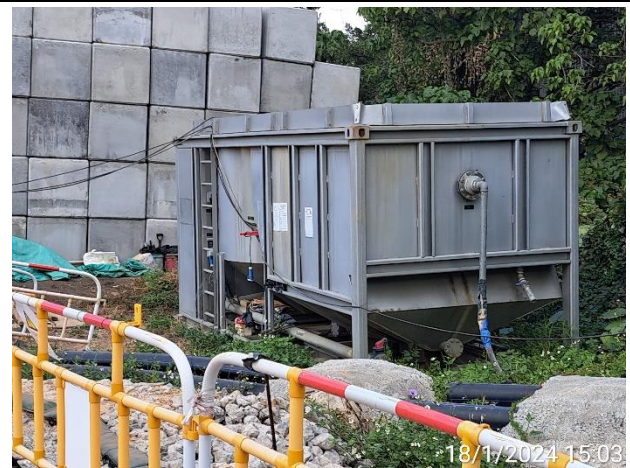
(P2)

Surface runoff and site effluent were collected and diverted to the WetSep for temporary storage and treatment before the water was used for fugitive dust suppression on site or discharged at designated location under the requirement of effluent discharge licence.

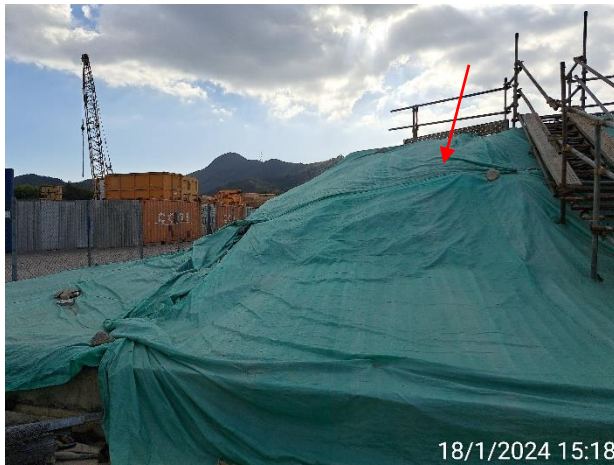
(P3)

Contaminated materials were stocked on site.

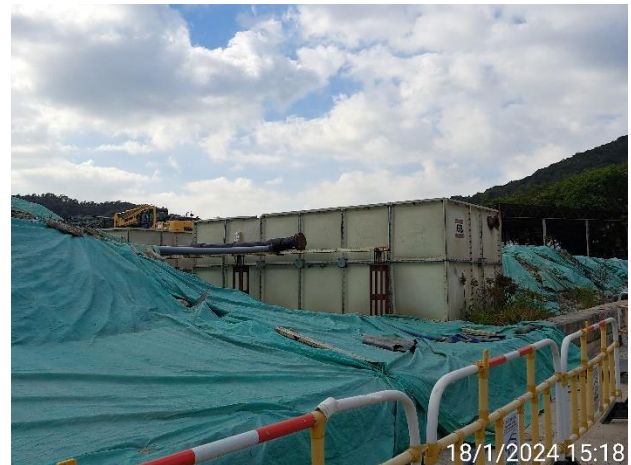
(P4)

Stockpiles within the contaminated soil treatment area were covered by impervious canvases. Leachate collection tanks were also in place.

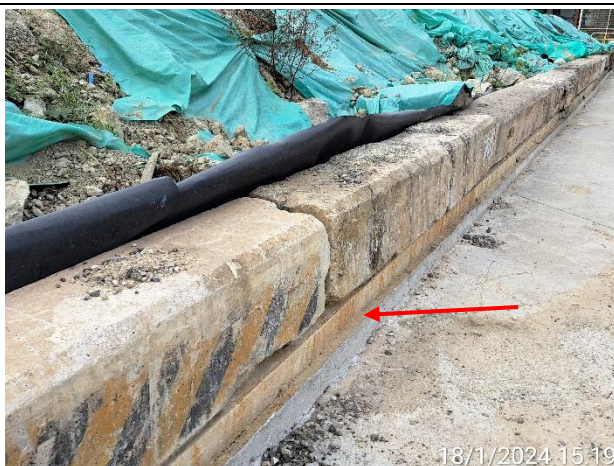
(P5)

Perimeter channels were installed outside the contaminated soil treatment area.

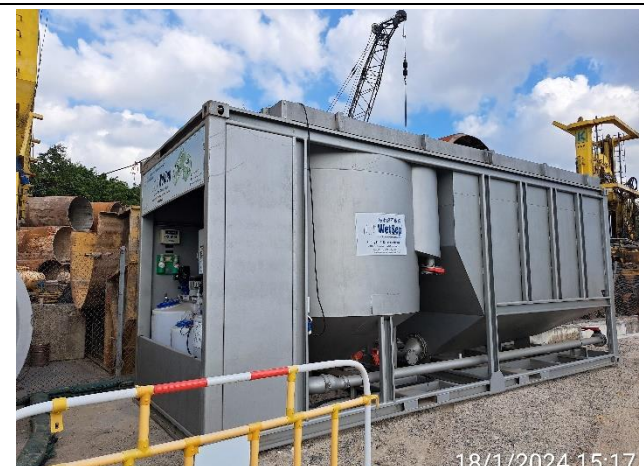
(P6)

A WetSep was provided on site to treat and store construction effluent from Site 3-6, Site 3-7, and Contaminated Soil Treatment Area. No off-site effluent discharge was recorded in January 2024.

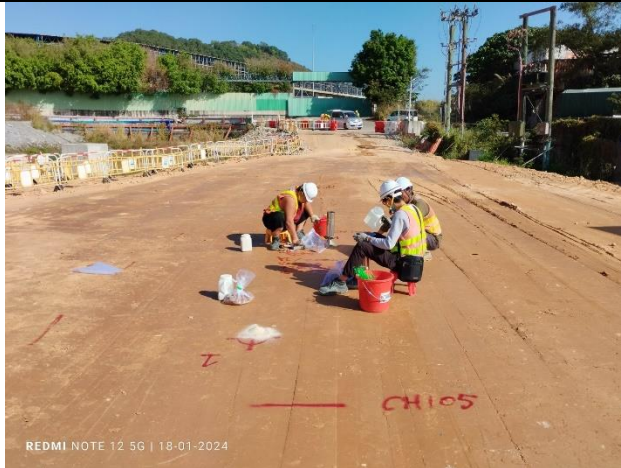
(R1)

No effluent discharge from the site was observed.

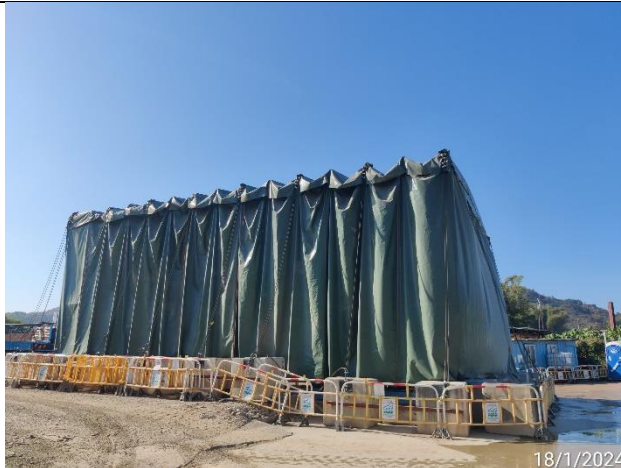
(R2)

The contaminated soil treatment area were covered by impervious canvas. No surface runoff or effluent was leaked from the contaminated soil treatment area during the site inspection.

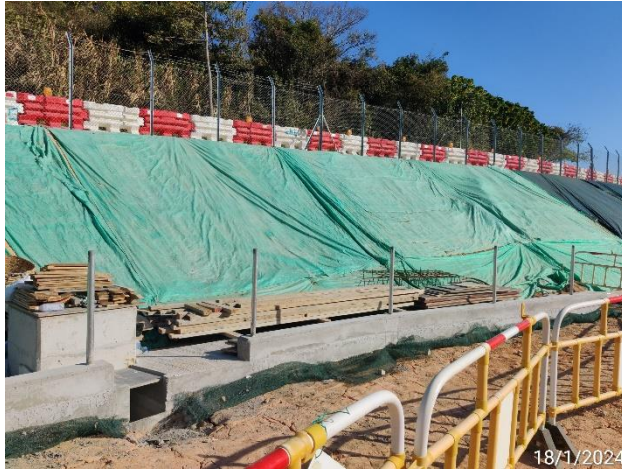
(R3)

No effluent discharge from the site was observed.

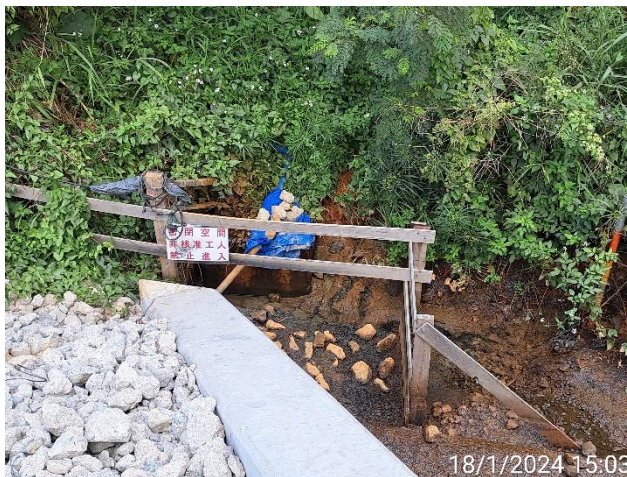
(R4)

No off-site effluent discharge was recorded in January 2024.

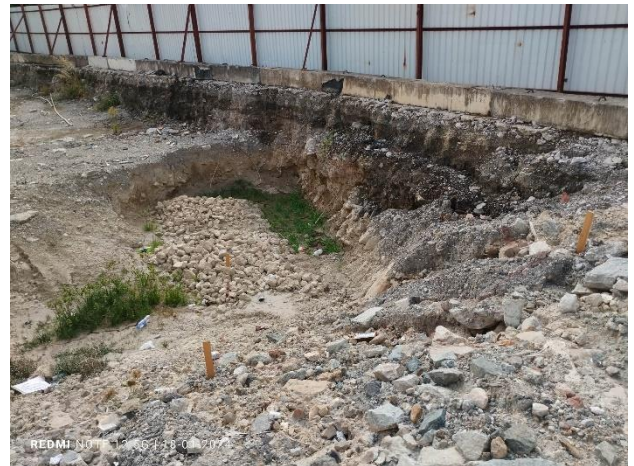
(R5)

No off-site effluent discharge was recorded in January 2024.

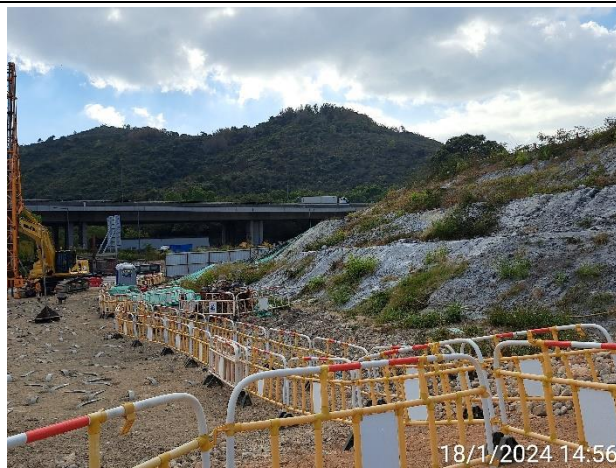
(P1)

Stockpile of dusty materials was covered properly to avoid generation of muddy runoff. No muddy surface runoff was observed during the site inspection.

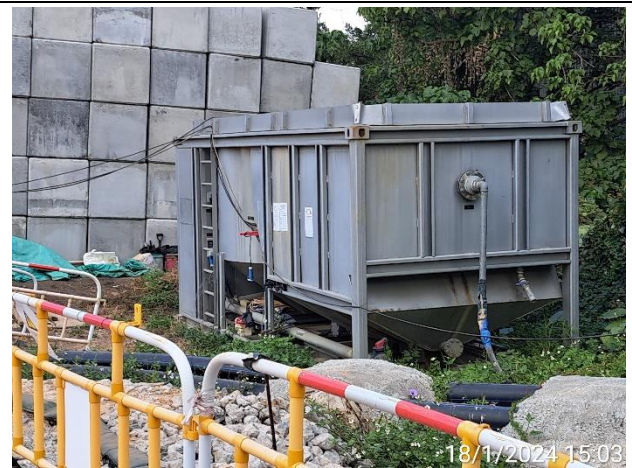
(P2)

Surface runoff and site effluent were collected and diverted to the WetSep for temporary storage and treatment before the water was used for fugitive dust suppression on site or discharged at designated location under the requirement of effluent discharge licence.

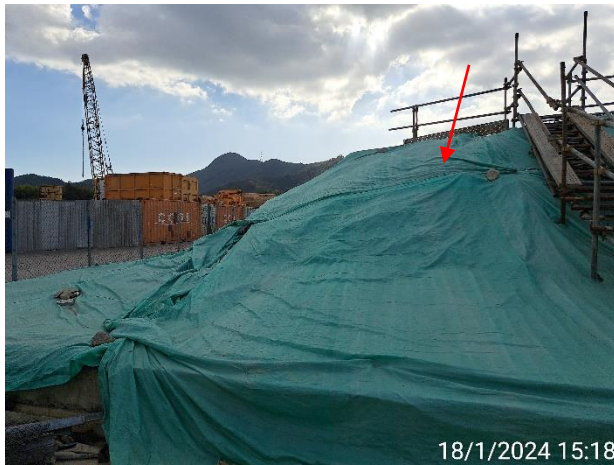
(P3)

Contaminated materials were stocked on site.

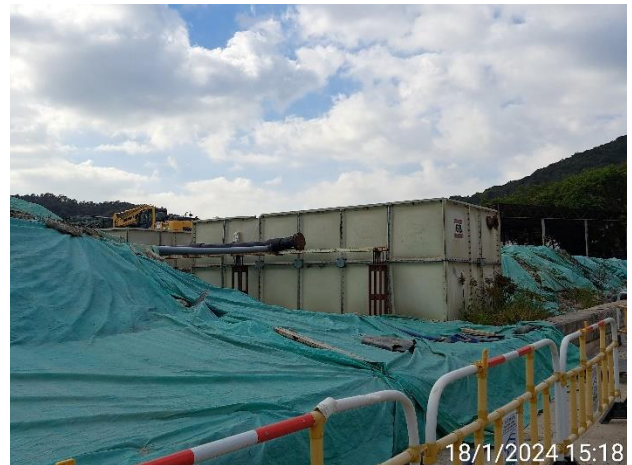
(P4)

Stockpiles within the contaminated soil treatment area were covered by impervious canvases. Leachate collection tanks were also in place.

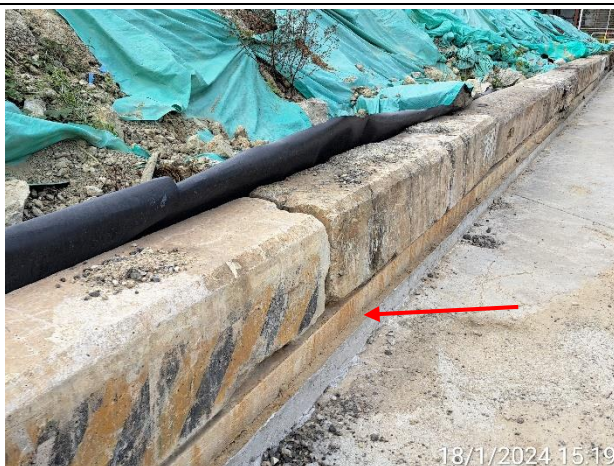
(P5)

Perimeter channels were installed outside the contaminated soil treatment area.

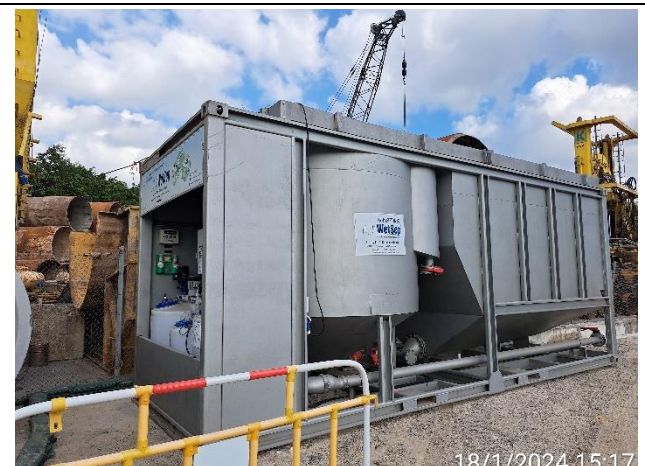
(P6)

A WetSep was provided on site to treat and store construction effluent from Site 3-6, Site 3-7, and Contaminated Soil Treatment Area. No off-site effluent discharge was recorded in January 2024.

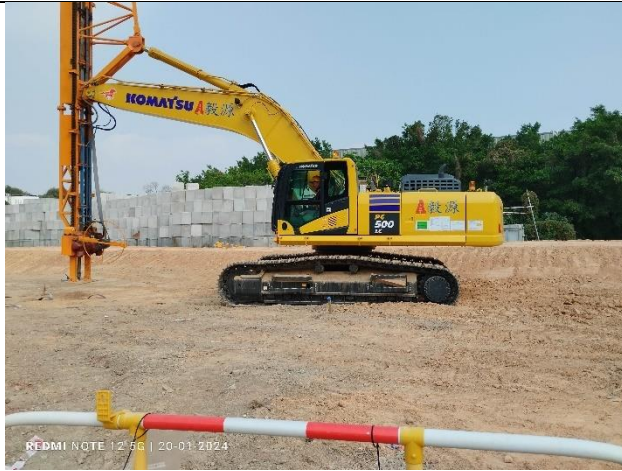
(R1)

No effluent discharge from the site was observed.

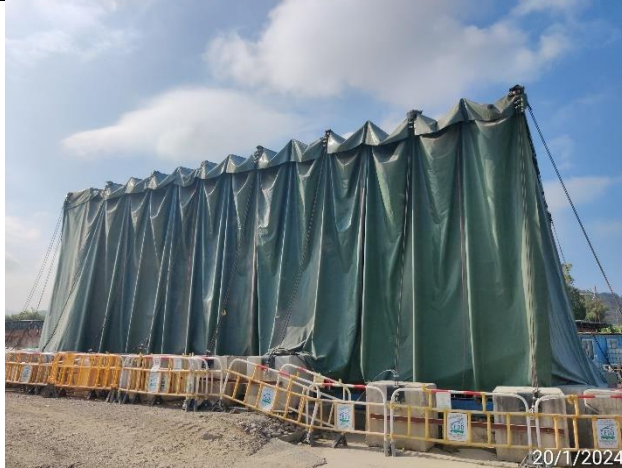
(R2)

The contaminated soil treatment area were covered by impervious canvas. No surface runoff or effluent was leaked from the contaminated soil treatment area during the site inspection.

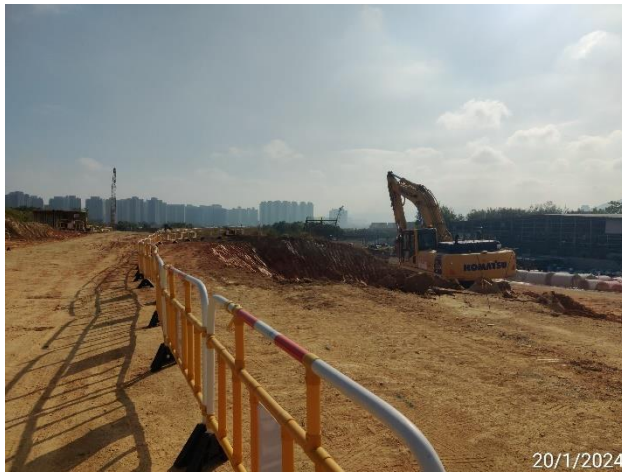
(R3)

No effluent discharge from the site was observed.

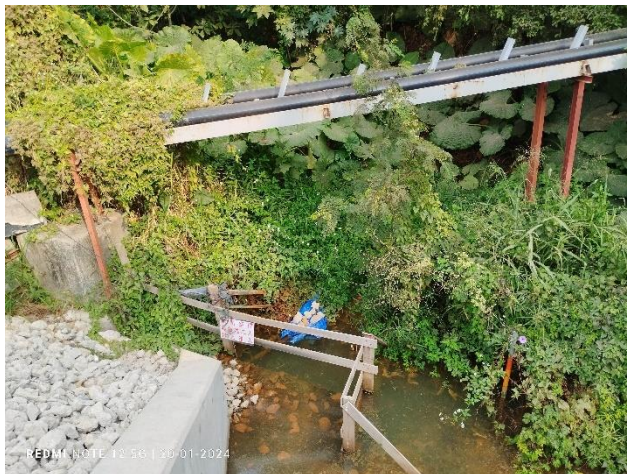
(R4)

No off-site effluent discharge was recorded in January 2024.

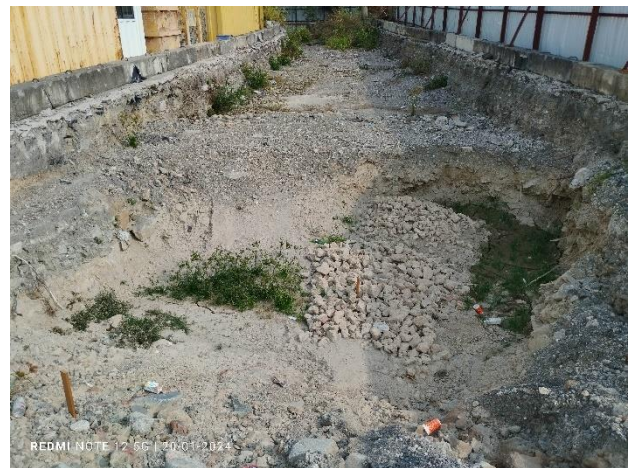
(R5)

No off-site effluent discharge was recorded in January 2024.
