## Investigation Report for Exceedances of Limit Levels of Water Quality Monitoring on 12 March 2024

Environmental Team for Hung Shui Kiu/ Ha Tsuen New Development Area Stage 1 Works – Site Formation and Engineering Infrastructure								
Date	Station	Parameter (Unit)	Depth-averaged Measured Value	Action Level	Limit Level	Exceedance		Project Related (Y/N)
						AL	LL	
12/03	SW	Dissolved oxygen (DO) (mg/L)	1.6	2.3	2.1		✓	N
	HT		1.6	2.2	2.1		✓	N

## Investigation Report for Exceedance of Limit Level of Water Quality Monitoring on 14 March 2024

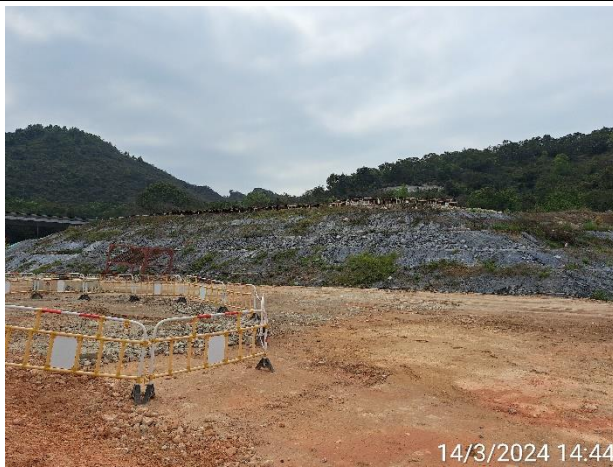
(P1)

Stockpile of dusty materials was pouring with concrete to avoid generation of muddy runoff. No muddy surface runoff was observed during the site inspection.

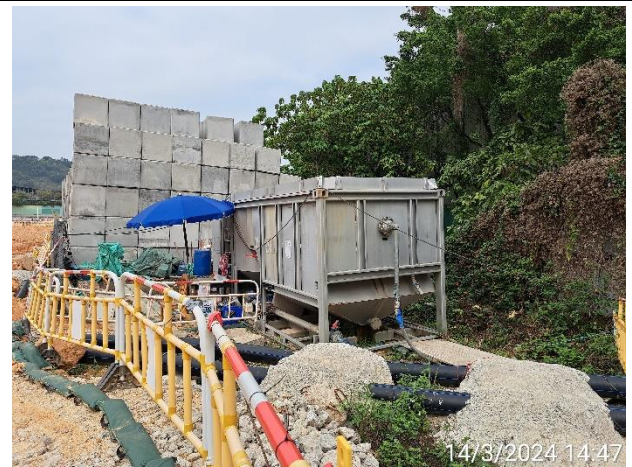
(P2)

Surface runoff and site effluent were collected and diverted to the WetSep for temporary storage and treatment before the water was used for fugitive dust suppression on site.

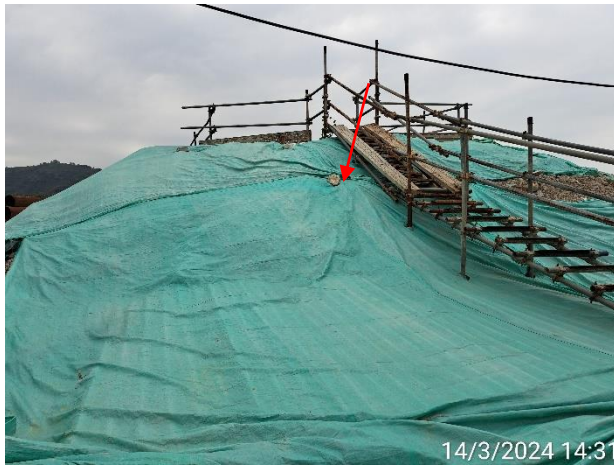
(P3)

Contaminated materials were stocked on site.

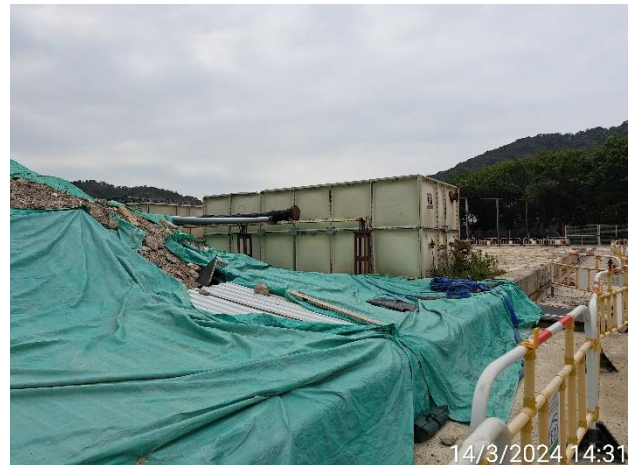
(P4)

Stockpiles within the contaminated soil treatment area were covered by impervious canvases. Leachate collection tanks were also in place.

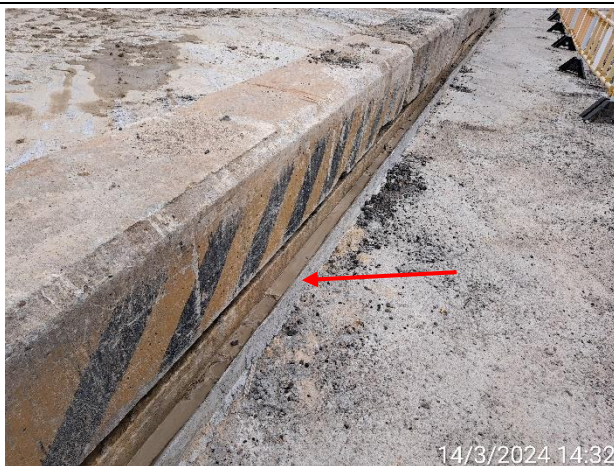
(P5)

Perimeter channels were installed outside the contaminated soil treatment area.

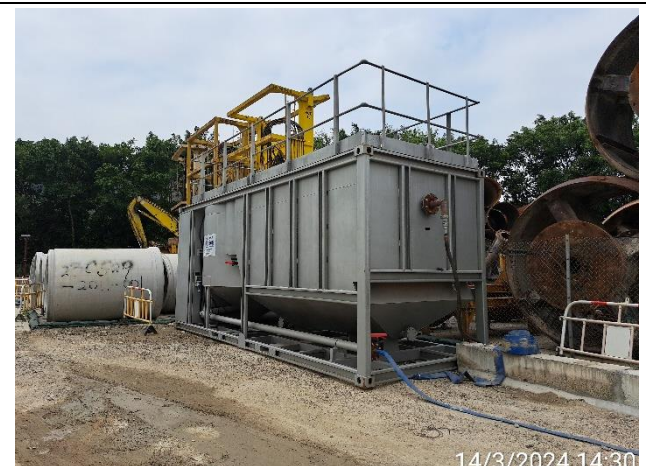
(P6)

A WetSep was provided on site to treat and store construction effluent from Site 3-6, Site 3-7, and Contaminated Soil Treatment Area. No off-site effluent discharge was recorded in March 2024.

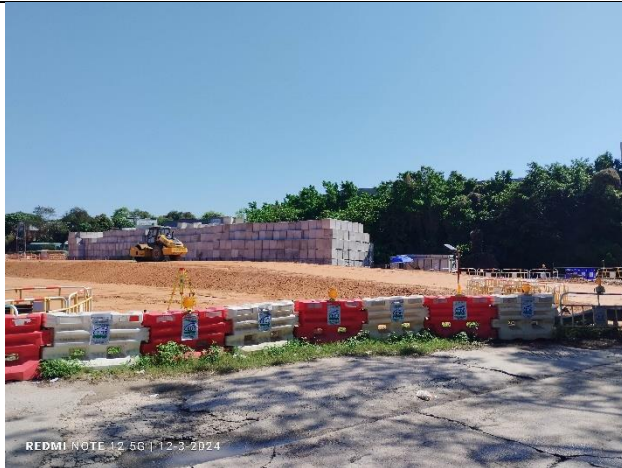
(R1)

No effluent discharge from the site was observed.

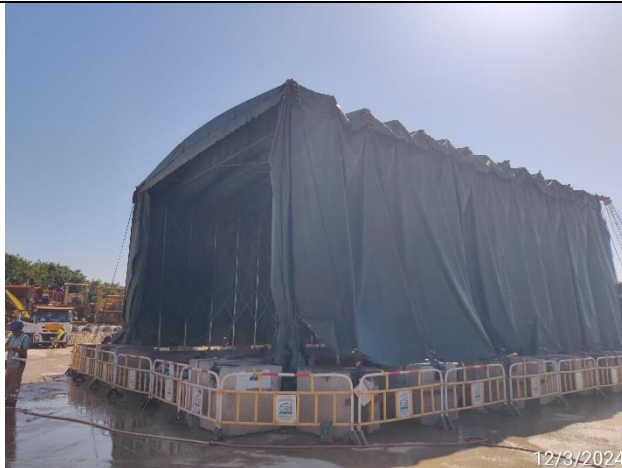
(R2)

The contaminated soil treatment area would be covered by impervious canvas during treating contaminated soil. No surface runoff or effluent was leaked from the contaminated soil treatment area during the site inspection.

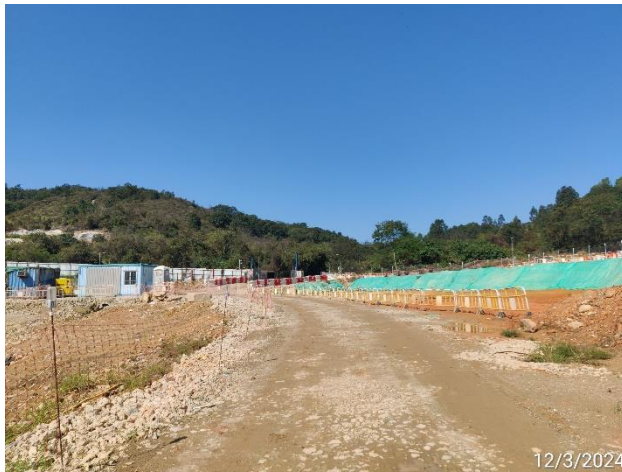
(R3)

No effluent discharge from the site was observed.

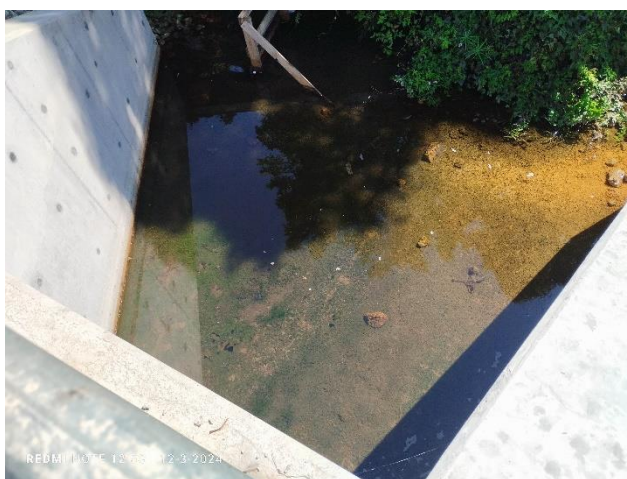
(R4)

No off-site effluent discharge was recorded in March 2024.

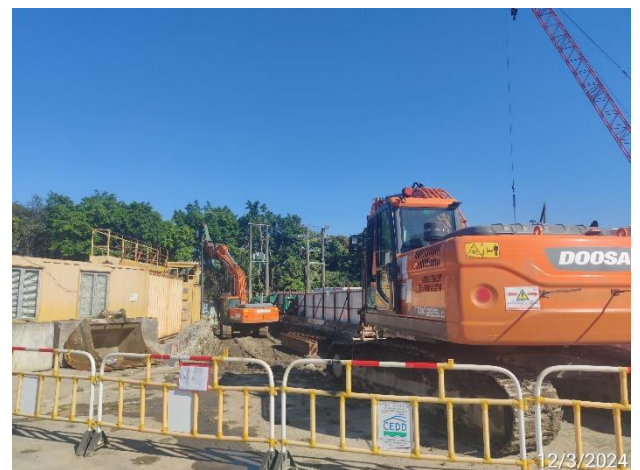
(R5)

No off-site effluent discharge was recorded in March 2024.

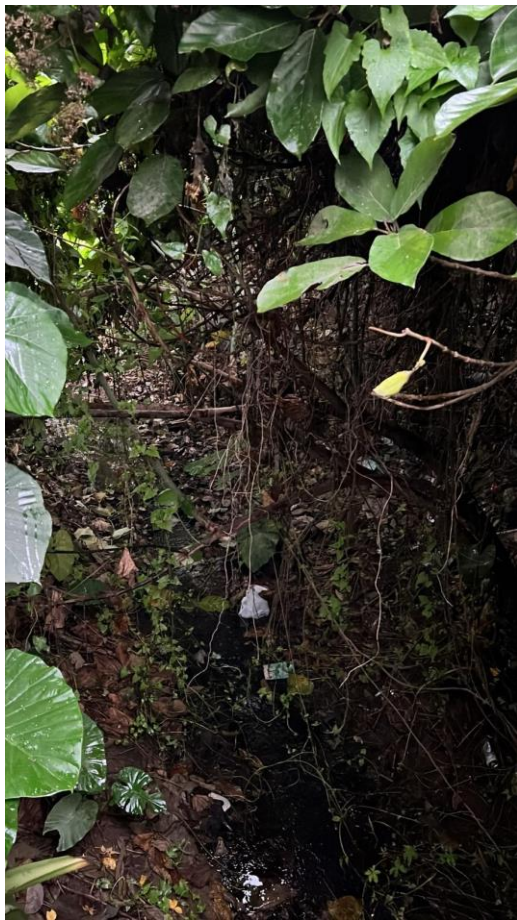
(W1)

Water Quality Monitoring Station: SW

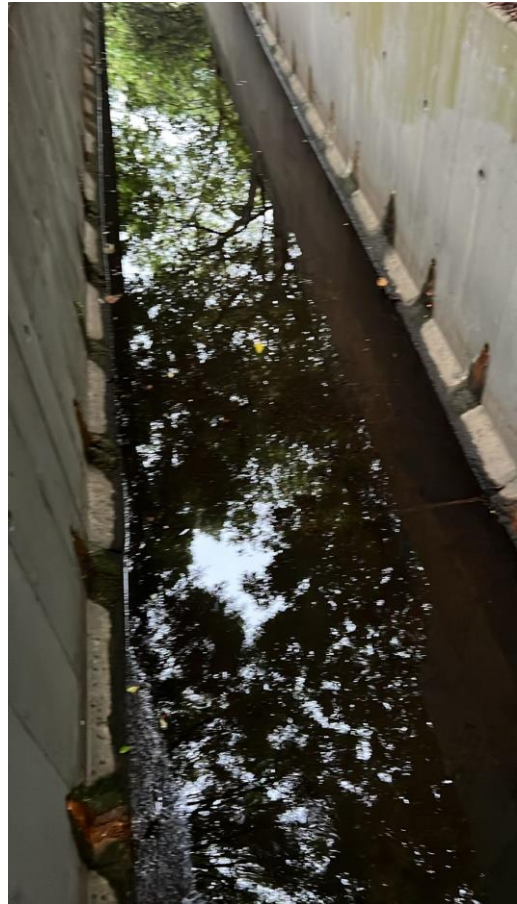
(W2)

Water Quality Monitoring Station: HT

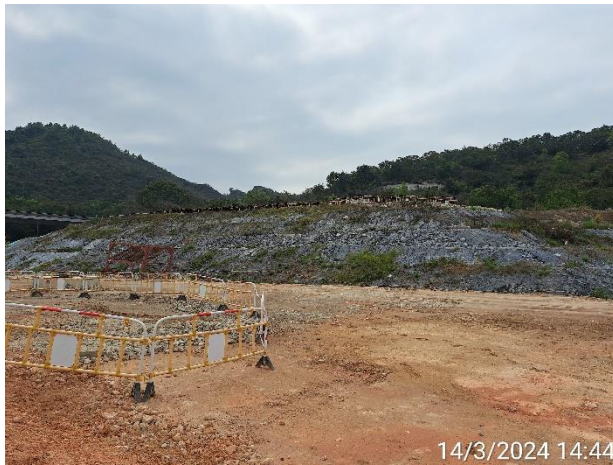
(P1)

Stockpile of dusty materials was pouring with concrete to avoid generation of muddy runoff. No muddy surface runoff was observed during the site inspection.

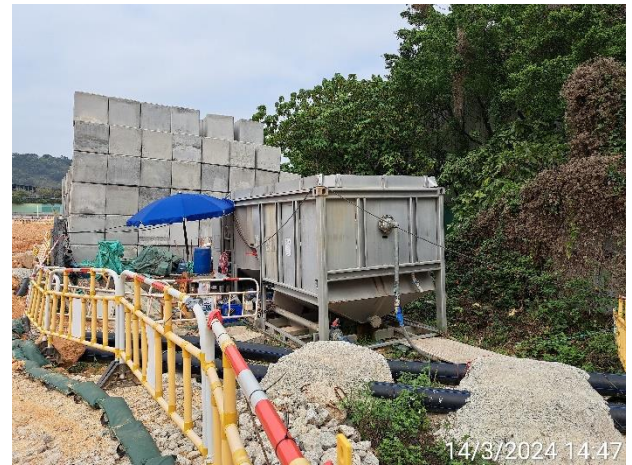
(P2)

Surface runoff and site effluent were collected and diverted to the WetSep for temporary storage and treatment before the water was used for fugitive dust suppression on site.

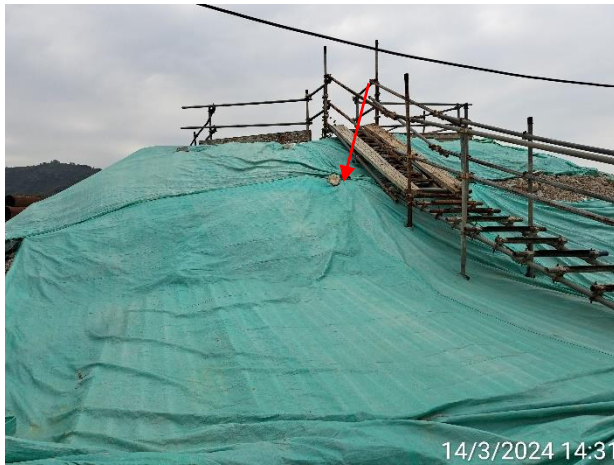
(P3)

Contaminated materials were stocked on site.

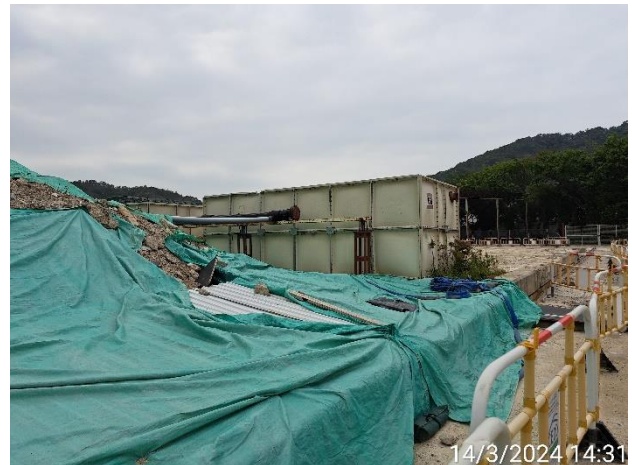
(P4)

Stockpiles within the contaminated soil treatment area were covered by impervious canvases. Leachate collection tanks were also in place.

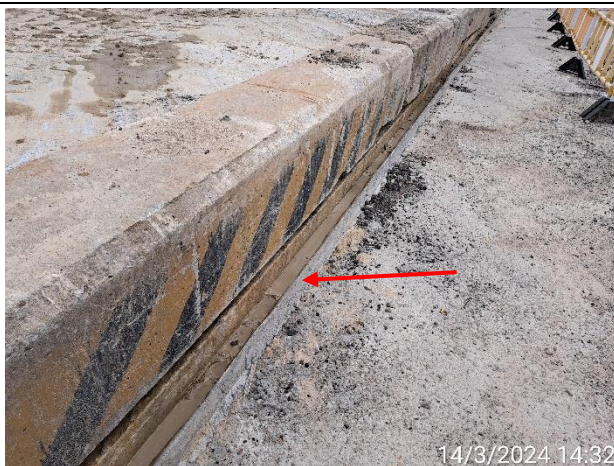
(P5)

Perimeter channels were installed outside the contaminated soil treatment area.

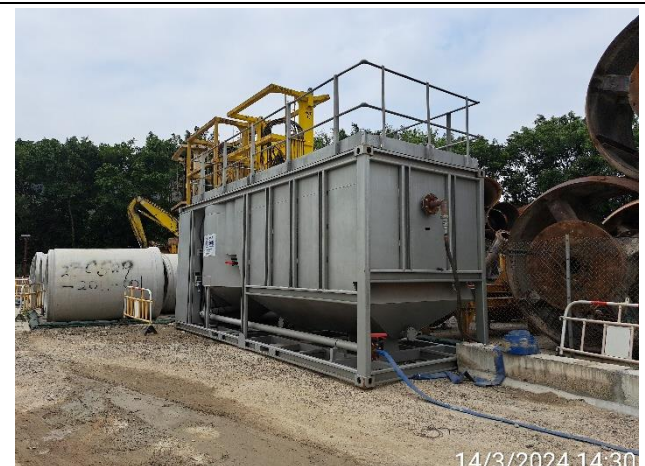
(P6)

A WetSep was provided on site to treat and store construction effluent from Site 3-6, Site 3-7, and Contaminated Soil Treatment Area. No off-site effluent discharge was recorded in March 2024.

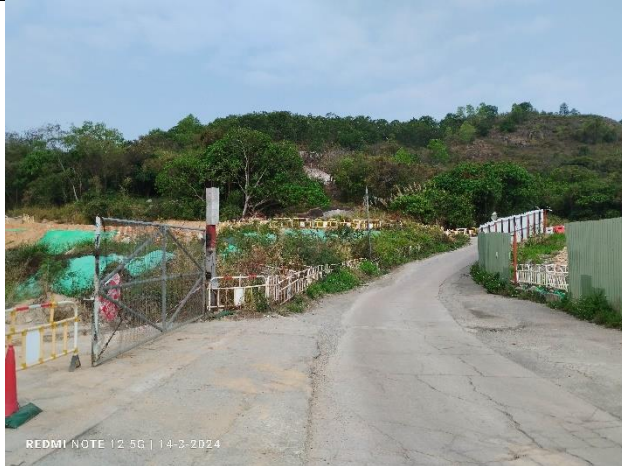
(R1)

No effluent discharge from the site was observed.

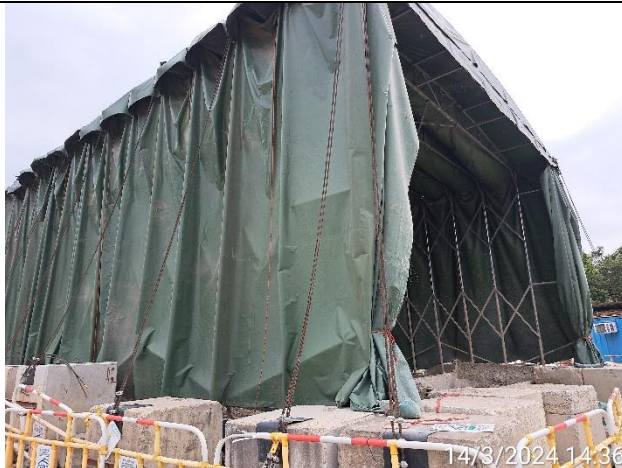
(R2)

The contaminated soil treatment area would be covered by impervious canvas during treating contaminated soil. No surface runoff or effluent was leaked from the contaminated soil treatment area during the site inspection.

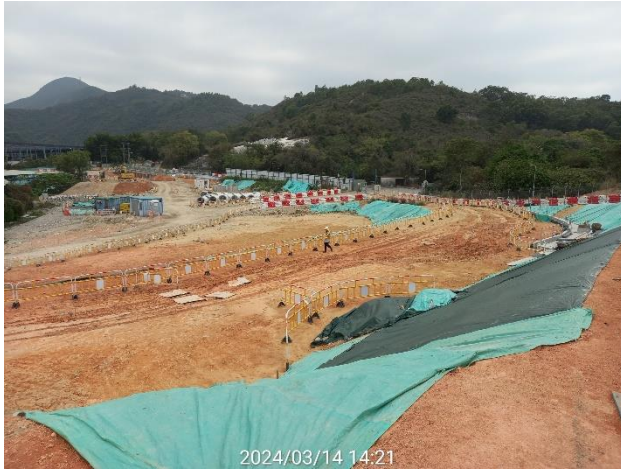
(R3)

No effluent discharge from the site was observed.

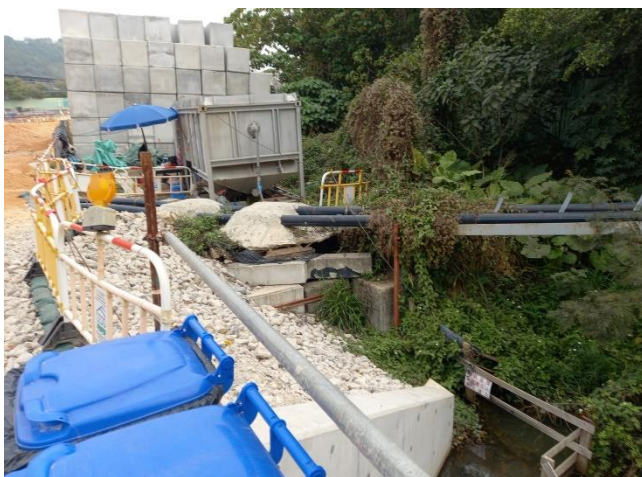
(R4)

No off-site effluent discharge was recorded in March 2024.

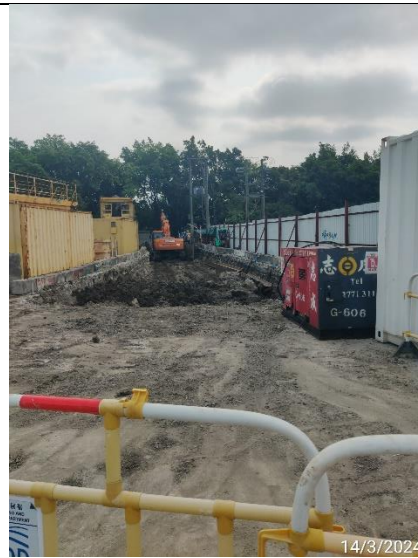
(R5)

No off-site effluent discharge was recorded in March 2024.
