## Investigation Report for Exceedances of Limit Level of Water Quality Monitoring on 4 May 2023

Environmental Team for Hung Shui Kui/ Ha Tsuen New Development Area Stage 1 Works – Site Formation and Engineering Infrastructure								
Date	Station	Parameter (Unit)	Depth-averaged Measured Value	Action Level	Limit Level	Exceedance		Project Related (Y/N)
						AL	LL	
04/05	TKW1	Suspended Solids (SS) (mg/L)	66.0	16.0	18.4		✓	N
	TKW		54.0	19.8	21.6		✓	N

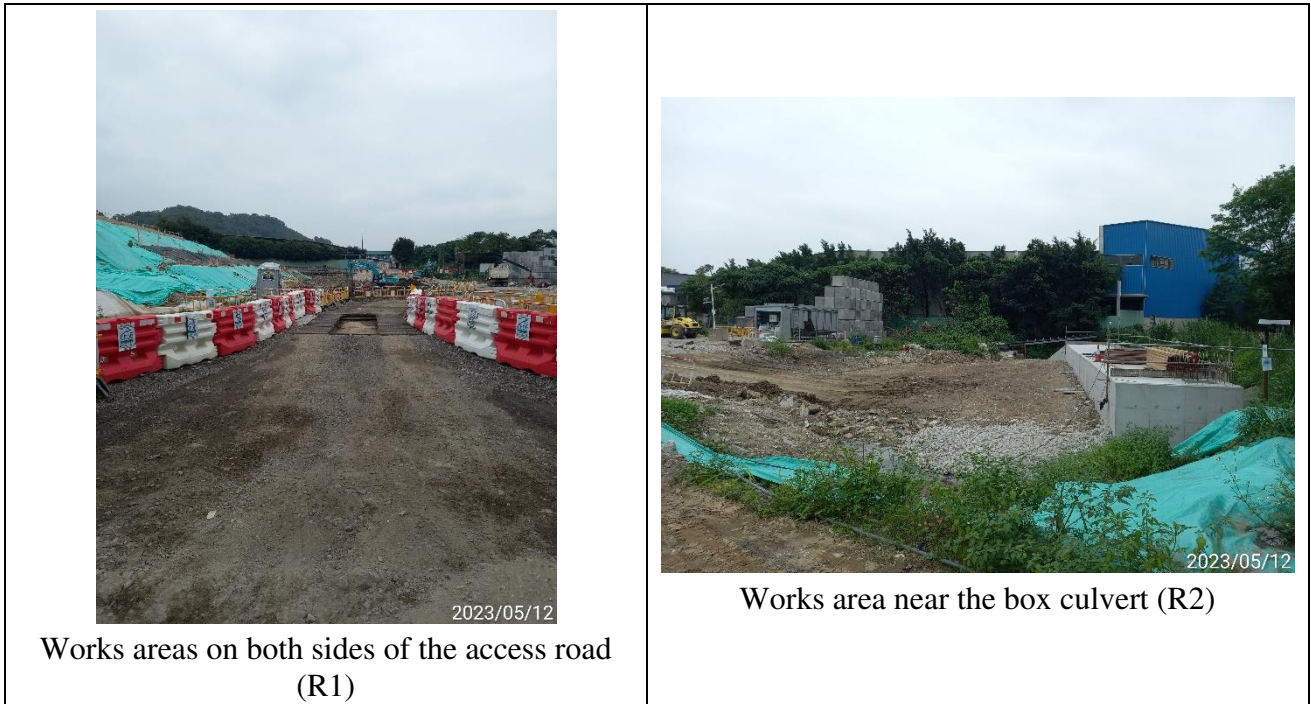
### Site Photos on 12 May 2023 provided by the Engineer

5. As requested by the RE and the ET, the Contractor stopped the overflow immediately and fixed the WetSep. No further overflow was observed after the WetSep resumed normal operation on the same day.
