Investigation Report for Exceedances of Limit Level of Water Quality Monitoring on 18 July 2023

Environmental Team for Hung Shui Kiu/ Ha Tsuen New Development Area Stage 1 Works – Site Formation and Engineering Infrastructure								
Date	Station	Parameter (Unit)	Depth-averaged Measured Value	Action Level	Limit Level	Exceedance		Project Related (Y/N)
						AL	LL	
18/07	TKW1	Turbidity (NTU)	121.5	27.9	29.2		✓	N
	TKW		122.5	24.2	24.6		✓	N
	TKW1	Suspended Solids (SS) (mg/L)	44.0	16.0	18.4		✓	N
	TKW		44.5	19.8	21.6		✓	N

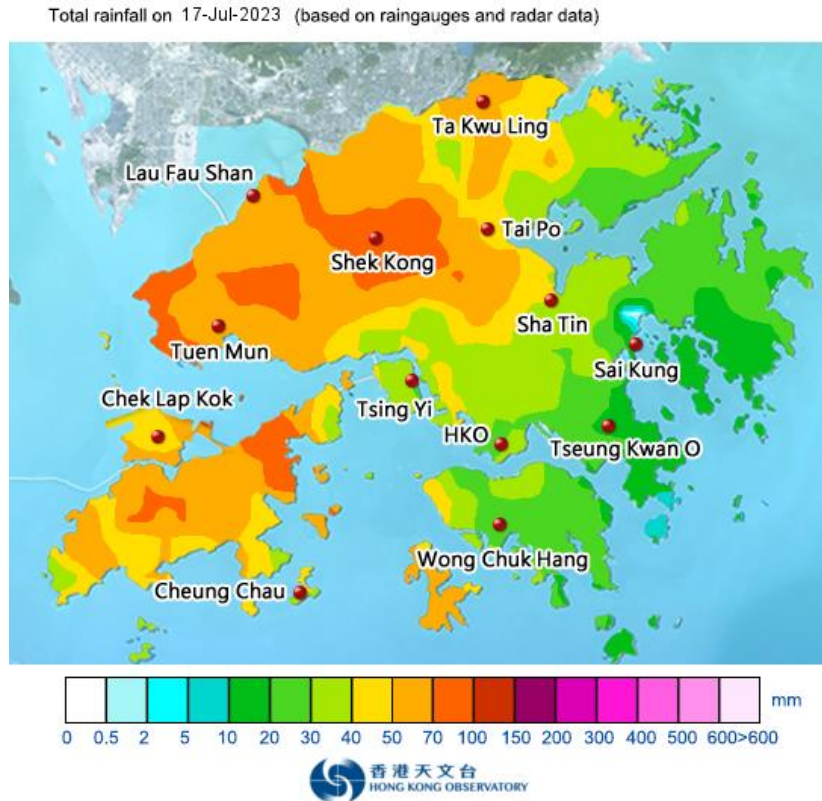
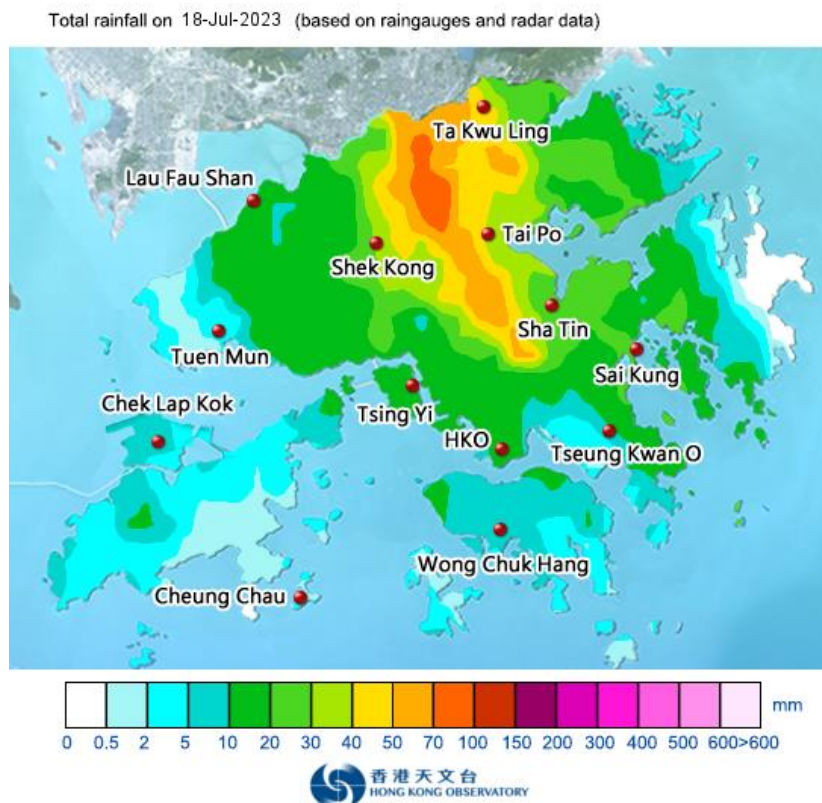
Figure 1 Rainfall Records from the Hong Kong Observatory

Possible reason for Action or Limit Level Non-compliance:	<p>According to the records of the Hong Kong Observatory, about 50 to 100 mm and 10 to 20 mm rainfalls were recorded over Hung Shui Kiu on 17 and 18 July 2023, respectively, which led to river</p>
