## Investigation Report for Exceedances of Limit Levels of Water Quality Monitoring on 12 March 2024

Environmental Team for Hung Shui Kiu/ Ha Tsuen New Development Area Stage 1 Works – Site Formation and Engineering Infrastructure								
Date	Station	Parameter (Unit)	Depth-averaged Measured Value	Action Level	Limit Level	Exceedance		Project Related (Y/N)
						AL	LL	
12/03	SW	Dissolved oxygen (DO) (mg/L)	1.6	2.3	2.1		✓	N
	HT		1.6	2.2	2.1		✓	N

## Investigation Report for Exceedance of Limit Level of Water Quality Monitoring on 14 March 2024

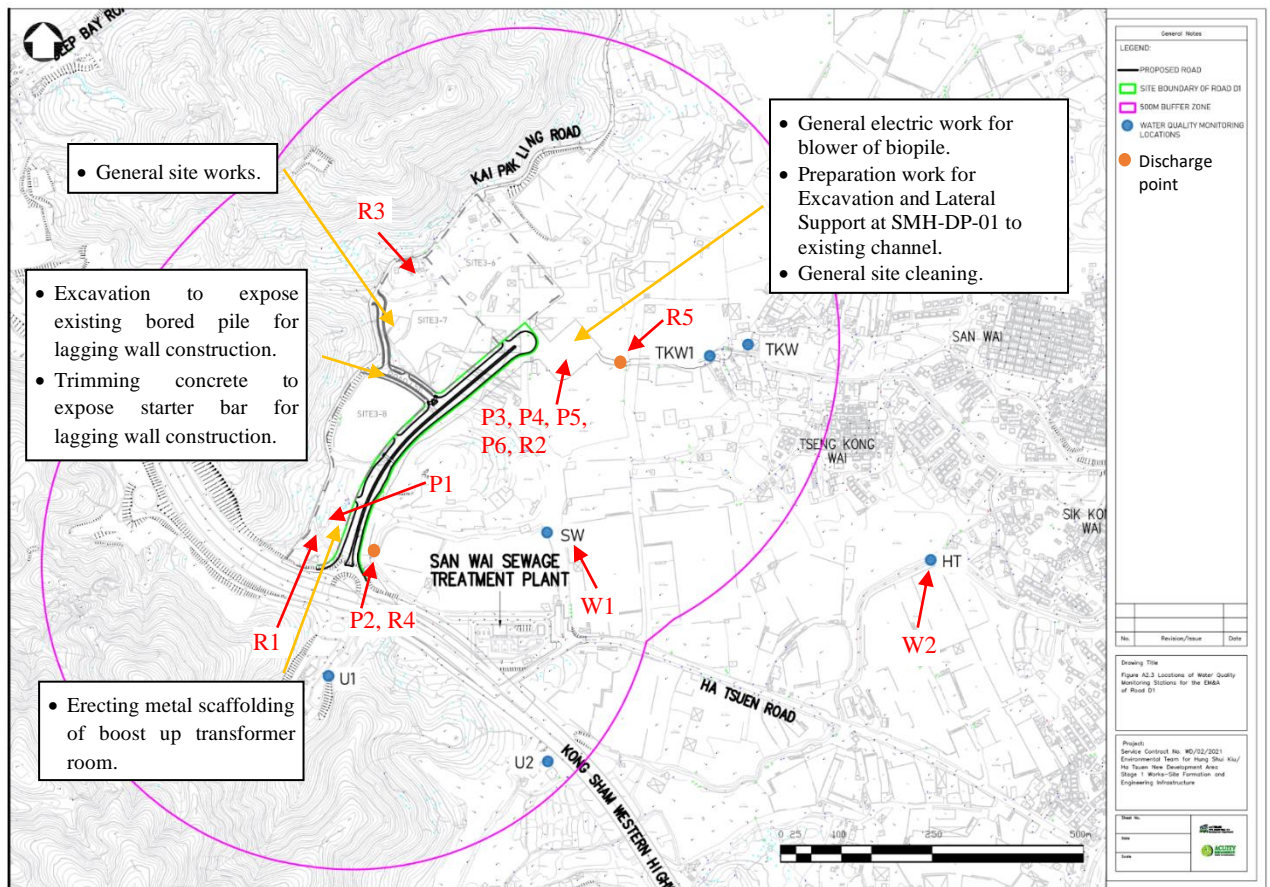
**Figure 1 Location Plan of Impact Water Quality Monitoring Stations (Site activities held on 12 March 2024 were reported in text boxes)**

Water Quality Monitoring Station: HT

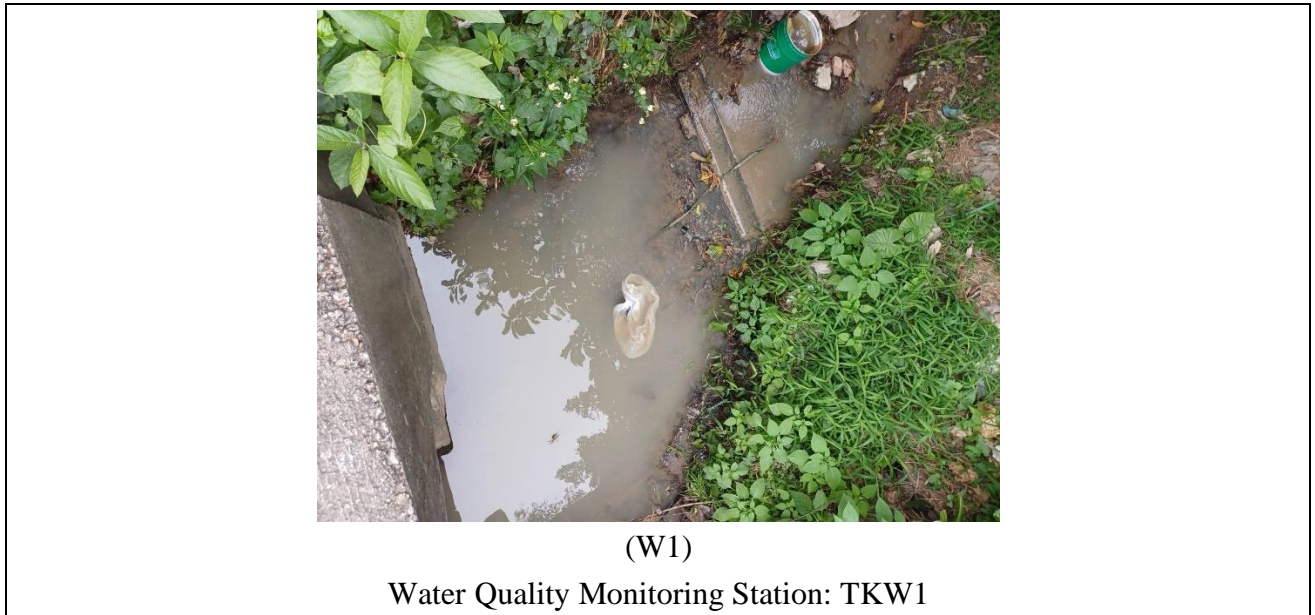
### Site Observation Photos around Water Quality Monitoring Stations taken by the ET on 14 March 2024

No off-site effluent discharge was recorded in March 2024.
