Environmental Team for Hung Shui Kiu/Ha Tsuen
New Development Area Stage 1 –
Site Formation and Engineering Infrastructure

Monthly EM&A Report
(January 2024)

(Environmental Permit No. EP-528/2017)

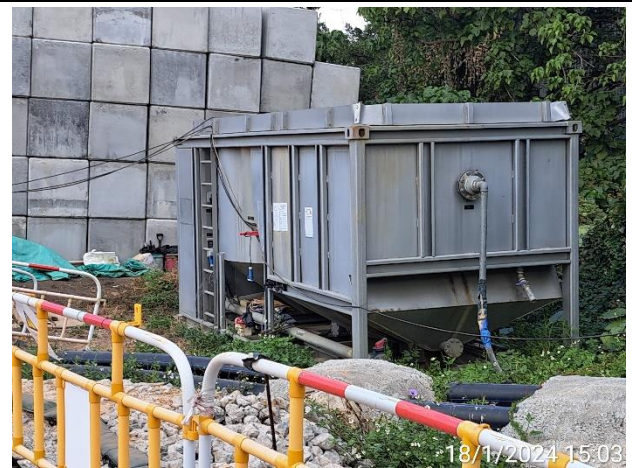
(P2)

Surface runoff and site effluent were collected and diverted to the WetSep for temporary storage and treatment before the water was used for fugitive dust suppression on site or discharged at designated location under the requirement of effluent discharge licence.

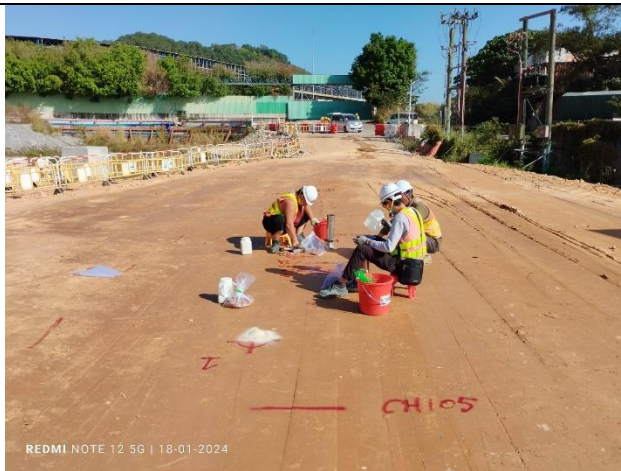
(R1)

No effluent discharge from the site was observed.

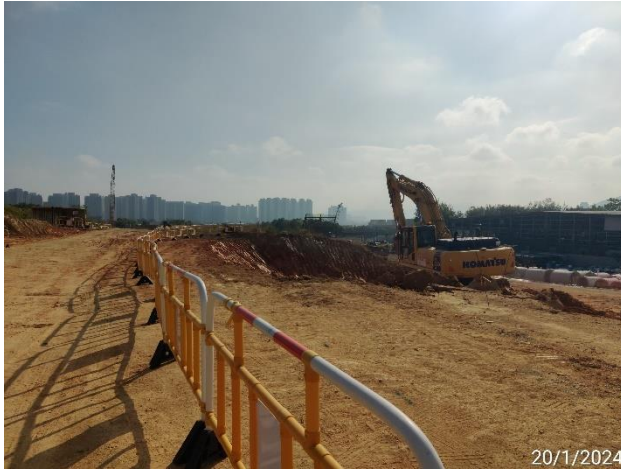
(R3)

No effluent discharge from the site was observed.

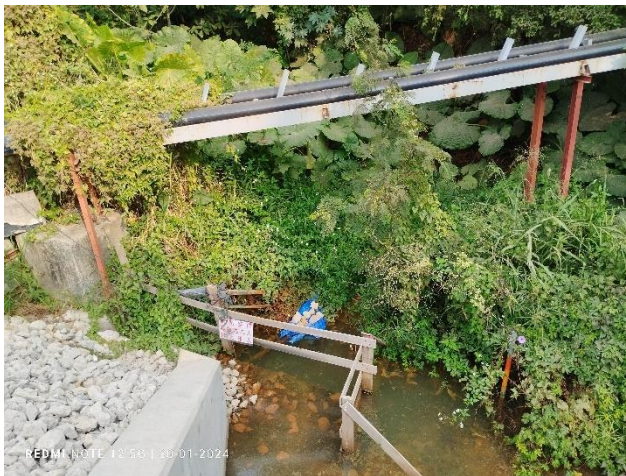
(R4)

No off-site effluent discharge was recorded in January 2024.
