Investigation Report for Exceedance of Limit Level of Water Quality Monitoring on 1 March 2023

Environmental Team for Hung Shui Kui/ Ha Tsuen New Development Area Stage 1 Works – Site Formation and Engineering Infrastructure								
Date	Station	Parameter (Unit)	Depth-averaged Measured Value	Action Level	Limit Level	Exceedance		Project Related (Y/N)
						AL	LL	
01/03	SW	Suspended Solids (SS) (mg/L)	14.0	8.8	10.5		✓	N

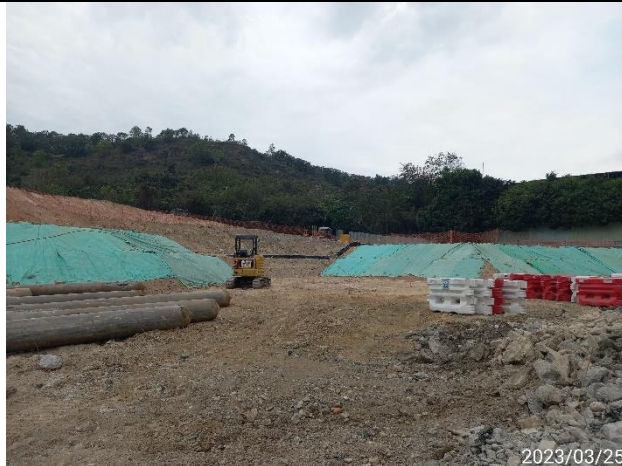
(R1)

Stockpile of dusty materials was covered properly to avoid generation of muddy runoff.
